## **COMPARISON OF FAULT-DETECTION METHODS IN PHOTOVOLTAIC MODULES**

An analysis of techniques utilising IV-tracing, UVF-imaging, EL-imaging,  
and IRT-imaging via visual analysis for fault-detection in PV-modules

**University of Agder, 2022**

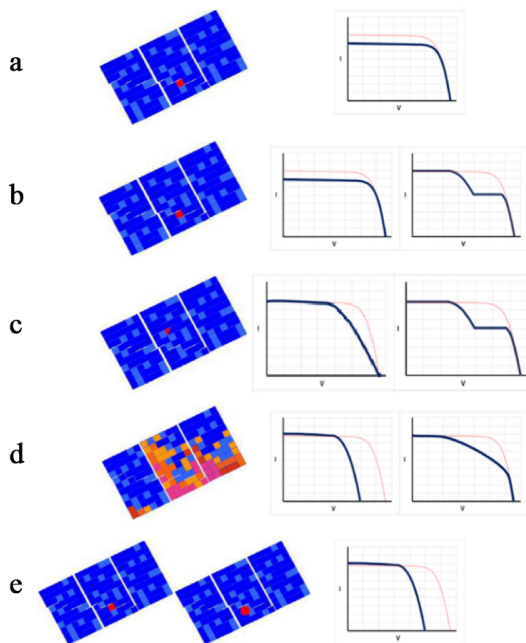
Figure 3.2.1: Table of infrared images and current-voltage curves correlated to different cell faults [7].

In Figure 3.2.1, case "a" shows an example of optical degradation of a cell. Here, there is one cell with a higher temperature than the others, and a drop in the short-circuit current,  $I_{SC}$ . They found that the power loss in this case is around 5% for issues with lamination, and around 10% for severe discolouration. The stress factor likely to cause these issues are high temperature and ultraviolet radiation.

Case "b" shows an example of a cell with cracks, micro-cracks or *snail trails*<sup>5</sup>. The amount of power loss in this case, heavily depends on the extent of the cracks and in which direction/pattern they run. An area of 8% inactivity will result in unacceptable losses, while 50% inactivity will trigger the bypass diode. The stress factors likely to cause such issues are thermal cycling or mechanical load.

Case "c" is an example of a piece missing from a cell, which has similar characteristics to the cracked cell, only with the missing piece showing increased temperature, instead of the whole cell. This fault causes an increase in series resistance,  $R_S$ , and the power loss is correlated to the size of the missing piece. The stress factors here are the same as in case "b". Both of case "b" and "c" shows typical signs of bypass-diode activation or drops in  $I_{SC}$  or  $V_{MPP}$ , respectively.

Case "d" shows an instance of *potential induced degradation*<sup>6</sup> (PID), which is most detectable at moments of low incident irradiation. The IRT-images show large areas of high temperature. The temperature difference in the module is higher for cases of medium degradation, compared to cases of more severe degradation. The power loss is up to 100 %, but the module is, in most cases, easily recoverable by applying a reverse voltage across the module. The amount of loss is dependent on the PV-module configuration. The IV-response shows either a drop in  $V_{OC}$  or both  $V_{MPP}$  and  $I_{MPP}$ . Stress factors are temperature, relative humidity, and electrochemical reactions.

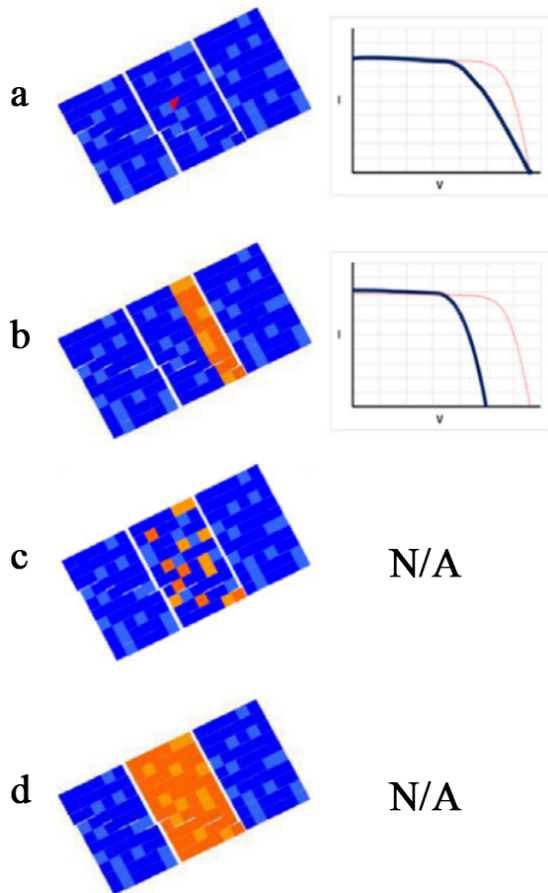
The first case shows an example where the connections between two cells are broken, to some degree. This kind of fault causes a very high temperature difference in parts or the whole of the cell in question, depending on the number of broken ribbons. In the case of an open circuit between the cells, the bypass diode would enable. The power losses are drastic for each of the broken ribbons, up to 30–50% loss. The fault is usually caused by thermal cycling or mechanical load.

Case "b" shows an example of a string in open-circuit with a defective bypass diode, or an internal short. The thermal response is a moderate, but uniform, temperature difference across the whole string or sub-string. The voltage loss in this case is according to

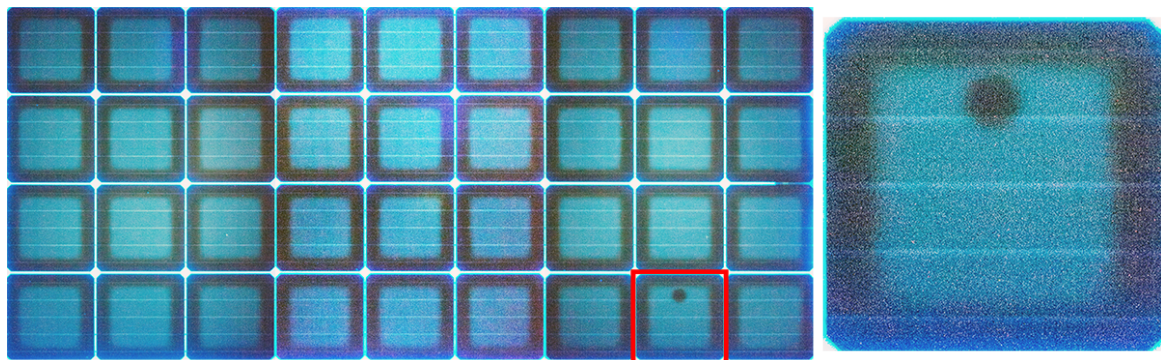
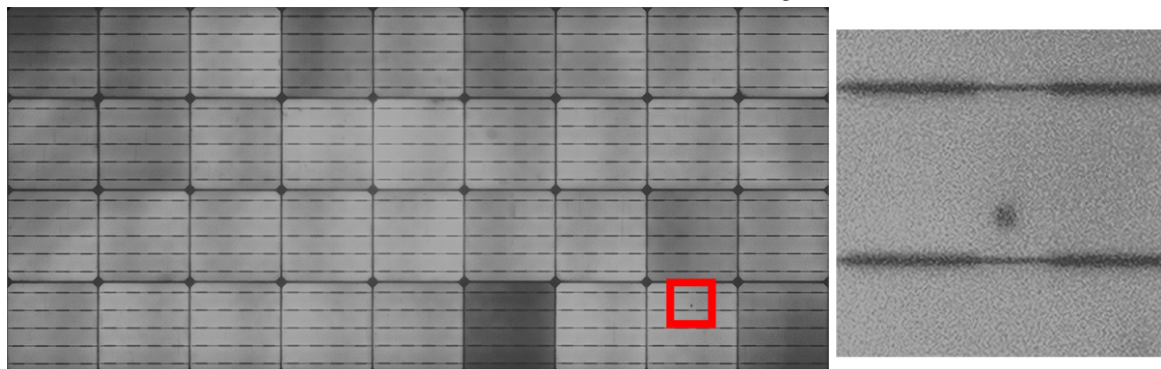
(a)  $\alpha$ -IV ultraviolet fluorescence zoom image.

(b)  $\alpha$ -IV electroluminescence zoom image.
