Moisture induced degradation in field-aged multicrystalline silicon photovoltaic modules

Oscar Kwame Segbefia^{*}, Naureen Akhtar, Tor Oskar Sætre

Department of Engineering Sciences, University of Agder, 4879, Grimstad, Norway

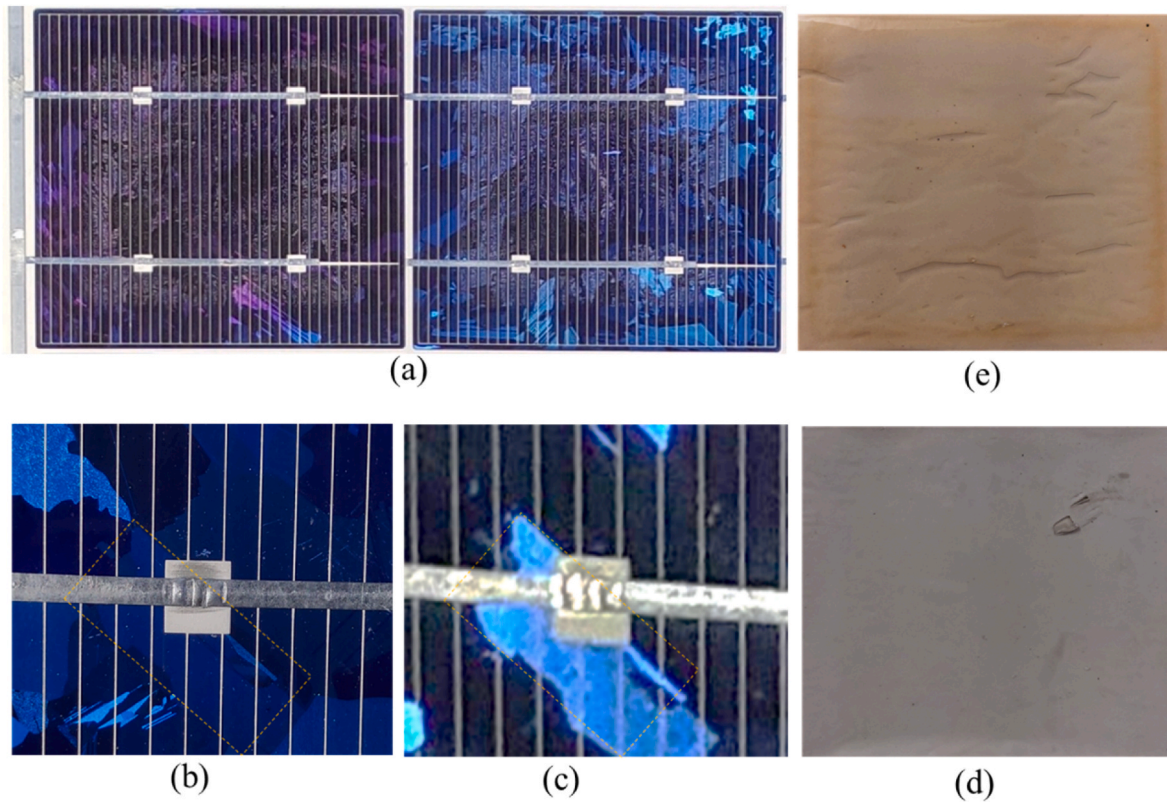
Fig. 3 shows some of the results from the visual inspection of the PV module. Fig. 3a shows the photographic images of a pair of solar cells acquired under clear sky outdoor conditions highlighting signs of optical degradation e.g., delamination and discolouration of the encapsulation. Fig. 3b and c are images acquired from the same area of the field-aged PV module under clear sky outdoor and dark room conditions, respectively. Fig. 3b and c shows complementary signs of MID degradations, which could not be seen in either of these Figs. alone.

Moisture induced discoloration is shown in the upper left corner in Fig. 3b whilst Fig. 3c shows accumulation of MID species around the solder joint. Fig. 3d and e shows the inner side of the TPT backsheets of solar cells extracted from the middle and the edge of the field-aged PV Module X, respectively. Fig. 3d is not discolored whereas Fig. 3e is discolored. Discoloration of the backsheets is a typical sign of degradation due to UV radiation. Yet, the effect of UV radiation is expected to be uniform across the backsheet in the same PV module. Hence, we believe that the degradation of the EVA encapsulation and the TPT backsheets of the PV module is due to moisture ingress. In Section 3.6, SEM-EDS analyses will be used to support this observation. Dark discolored backsheets were also observed in optically degraded PV modules

Corrosion at the solder joint is attributed to the dissolution of lead and tin (main components of solder) in moisture and acetic acid due to galvanic corrosion [17]. This could be due to low adhesion at the solder joint or the presence of defects during the soldering process [18]. The observed corrosion at the solder joint region could also be as a result of MID of the Ag grids [8]. However, this corrosion mechanism is only feasible in the presence of moisture. It can be seen in Fig. 4 that the metal grids have been masked out by MID species. The optical integrity of these areas in Fig. 4 appears to be compromised as well. Earlier investigation by the present authors established that more than 90% of these field-aged PV modules were affected by optical degradation, though other stressors such as UV radiation also can play significant roles [5, 40]. This observation agrees with other reports on the role of MID products in optical degradation of PV modules [13,14,16,27].

Fig. 3. Visual images of the field-aged PV module. Photographic images of a (a) pair of solar cells showing signs of delamination and discoloration of encapsulation, a copper ribbon under (b) clear sky outdoor and (c) optimized light exposure in dark room conditions, and the inner side of the backsheet of a solar cell (d) not affected and (e) affected by moisture ingress.

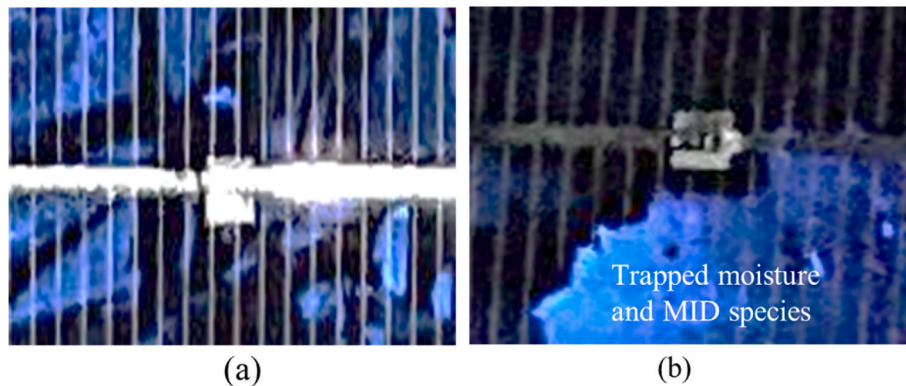
by other researchers [39]. Fig. 4 shows the visual images acquired from the same area of a solar cell close to the edge of field-aged PV Module X showing the degradation state of a Cu ribbon. Fig. 4a was acquired under clear sky outdoor conditions and Fig. 4b was acquired under optimized dark room conditions. The figure shows corrosion and oxidation of the metal grids, and trapped moisture and MID species, especially around the solder joint. Corrosion of metal grids around the solder joint area due to moisture ingress was also reported by other authors [17–19,23]. Fig. 4 suggests that Module X has been affected by moisture induced defects.

Fig. 4. Part of a solar cell and degraded copper ribbon showing signs of moisture ingress. Images were acquired under (a) clear sky outdoor and (b) optimized light exposure dark room conditions from the same area of the solar cell.

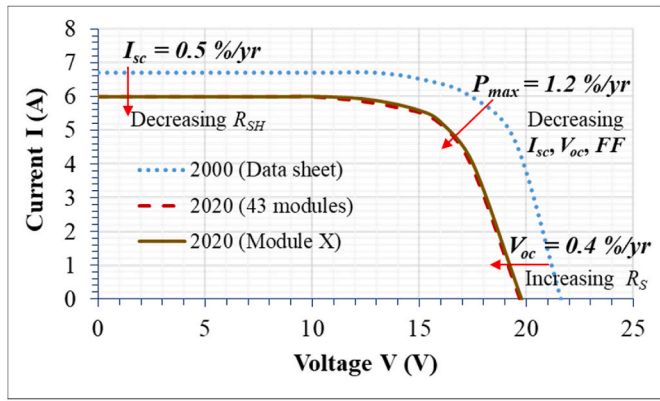
Fig. 5 shows the electrical characteristics of field-aged PV Module X. Degradation in the P_{max} , V_{oc} , and I_{sc} due to increased series resistance (R_S), low shunt resistance (R_{SH}), and reduced fill factor are illustrated. The annual degradation in P_{max} , V_{oc} , and I_{sc} for PV Module X were found to be approximately 1.2%, 0.4%, and 0.5%, respectively. The degradation in PV Module X is similar to the average degradation in all the field-aged PV modules. Corrosion of metal grids, optical degradation, and PID due to moisture ingress are known to be the underlying causes of resistance losses, hence, power degradation [4,25]. Considering the location of the present investigation, the influence of MID mechanisms on the degradation of these PV modules is high [5]. MID products such as acetic acid, acetates, oxides and hydroxides of silver, lead, silver, tin, and copper were reported to be responsible for increased series resistance and shunting [12,14,30].

Fig. 5. Electrical characteristics of the solar PV module. Degradation per year (yr) in P_{max} , V_{oc} , and I_{sc} as well as the effect of the series resistance (R_S), shunt resistance (R_{SH}), and fill factor (FF) are illustrated.

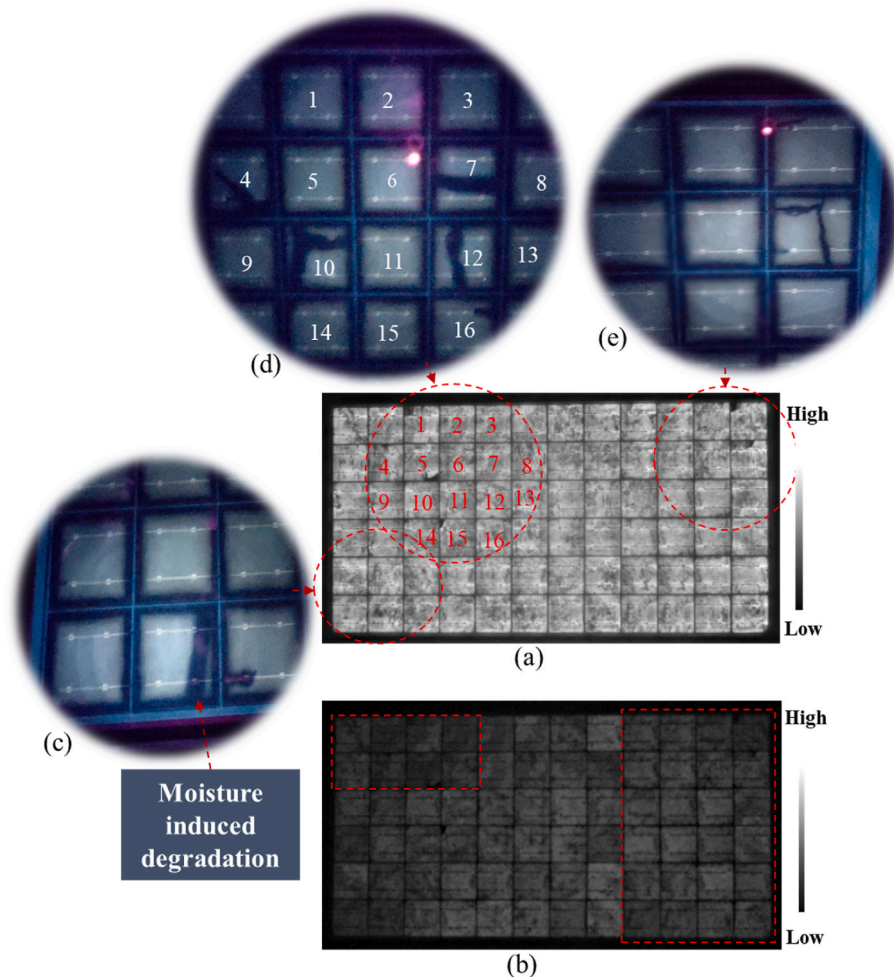
Fig. 6 shows the EL and UV-F images of field-aged PV Module X. Fig. 6a and b are the EL images acquired under I_{sc} and $0.1I_{sc}$ forward bias conditions, respectively. Fig. 6a shows the presence of microcracks and darker regions at the edges of the solar cells. Microcracks are conduits and reservoir for moisture ingress [4]. Darker marks at the edges of the solar cells suggest that degradation at the cell edges is more severe [26]. From Fig. 6b, it can be seen that the majority of the solar cells around the

edge of the module are darker than those in the middle of the module. Dark cell patterns (especially around the edge of the module) indicate the presence of MID products such as metal oxides and acetates [12,14,19,30]. In addition, most of the darker cells are located nearer to the perimeter of the PV module indicate moisture induced PID, as indicated by the β_{Jmpp} . This observation is in line with other reports [25,26]. The satellite cells in the areas affected by cracks also show darker patterns.

Module X was chosen were found to show weak fluorescence and luminescence signal intensities [5]. Fig. 6c, d, and 6e are the UV-F images of the corresponding marked out areas in Fig. 6a showing the evidence of microcracks and MID. Although most of the defective areas (microcracks) in the UV-F images correspond with the observation in the EL image (Fig. 6a), some microcracks were hidden in the EL images. Defects that do not affect current flow are not seen in EL images [26,47]. On the other hand, only degraded encapsulation areas are seen as dark areas in UV-F images [36,37].

Fig. 6. EL characteristics of PV Module X acquired under (a) I_{sc} and (b) $0.1I_{sc}$ forward bias conditions. (c)–(e) UV-F characteristics of various parts of PV Module X showing signs of microcracks and MID. All images were acquired in a dark room.

Fig. 6c, d, and 6e. Specifically, the geometry of the microcracks and the presence of some of the microcracks was not very clear in the EL images. In Fig. 6c, the copper ribbon in the defective area appears unbroken. Hence, the position of the defect in Fig. 6c is not very clear in the EL images (Fig. 6a and b). This defect is likely a moisture induced degradation. In Fig. 6d, the copper ribbons of the defective cells (e.g., Cells 4, 7, 10 and 12) appear to be completely broken. These microcracks are also multidimensional to the busbars and are more critical to power loss. Since these microcracks are located close to the edge of the PV module, the influence of moisture ingress on the microcracks formation and degradation cannot be ruled out. The geometry and positions of the microcracks in Cells 4, 7, 10, and 12 are not very clear in Fig. 6a, however. Hence, UV-F technique is better suited for detecting moisture induced defects and fault modes.

In addition, the nature of the microcracks (e.g., crack width) in Fig. 6c and d shows further degradation of the microcrack regions which might be due to the influence of moisture ingress under multiple real field environmental stressors. The microcrack patterns in Fig. 6c and d are broader in width and extend beyond the immediate crack regions. However, the microcrack in Fig. 6e is narrower and suggests that the effect of moisture ingress on this crack region is less severe. In Fig. 6e, even though the microcrack is located at edge of the PV module, the microcrack appears to be opened inwards away from the Al- frame. However, in Fig. 6c, the microcrack opens towards the Al- frame. In Fig. 6c, the influence of moisture ingress from the edge of the module is greater than in Fig. 6e. In an earlier investigation on these field-aged PV modules, PV modules with strong fluorescence and luminescence signals show sharper crack patterns [40]. The effect of moisture on the degradation of microcracks was also observed elsewhere [48]. Moisture ingress induce the formation of silver and lead acetates, oxides, sulfides, and phosphates in the affected areas in PV modules [13,28]. These degradation products are witnessed as dark areas in EL and UV-F images [13,14,16].

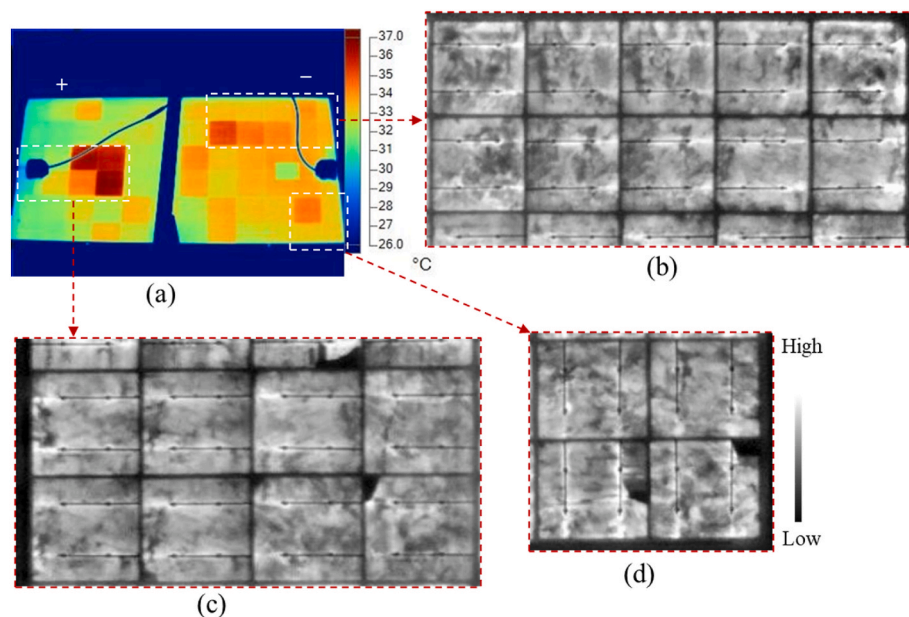
with the highest and lowest T_c can be an indication of the presence of specific defects and fault mechanisms [26,47,49]. Fig. 7a shows the IR-T image of PV Module X. The respective zoomed-in EL images of the marked-out areas in Fig. 7a are shown in Fig. 7b, c, and 7d. The marked-out areas in Fig. 7a are closer to the frame of the module and show the most critical hotspots. This is an indication of the occurrence of large leakage current during operation. There are other hotspots all over the module, however. The respective location of the hotspot cells closer to the frame of the PV module supports the observations in the EL images. The number of hotspot cells suggests that the majority of the cells in field-aged PV Module X are at different stages of degradation.

In Fig. 7b, no obvious crack was observed. Yet, the corresponding area in Fig. 7a shows hotspots. The observed hotspots in Fig. 7a might be due to metal grids corrosion and/or solar cell degradation. Fig. 7c shows the presence of microcracks and the warmest cells were observed in this area in the IR-T image, see Fig. 7a. On the other hand, Fig. 7d shows some cracks. However, the hotspots of its corresponding area in the IR-T image were not as high as the hotspots in Fig. 7c. The criticality of cracks to current flow underpins the occurrence and severity of the hotspots observed in Fig. 7c [25,26]. The ΔT of PV Module X was found to be $\sim 8.2 \pm 2$ °C. The presence of MID products such as acetic acid, oxides and acetates of silver, lead, and copper could also influence the formation and the characteristics of the hotspots [12].

Fig. 7. (a) IR-T characteristics of PV Module X acquired under clear sky outdoor conditions. (b)–(d) EL characteristics acquired under I_{sc} bias conditions of the corresponding marked areas in (a).

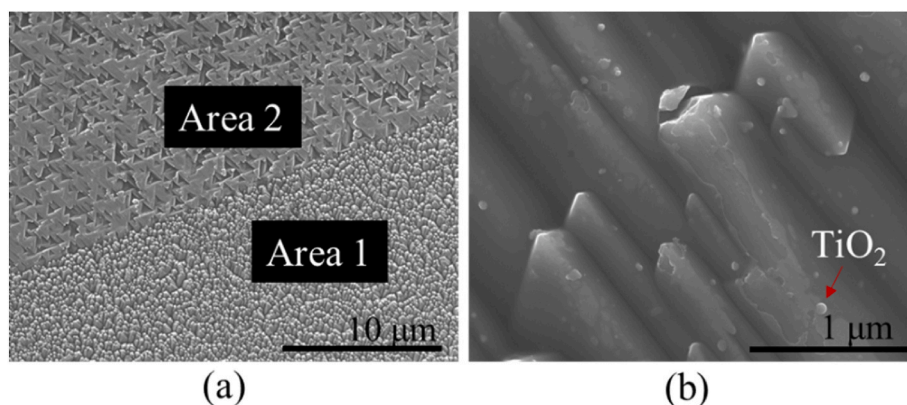
Fig. 8 shows the SEM micrographs of a multicrystalline silicon solar cell extracted from the edge of PV Module X. Fig. 8a shows two distinct surface morphology of the silicon microcrystal structures present in the solar cell. Area 1 appears to be the characteristic surface morphology of alkaline anisotropic etching of crystalline silicon [50]. On the other hand, Area 2 depicts the surface morphology of isotropic etching using acidic solutions [50]. As a multicrystalline silicon solar cell, the cell is made up of different crystals with random crystallographic orientations. It is known that etching rate depends on the etchant, crystal type and orientation. Hence, the crystal type and orientations might be the reason for the difference in the surface morphology in Fig. 8a.

Fig. 8. SEM micrographs of a solar cell extracted from PV Module X showing (a) the types of micro crystallographic features and (b) high magnification micrograph of Area 1.

panel bulk depending on the voltage bias in the field. Under negative bias, as typical of solar panels affected by PID, the EVA under moisture ingress can produce basic environment in the panel. High basic environment can make degradation of the silicon solar cell, antireflection coating, and corrosion of the metal grids feasible. However, under negative bias, the effect of basic environments on the corrosion of Ag metallization is negligible [51]. Yet, the amount of moisture accumulation within the solar panel is the rate determining step for the resulting basic or acidic environment in the panel. Moreover, since the solar cells used for the present investigation were extracted from the edge of the module, the influence of voltage bias (i.e., PID) on the degradation mechanisms in the module cannot be ruled out. Fig. 6b shows that the module might be affected by PID. Therefore, it is likely that the EVA encapsulation degraded and provided both acidic and basic environments inside Module X. This suggests that degradation of different crystals in the solar cell to different degrees is possible. This is likely one of the reasons for the differences in the surface morphologies observed in Fig. 8a.

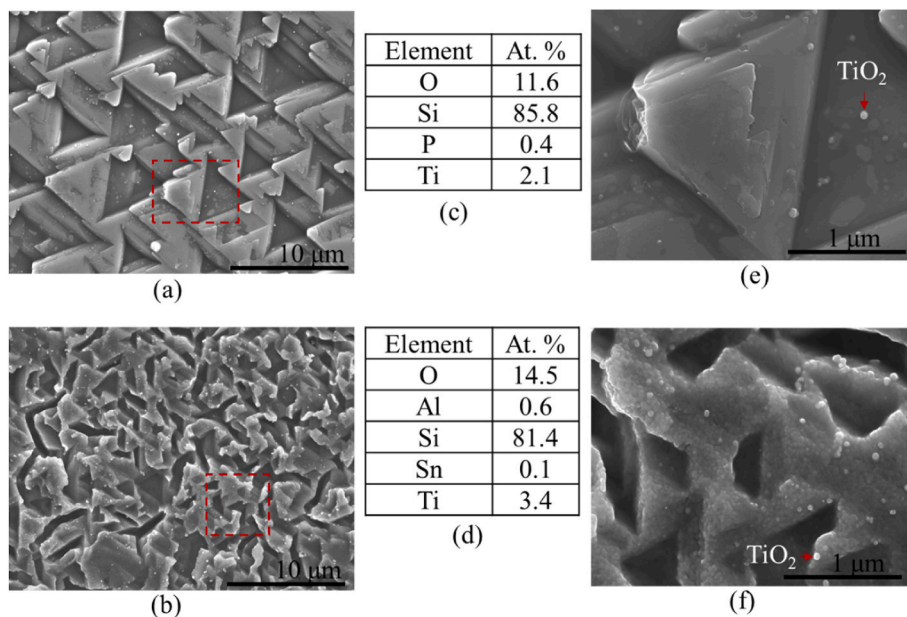
Fig. 9 shows the SEM micrographs and EDS analyses of a solar cell extracted from the edge of the module. Fig. 9a and c are the respective SEM and EDS analyses acquired approximately 10 mm from the edge of the solar cell. In Fig. 9b and d, the SEM micrograph and EDS analysis taken from the edge of the cell are shown, respectively. The EDS

Fig. 9. SEM micrographs and EDS analyses of a solar cell extracted from the edge of PV Module X. (a)–(b) SEM micrographs and (c)–(d) EDS analyses acquired ca. 10 mm from the edge and just at the edge of the solar cell. SEM micrographs of the marked-out areas in (a) and (b) are shown in (e) and (f), respectively. The EDS analyses are represented in atomic % (at. %).

analyses show the composition of oxygen (O), silicon (Si), phosphorus (P), titanium (Ti), aluminum (Al), tin (Sn), and lead (Pb) in atomic % (at. %). Fig. 9e and f are the SEM micrographs of the marked-out areas in Fig. 9a and b, respectively. The microcrystal structures in Fig. 9a are similar to what was observed in Fig. 8a, Area 2. However, the microcrystal structures in Fig. 9b are completely different from what was observed in Fig. 8. The microcrystalline features of the solar cell in Fig. 9b appear to be more amorphous. The EDS analyses in Fig. 9c and d shows that the amount of oxygen is higher in the results acquired from the edge of the field-aged PV module. It is clear from Fig. 9e and f that the region of the solar cell in Fig. 9f is more amorphous than what is observed in Fig. 9e. The presence of oxygen in Fig. 9e and f suggests that there is a general trend of degradation across the solar cell. With these microcrystalline structures, poor charge carrier generation and high parasitic recombination in the solar cells is expected. This is likely one of the key factors for the observed degradation in P_{max} of the field-aged PV module, refer to Fig. 5. Phosphorus (P) in Fig. 9c is believed to come from the MID of the EVA encapsulation [23].

Fig. 9d shows the presence of Al and Sn. Aluminum can leach from the back contact of the cell or from the Al- frame of the PV module to the cell surface under the influence of moisture ingress [16,20]. Galvanic

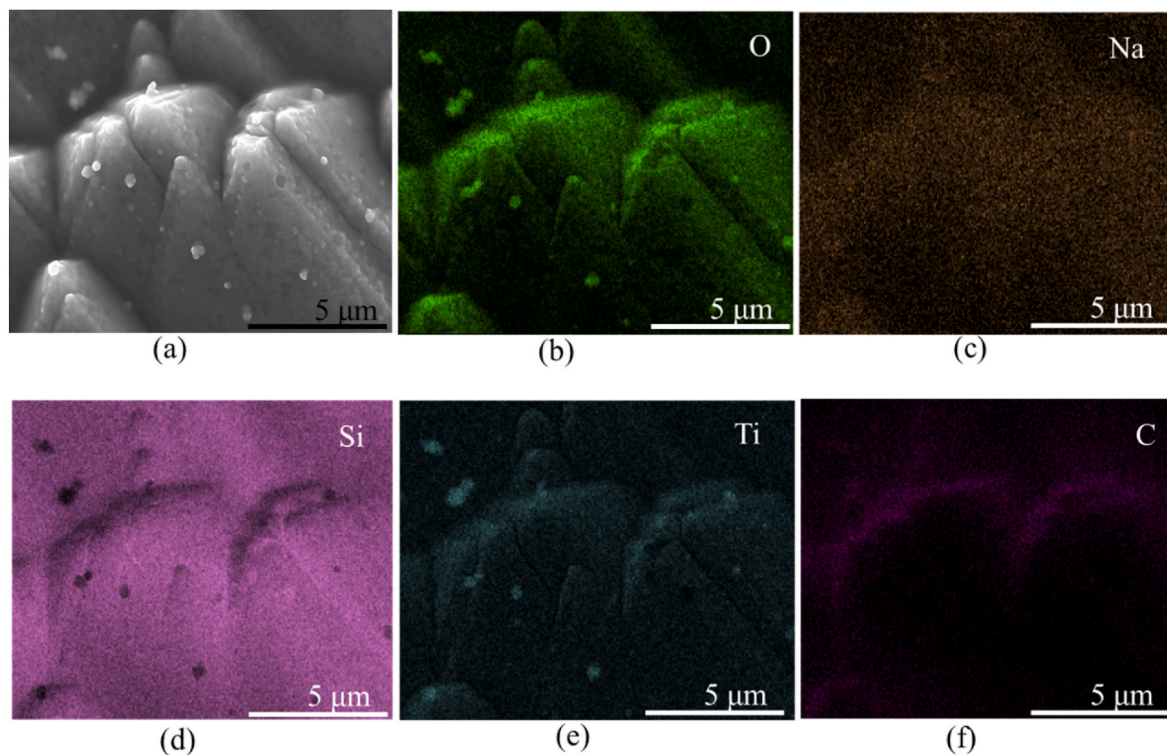
From Fig. 10b and d, distribution of oxygen across the surface of the cell can be observed. The black spots and traces around the pyramids of the Si microcrystals are the traces of oxidized TiO_2 ARC NPs around these areas. This was also observed elsewhere [16]. Fig. 10e also suggests that beside the TiO_2 ARC NPs, traces of Ti were observed across the cell area. The traces of carbon (Fig. 10f) indicate that the presence of acidic species e.g., acetic acid in the module is possible. EVA encapsulants produce acetic acid under the influence of moisture and light [4]. The presence of carboxylic acids led to further degradation of Si in these

Fig. 10. (a) SEM micrograph and EDS element mappings of (b) oxygen, (c) sodium, (d) silicon, (e) titanium, and (f) carbon acquired from the edge of a solar cell extracted from PV Module X.

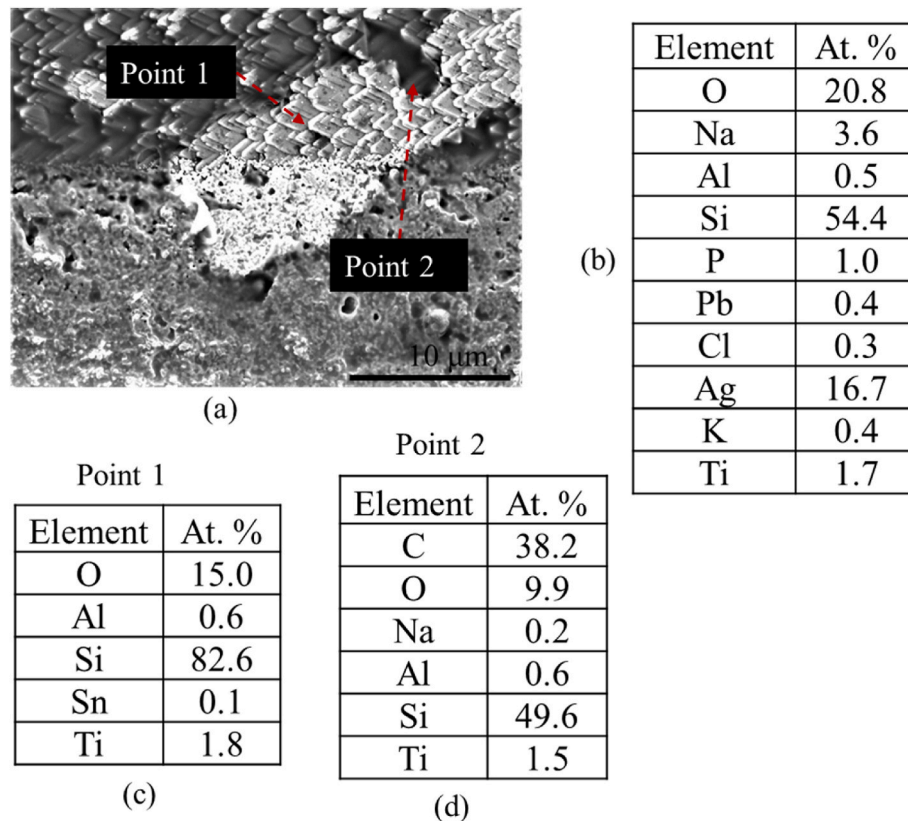
The presence of carbon could also be due to the diffusion of carbon dioxide (CO_2) from the edge of the module or/and through cracks created in the module during field operation [4]. Fig. 11 shows the SEM micrograph and the respective EDS analyses of a cell area close to the Ag fingers of a solar cell extracted from the edge of Module X. The SEM micrograph in Fig. 11a suggests that the front surface of the solar cell and the Ag finger have undergone substantial degradation.

This observation is supported by the EDS full area analysis (Fig. 11b) and spot analyses in Fig. 12c and d. The presence and amount of oxygen in the EDS analysis in Fig. 11b suggest the influence of moisture ingress on the observed cell degradation. There is migration of cations of sodium, aluminum, lead, silver, potassium, and titanium to the surface of the solar cell under the influence of moisture ingress. Subsequently, the spot analysis of Point 1 shows that the silicon solar cell has been oxidized, see Fig. 11c. Interestingly, the amount of Si at Point 2 is the least due to the presence of C and O, see Fig. 11d. Moreover, the presence and amount of carbon in Point 2 indicates the presence of MID products of EVA such as acetic acid.

The release of chlorine and phosphorus in the degradation process of the EVA encapsulation material is also possible, see Fig. 11b. Not long ago, Kumar et al. [12] also observed about 0.28 atomic % of chlorine in a field-aged PV module that was deployed in India. The presence of moisture and acetic acid accounts for the observed degradation of the solar cell and Ag grid in Fig. 11a. Ingressed moisture activates the surface of the Ag followed by reaction of the activated Ag grid with acetic acid to form silver acetate [13,14,16]. The formation of silver acetate leads to optical degradation [27]. Fig. 12 shows the EDS mappings of oxygen, silicon, carbon, and phosphorus of the SEM micrograph in Fig. 11a.

Fig. 11. (a) SEM micrograph of front surface of solar cell and (b) EDS analyses of the full area of SEM micrograph in (a). (c) Point 1, and (d) Point 2 of the Ag-Si region of a solar cell extracted from the edge of the field-aged PV module showing degradation of the solar cell and the Ag finger.

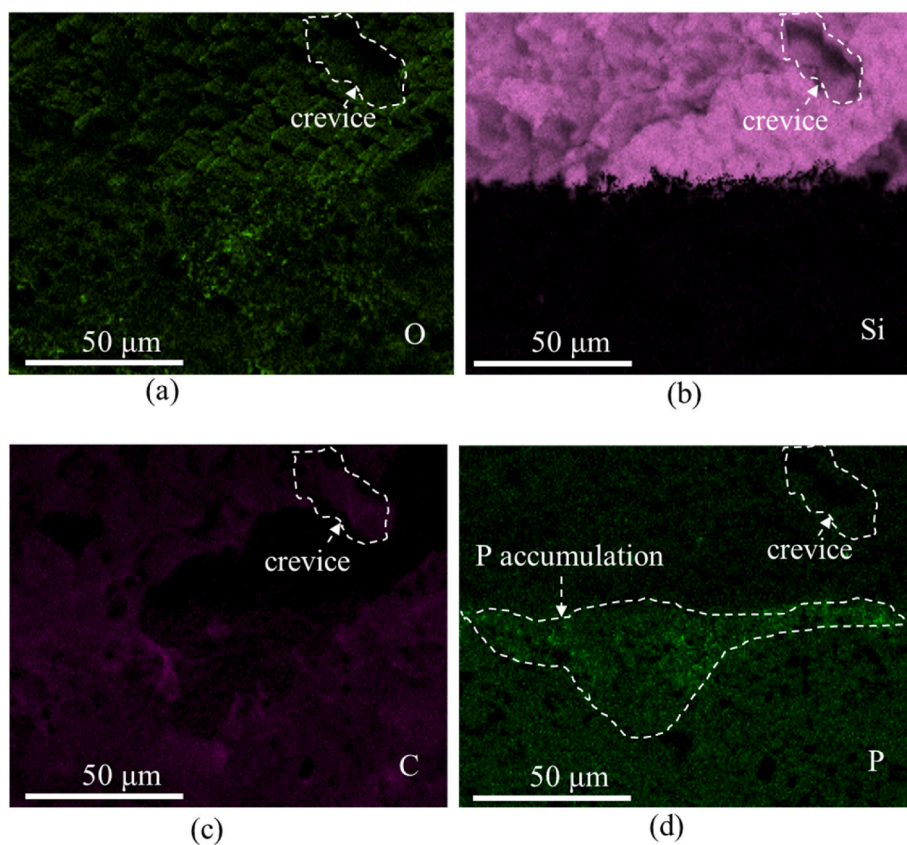
Fig. 12a shows that oxygen is found across the surface of the solar cell. In Fig. 12b, it appears that Points 1 and 2 are at different vertical

heights on the solar cell, compare with Fig. 11a. The Si mapping shows crevices or pits at the regions where carbon is present. The crevices appear dark in the EDS maps, see Fig. 12. These crevices appear to serve as reservoirs for moisture and MID products, refer to Fig. 11d. In that regard, acetic acid might accumulate and contribute to further degradation in the localized areas of Point 2 which can result in the observed crevices in Fig. 11. In addition, Fig. 12c shows that carbon is present across the surface of the solar cell, even on the Ag grids, except at Point 1 (as in Fig. 11a). Point 1 is therefore appears to have undergone full carboxylic acid degradation, and hence, the presence of carbon in these regions is negligible. This is because it is unlikely that the diffusion of moisture and its degradation species will be restricted to Point 2 (refer to Fig. 11a) alone. Furthermore, MID products such as Ag ions tend to absorb CO_2 to form their respective carbonates and acetates [13,54]. This could reduce the concentration of C at Point 1, and hence, could not be present in the EDS analyses of this area. Moreover, the production and accumulation of phosphorus across the solar cell-Ag grid boundary is consistent, see Fig. 12d. It is believed that MID processes of the solar cell and the encapsulation release phosphorus to form silver phosphates [13]. In addition, the accumulation of phosphorus at the cell-Ag grid boundary is greatest nearer to Point 1 (where C is absent). Production and accumulation of phosphorus in the PV module can be correlated to the degree of EVA encapsulation degradation in the presence of moisture [8,55]. The silver phosphates (Ag_3PO_4) degradation products lead to optical degradation [13,55].

Fig. 12. EDS element mappings of (a) oxygen, (b) silicon, (c) carbon, and (d) phosphorus of the SEM micrograph in Fig. 11a.

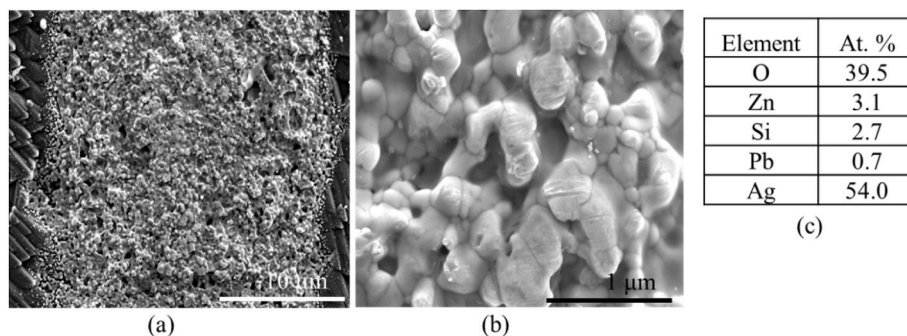
In Fig. 13b, the morphology of the Ag grid shows a compact and well-ordered microstructure. The neck of the Ag micro-clusters is thicker as compared to the pore sizes. The pore density of the Ag micro-clusters is low as well. Fig. 14 shows the SEM micrographs and the EDS analysis of the Ag finger of a solar cell extracted from the edge of field-aged PV Module X. Fig. 14a and b shows the morphologies of the Ag grid of the solar cell and the EDS analysis is shown in Fig. 14c. The microstructure of the Ag grid in Fig. 14a is coarser than what is observed in Fig. 13a. Also, the neck of the Ag micro-clusters in this case are thinner and irregular, see Fig. 14b. The pore density is also higher as compared to what was observed in Fig. 13b. In addition, white micro crystallites were observed on the Ag NPs. These white crystallites are expected to be the acetates of silver or lead. These observed morphological changes agree with other reports in literature [13,14]. Duerr et al. [13] observed coarse Ag finger grids, white silver acetate crystals, and more porous Ag clusters in crystalline silicon modules affected by snail trails.

Jeffries et al. [14], observed thinner Ag cluster necks, larger and more pores, and irregular bumps, and white spot crystallites after a commercial Ag paste was subjected to 3000 h of acetic acid exposure. Moreover, Fig. 14c suggests that the Ag grids have been oxidized. This suggests that the formation of zinc, silicon, lead, and silver oxides is feasible. Fig. 15 shows the SEM micrographs and EDS analyses of the Ag busbar (refer to Fig. 2) of a solar cell extracted from the field-aged PV module. The analysis was carried out in the region nearer to the solder joint of the solar cell.

Fig. 14. (a)–(b) SEM micrographs of the Ag finger of a solar cell extracted from the edge of the field-aged PV module and (c) EDS analysis of the SEM micrograph in (b).

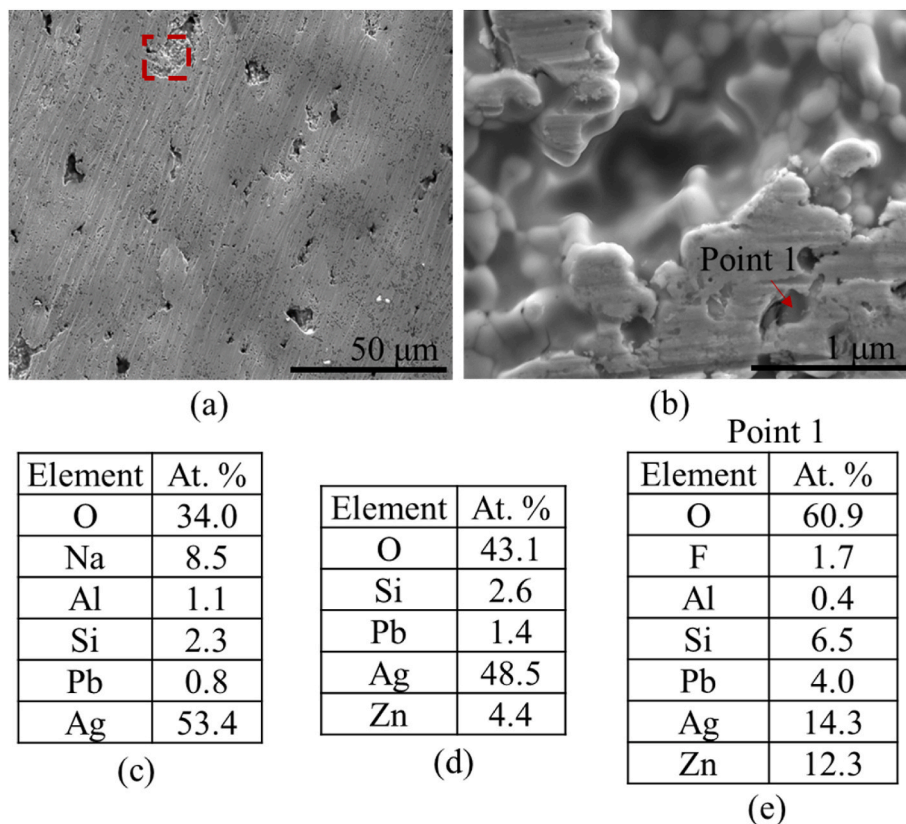
Fig. 15a shows that degradation of the Ag grid is possibly minimal. However, the EDS analysis of Fig. 15a suggests that Ag₂O is the main degradation product, see Fig. 15c. Fig. 15b is the SEM micrograph of the marked-out area in Fig. 15a, which highlights the degradation of the Ag grid better. This observation is supported by the corresponding EDS analysis in Fig. 15d, where the main degradation product expected in this area is AgO. A further EDS analysis at Point 1 in Fig. 15b suggests that the Ag grid could be present in a more severe degraded form, see Fig. 15e. The presence of fluorine in the EDS analysis in Fig. 15e might be coming from the degradation of the EVA encapsulant. The migration of Na, Al, and Pb to the surface of Ag grid is due to moisture ingress, as observed elsewhere [12,13,15–17,19]. Zinc, a component of Ag paste, is one of the degradation products responsible for optical degradation [13, 28]. Zinc oxide (ZnO) was reported to be the intermediate compound for the formation of silver carbonate and silver hydroxide [54]. In this reaction mechanism, ZnO catalyzes the adsorption of ingressed CO₂ onto the Ag grid [13,54,56]. CO₂ could also be the byproduct of EVA degradation [4,13].

Fig. 15. (a) SEM micrograph of the Ag busbar from the region nearer to the solder joint of the field-aged solar cell. (b) High magnification SEM micrograph of the marked-out area in (a). (c)–(e) EDS analyses of the SEM micrograph areas in (a), (b), and point analysis at Point 1, respectively.

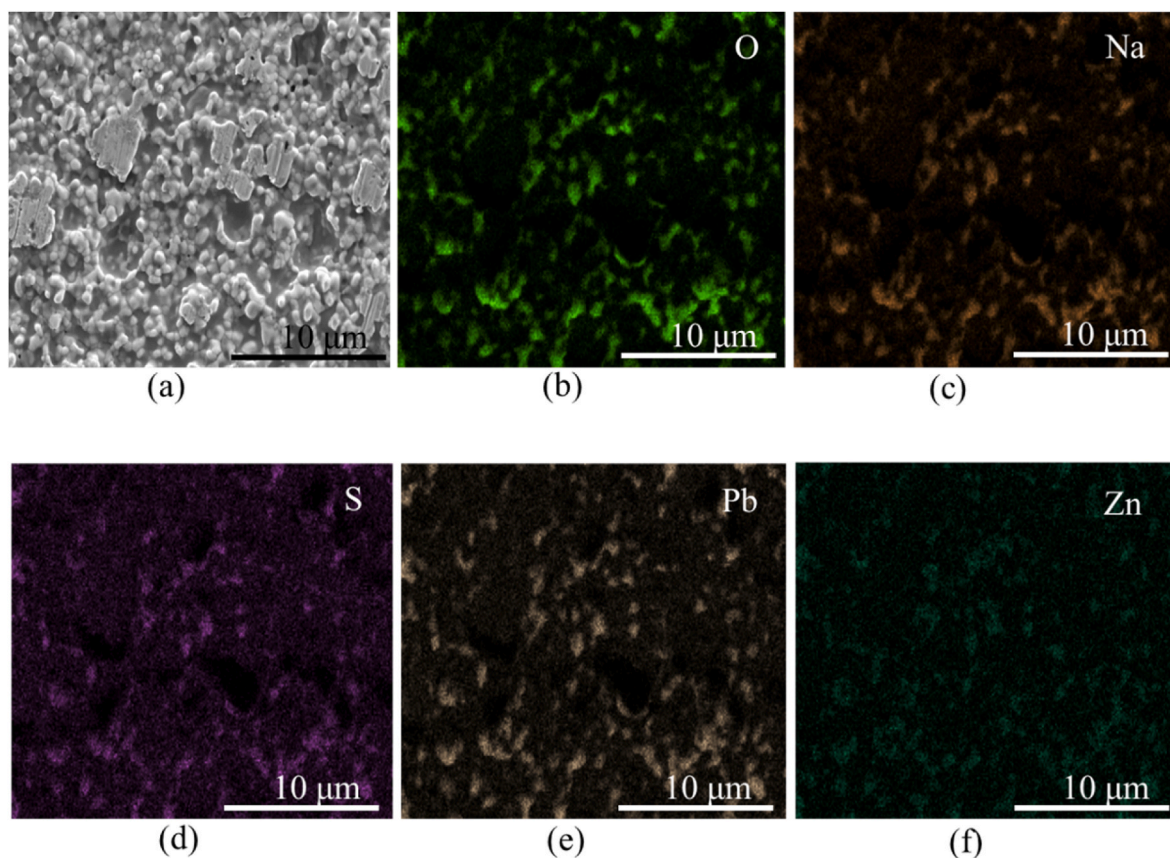
It was reported that under the influence of moisture, Ag has affinity for phosphorus, silicon, and sulfur [55]. Fig. 16 shows the SEM-EDS element mappings of oxygen, sodium, sulfur, lead, and zinc of the Ag busbar around the solder joint. The SEM micrograph in Fig. 16a shows a degradation trend similar to what was observed in Fig. 15b. The observed degradation is likely due to the presence of moisture and MID

Fig. 16. (a) SEM micrograph and EDS element mappings of oxygen (O), sodium (Na), sulfur (S), lead (Pb), and zinc (Zn) of the Ag busbar at the solder joint of the extracted solar cell.

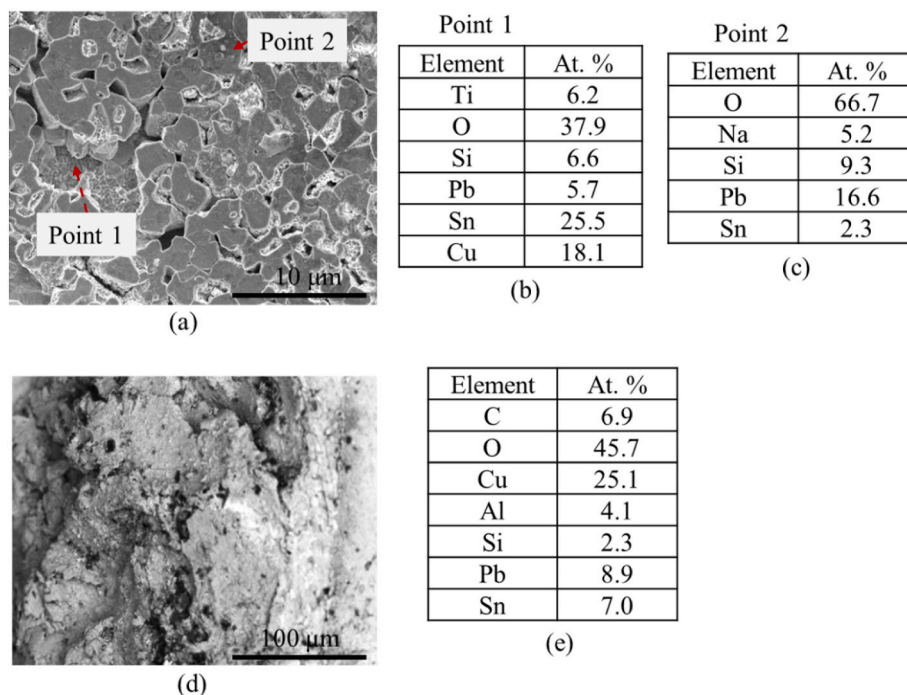
Fig. 17 shows the SEM micrographs and EDS analyses of the top and rear surfaces of the tinned Cu ribbon extracted from the field-aged PV module. The surface of the Cu ribbon is seen with microcracks which accelerate moisture ingress and degradation, see Fig. 17a. The observed oxidized layers along the crack contours suggest the influence of moisture ingress. It also indicates the role of moisture ingress in the development of microcracks. Cracks on Cu ribbons during thermal cycling has been observed and reported previously [15,57,58]. Point 1 shows erosion of the tin-plated surface on the Cu ribbon, see Fig. 17a. The EDS analysis of this region is shown in Fig. 17b indicating the presence of Cu. The EDS analysis of Point 2 shows the ‘uneroded’ surface of the tin-plated Cu ribbon in Fig. 17c, in which Cu is absent. The amount of Sn in Fig. 17b is higher than the amount of Sn in Fig. 17c. On the other hand, the amount of oxygen, silicon and lead are higher in Fig. 17c. In the first place, migration of O, Na, Ti, Si, and Pb elements to the surface of tinned Cu ribbon is normally due to moisture ingress. The amount of oxygen in Fig. 17b and c suggests that the surfaces of the tinned Cu ribbon are more oxidized due to the formation of surface oxide layers of Sn and Pb in the presence of moisture. That is, Sn and Pb of the tinned plated component of the Cu ribbon were oxidized preferentially to protect the Cu ribbon from degradation. This is likely the reason for the lower amount of Sn observed in Fig. 17c. However, when a large chunk of the protective oxidized Sn is removed, Cu could be found in a greater amount with lesser amount of oxygen, see Fig. 17b. Fig. 17d is the SEM micrograph of the rear surface of the tinned Cu ribbon and the corresponding EDS analysis is shown in Fig. 17e. The SEM-EDS analyses of the rear surface of the Cu ribbon suggest that this region has also undergone degradation due to moisture ingress.

The substantial amount of oxygen, aluminum, and the presence of carbon suggest the effect of moisture ingress and subsequent formation of carboxylic acids in this region. The presence of moisture together with acetic acid means that the formation of copper oxides, hydroxides, and acetates is feasible. In addition, the formation of metal complexes such

Fig. 17. (a) SEM micrograph of the top surface of the Cu ribbon and the corresponding EDS analyses of (b) Point 1 and (c) Point 2. (d) SEM micrograph and (e) corresponding EDS analysis of the rear surface of the Cu ribbon. Data was acquired from the field-aged PV module.

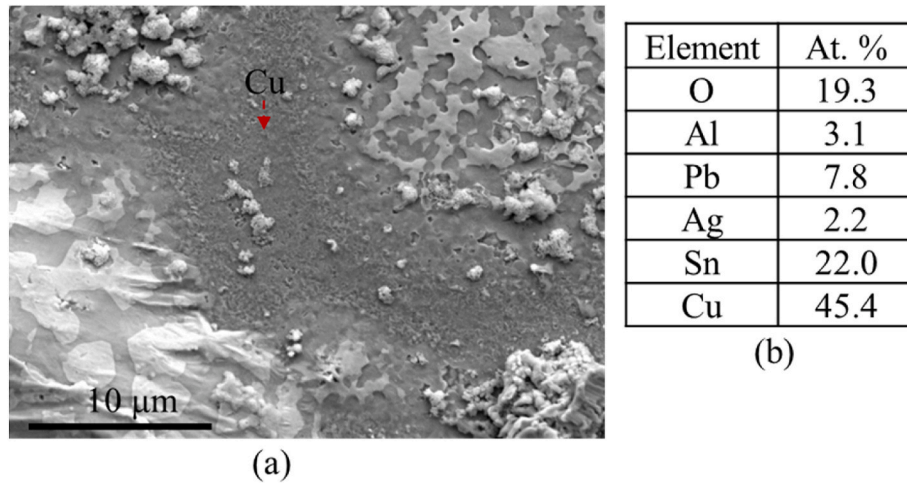
Fig. 18. (a) SEM micrograph and (b) EDS analysis of the Ag busbar beneath the Cu ribbon of the solar cell at the solder joint extracted from the PV module.

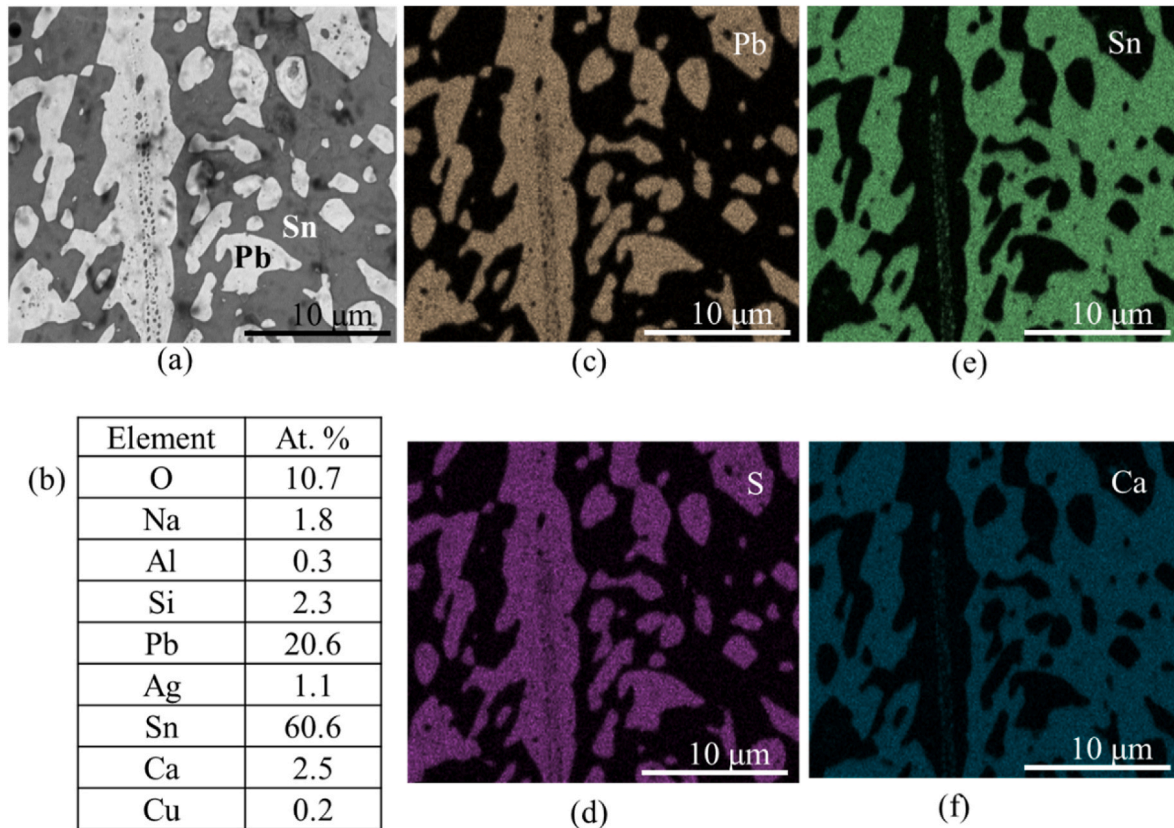
Fig. 19. (a) SEM micrograph and (b) EDS analyses of the solder bond in the solar cell extracted from the field-aged PV module. EDS element mappings of (c) lead, (d) sulfur, (e) tin, and (f) calcium indicating formation of metal complexes due to moisture ingress.
