## Conference proceedings, ICTB 2017, 3rd International Conference on Timber Bridges

Conference proceedings from the conference ICTB 2017, the 3rd International Conference on Timber Bridges, 26-29 June 2017 in Skellefteå, Sweden.

SP Rapport 2017:26

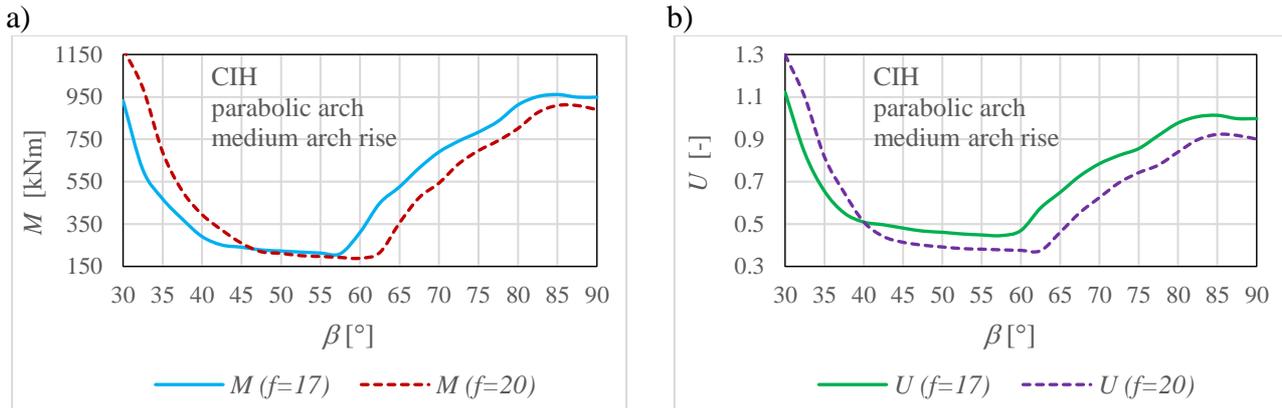
Fig. 4 Maximum bending moment  $M$  (a) and arch utilization  $U$  (b) as a function of angle  $\beta$ , for patterns with constant inclination of hangers (CIH),  $n=18$  and arch rise  $f=17$ m and  $f=20$ m

The arch utilization is usually the governing design criterion. However, in the considered patterns, analysis of the bending moments and the utilization function leads to similar conclusions. In Fig. 4 an example of maximum bending moment  $M$  and utilization  $U$  for a range of patterns is presented. The utilization  $U$  is calculated as combination of the bending moment and an axial force, according to EN5-1-1 [15]. Both functions reach minimum for similar geometric feature of the pattern, i.e. angle. Moreover, the same behaviour can be observed for all types of tested patterns.

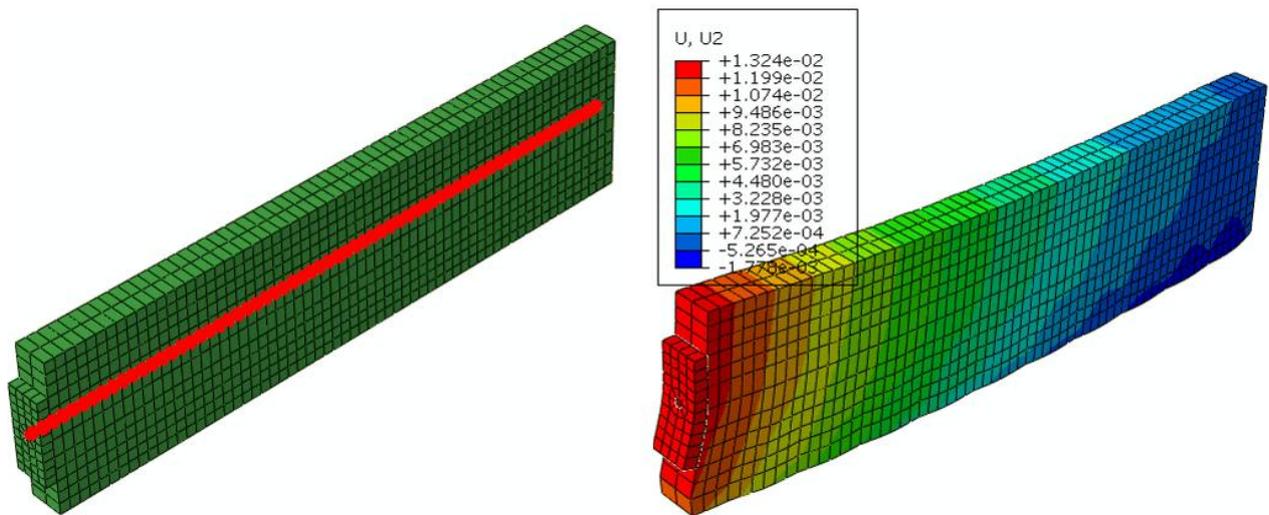
Figure 2. Left: Abaqus model (steel bar in red). Right: vertical displacements (right) at the end of the 15 month analysis (1<sup>st</sup> August 1996) for the specimen tested in Skellefteå, Sweden

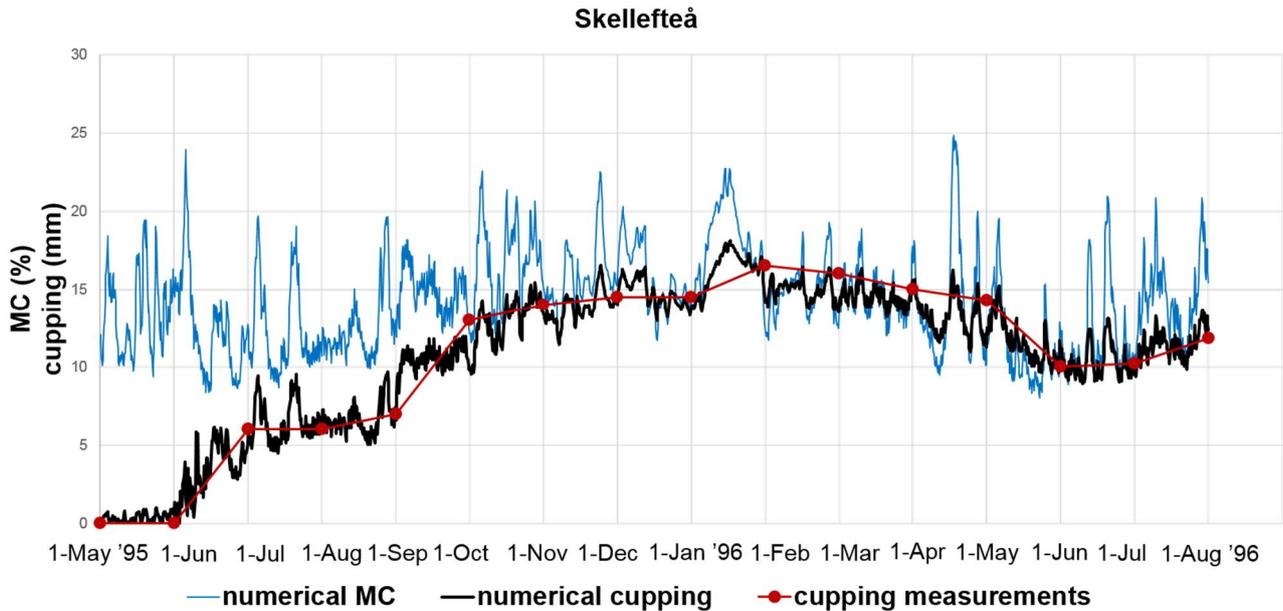
Figure 3. Numerical moisture content (MC), measured and numerical cupping at the underside of deck specimen in Skellefteå, Sweden

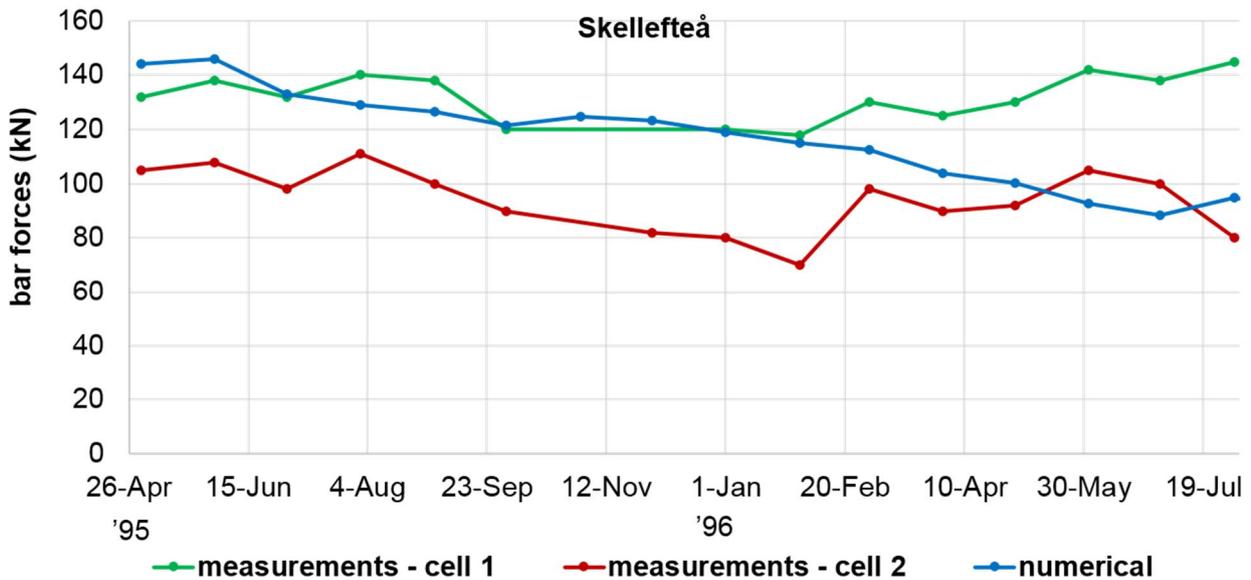
Figure 4. Measured and numerical bar forces of the deck specimen in Skellefteå, Sweden

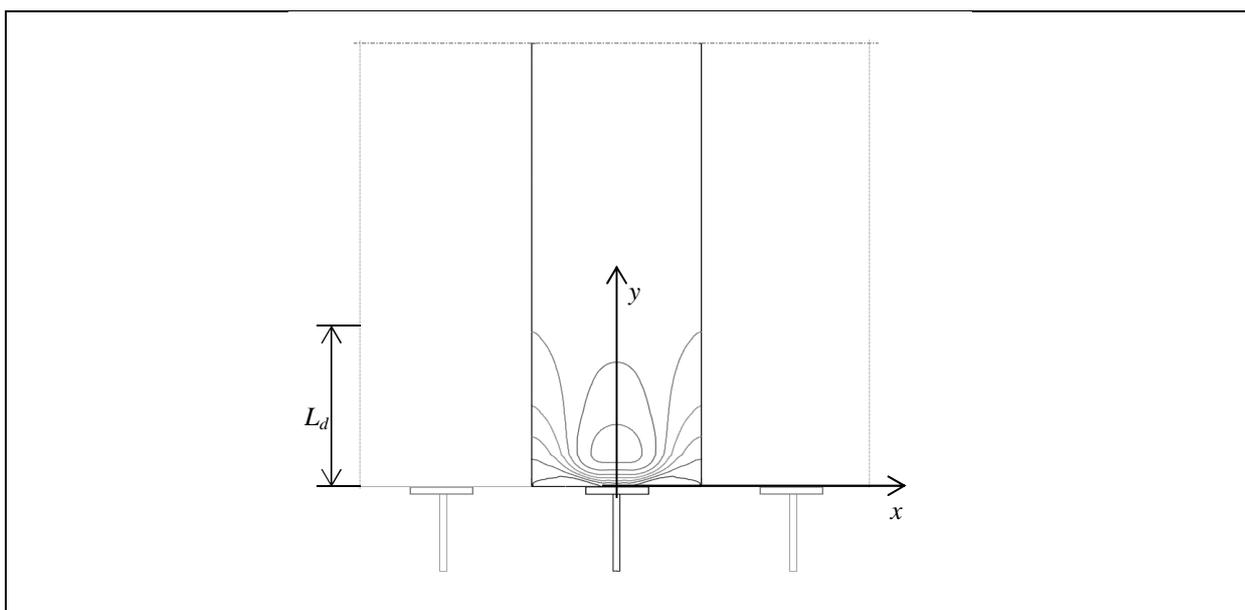
Figure 6 Diffusion of compression stress in section of a pre-stressed deck (plane section of a deck: the x-direction is the longitudinal to grain direction)

Stress laminated timber decks are pre-stressed by means of steel rods as described in paragraph 1. The pre-stressed rods cause a compression stress in the timber deck that is higher in proximity of the edge and become constant after a diffusion length  $L_d$  (see Figure 6).

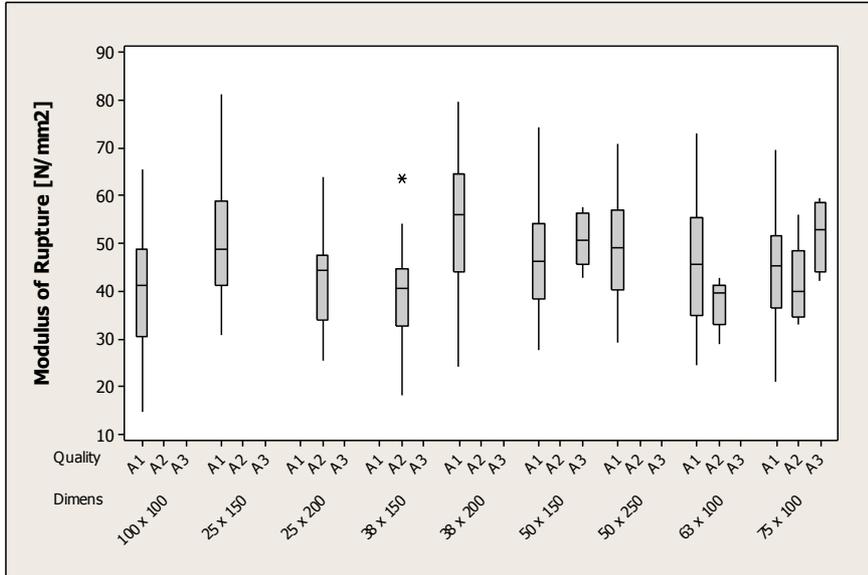
Figure 5 Bending strength distribution per dimension and quality (edgewise bending tests)

In Figure 5 and Figure 6 distributions of the bending strength (MOR) and (local) bending stiffness (MOE) respectively per dimension and wood quality are shown. In total the mean bending strength of 449 boards Accoya radiata pine of different dimensions is  $48.7 \text{ N/mm}^2$ , and the stiffness  $10.000 \text{ N/mm}^2$ . The average density is  $530 \text{ kg/m}^3$ . Influence of the knots on the strength properties could not be found.

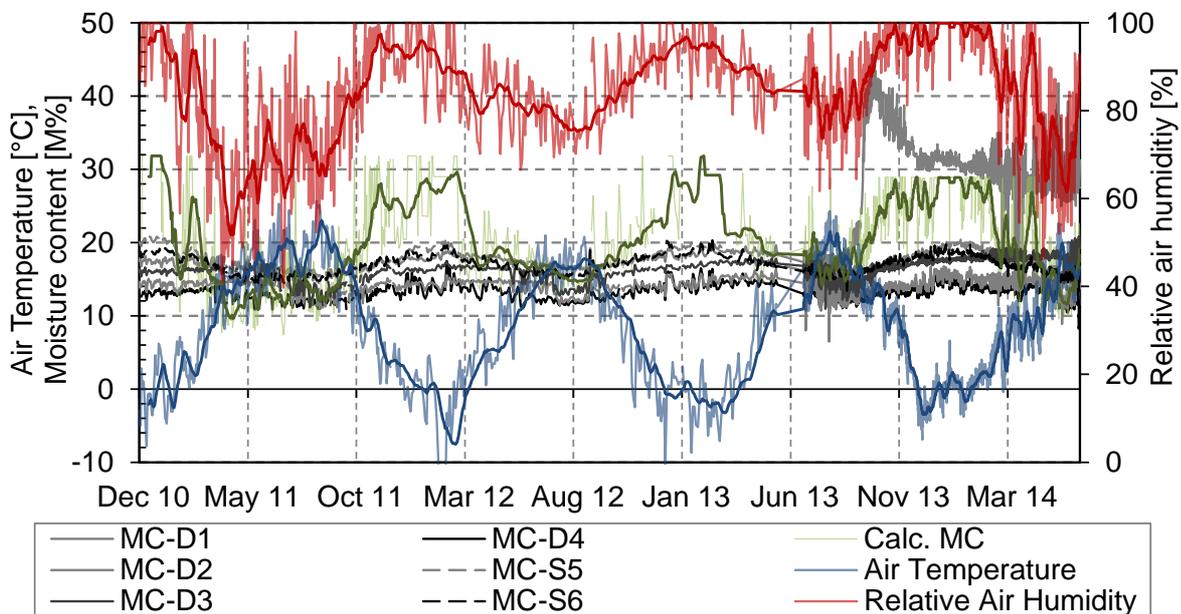
Fig. 4: Timber bridge Obermatt, Measured climate and moisture content and calculated equilibrium moisture content

The moisture content developments of six timber bridges were monitored continuously for several years. The moisture content adapted to the daily and seasonal surrounding climatic conditions. Whereas the outer parts responded more direct to the ambient climate loads, the inner parts responded slowly and with significant time lag, as shown in e.g. in Fig. 4. The moisture content is shown for sensors close to the surface (MC-S) and sensors at a depth of 200 mm (MC-D). The equilibrium moisture content at the surface was calculated [14] according to the measured ambient climate and temperature and added to the figure as comparison. Theoretically, the equilibrium moisture content is valid for the complete cross section at a constant climate. The moisture content measured in the timber cross section follows the seasonal effective climate changes. The response in the centre of the cross section is delayed along with lower variations for both sensor locations compared to the calculated equilibrium moisture content. The moisture content at the surface gauges varies between about 14 %M and 20 M%. The variation of the moisture content at the surface varies about 5.5 M% around the mean between the summer and winter period.

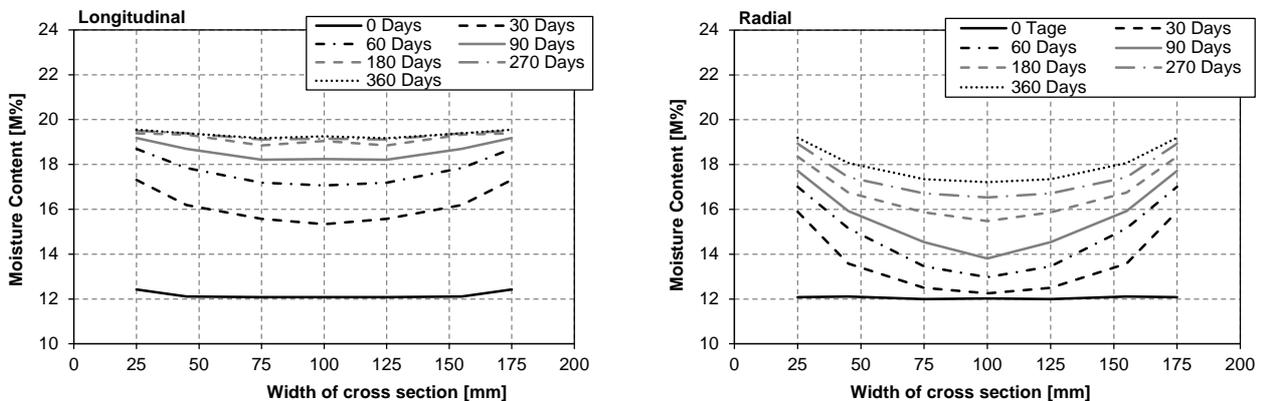
Fig. 5: Results of wetting process of 200/200/200 mm test series in longitudinal and radial direction

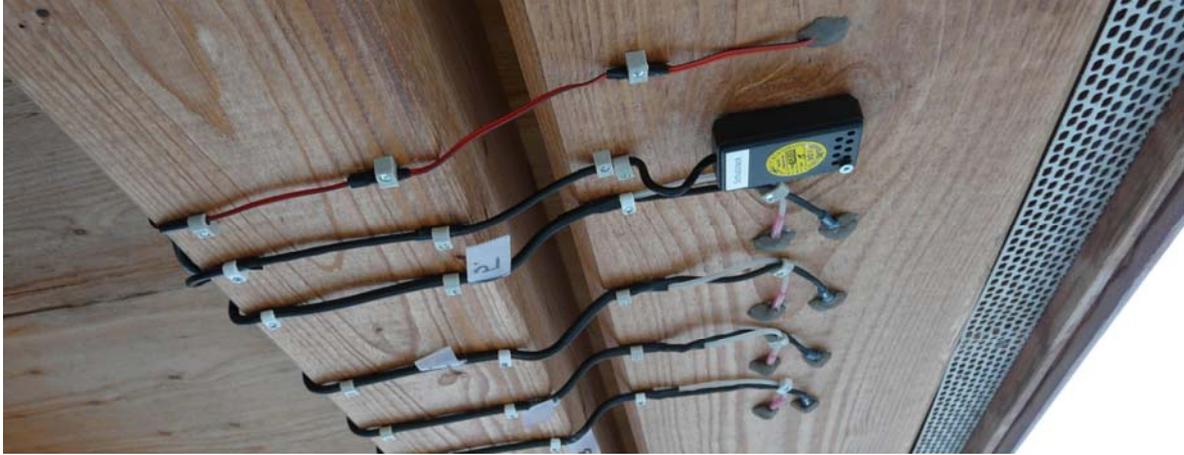
Fig. 3: Example of a measuring area at the cycle path bridge in Frankenroda

shown in the figure, a temperature sensor (red cable) is usually implemented close to the electrodes. That is a necessity for the temperature compensation of the moisture values. Last component is the sensor for measuring the ambient climate conditions, air temperature and relative humidity. Fig. 3 it can be seen as the small black case between the electrodes and the temperature sensor.

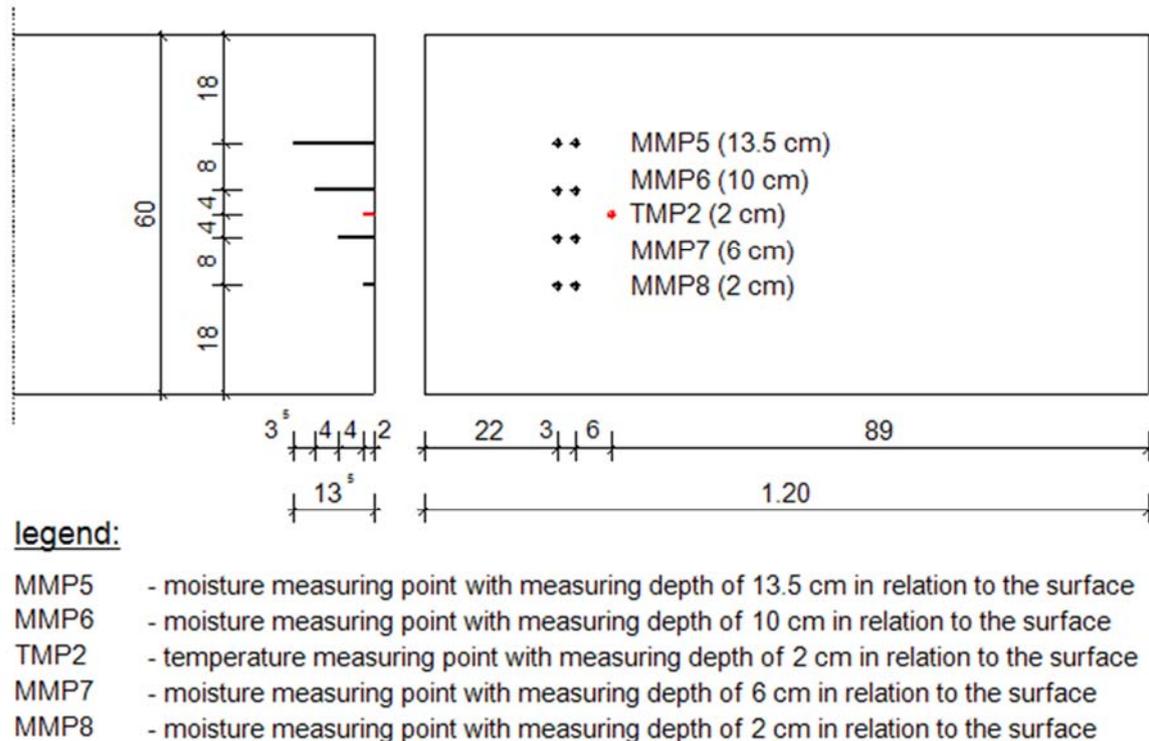
Fig. 6: Measuring area above the foreland at the end grain of a main girder; longitudinal section (left) and view on the end grain (right)

The third measuring area has been placed above the foreland at the end grain of a main girder. The timber moisture content is measured in depths of 20, 60, 100 and 135 mm, a temperature sensor has been implemented nearby. The measuring area is shown in Fig. 6. A climate sensor was later set up, in October 2016.

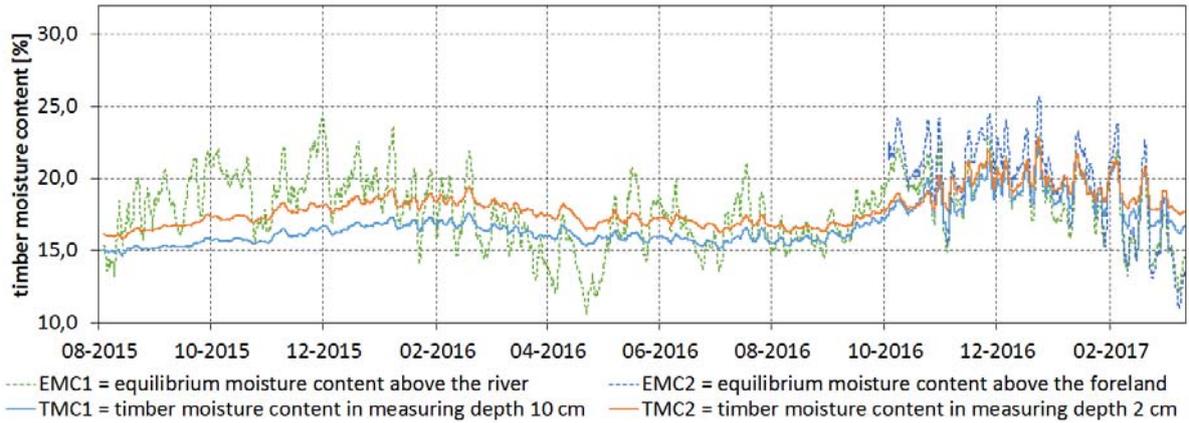
Fig. 7: Measurement results of the measuring area at the tie beam above the river

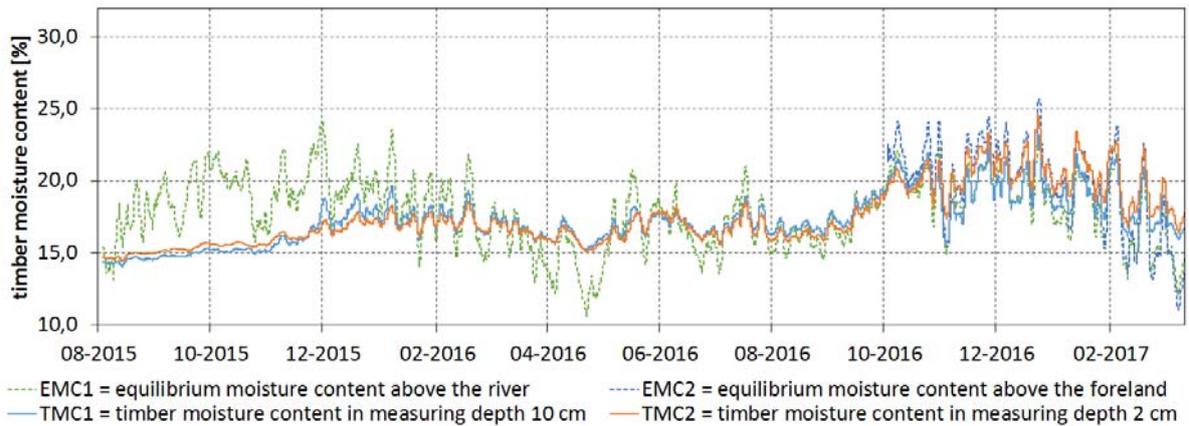
Fig. 8: Measurement results of the measuring area at the bridge deck above the river

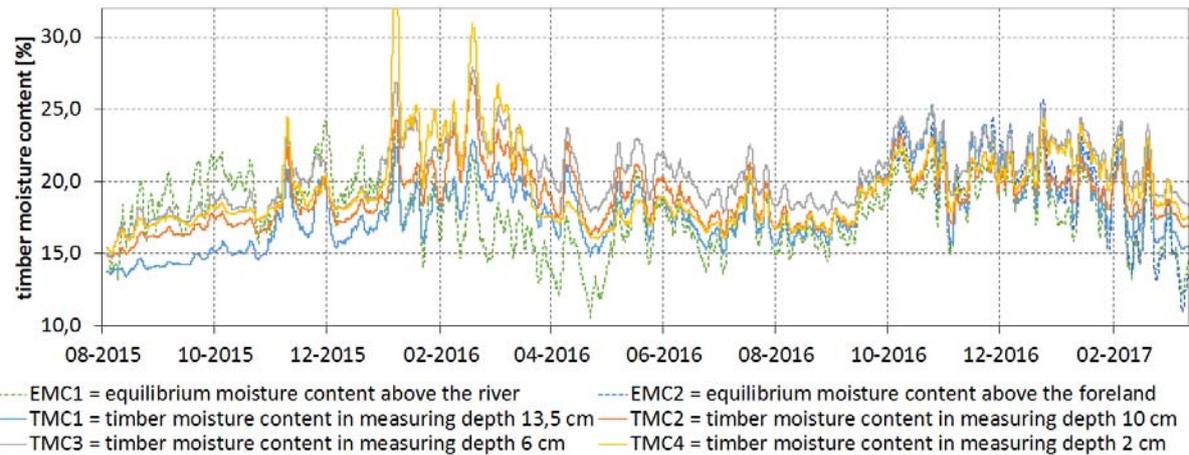
Fig. 9: Measurement results of the measuring area at a main girder above the foreland

Fig. 9 shows the development of the timber moisture content of the measuring point above the foreland. The moisture content increased strongly in November 2015 and in the first quarter of 2016. Moisture values were observed high above the fibre saturation point. An inspection revealed that the expansion joint had a leak, exactly above the measuring area. Hence, rainwater penetrated the structure and ran over the measuring area. A ventilated cladding was installed at the end grain of the beams to protect them against the penetrating water. The work was done in April 2016 and it can be seen that the timber moisture content decreased in summer. This demonstrates the high influence of structural protective measures on the timber moisture content. A simple installation of a cladding improved the situation considerably.

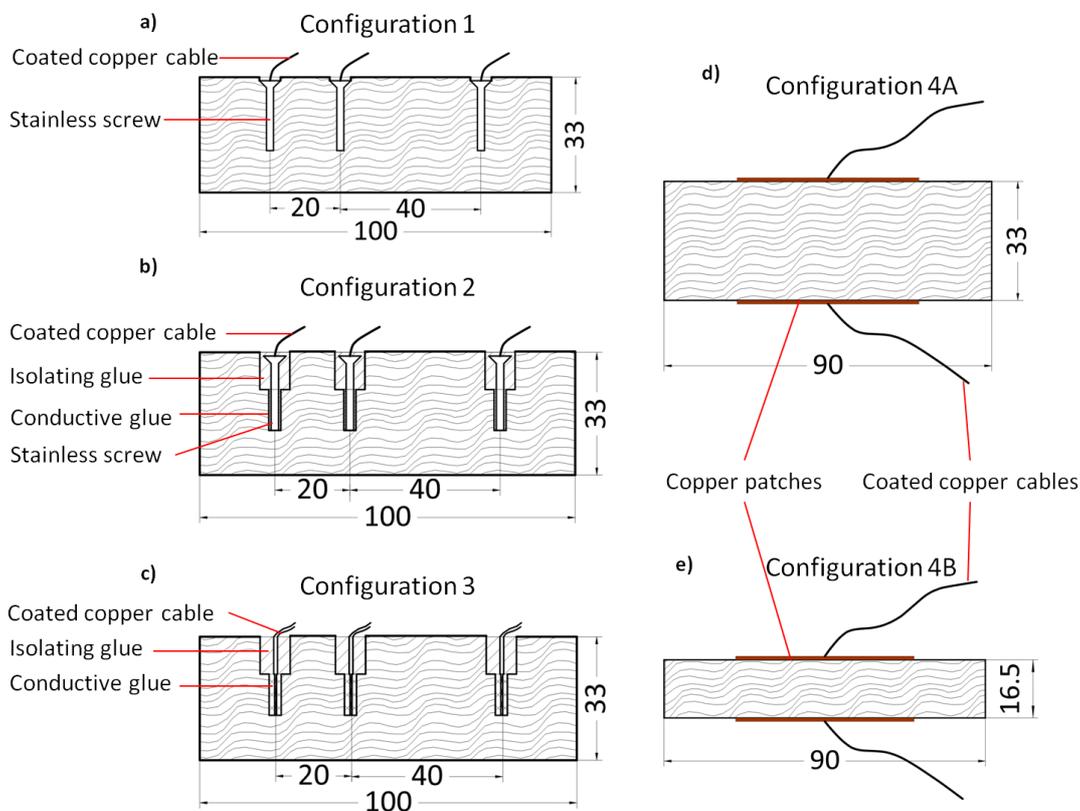
Fig. 1 Measurement configurations: a) Configuration 1; b) Configuration 2; c) Configuration 3; d) Configuration 4A; e) Configuration 4B

Furthermore, in order to verify the influence of the electrode spacings on MC measurements, specimens were prepared with two different electrode spacings. As for the Configuration 1, 2 and 3, two spacings (20 mm and 40 mm) were achieved on the same specimen (Fig. 1). Regarding the Configuration 4, the two spacings were realized with two different specimens with respective thicknesses 33 mm and 16.5 mm (Fig. 1). In order to distinguish the specimens with different electrode spacings in Configuration 4, we name those with an electrode spacing of 33 mm Configuration 4A and those with an electrode spacing of 16.5 mm Configuration 4B.

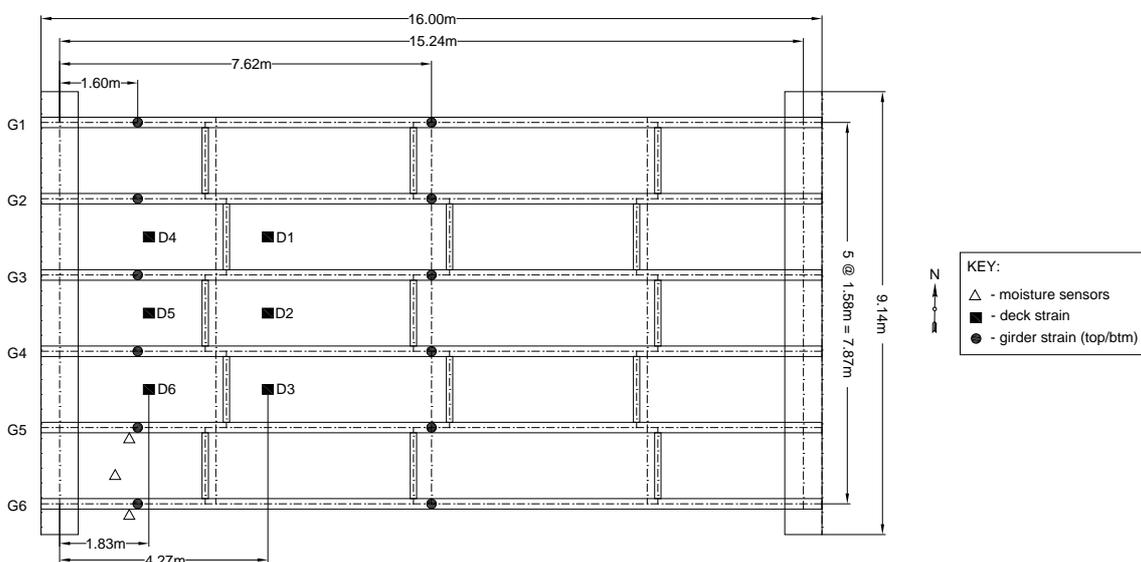
Fig. 6 GRS timber bridge instrumentation layout

The two main objectives of the SHM system on this bridge were to (1) collect structural performance data from the bridge and (2) provide real-time, continuous load rating of the superstructure for damage and deterioration detection. The SHM system for the GRS timber bridge consists of 36 strain gages installed on the glulam girders, 6 strain gages installed on the underside of the transverse glulam deck panels, 3 moisture sensors (2 in girders, 1 in deck) [9], and 2 temperature sensors. All 47 of these sensors are connected to and monitored by a CR9000X datalogger (Campbell Scientific). Figure 6 illustrates the instrumentation layout for the GRS timber bridge. An on-site desktop computer collects the data from the data logger and pushes them wirelessly via cell modem and router to the BEC main servers at the home office in Ames, IA. Figure 7 illustrates the logger enclosure mounted on the wingwall of the bridge. After the data are received by the servers, they are filtered and reduced, separating out data files with a detected truck event for further analysis and evaluation.

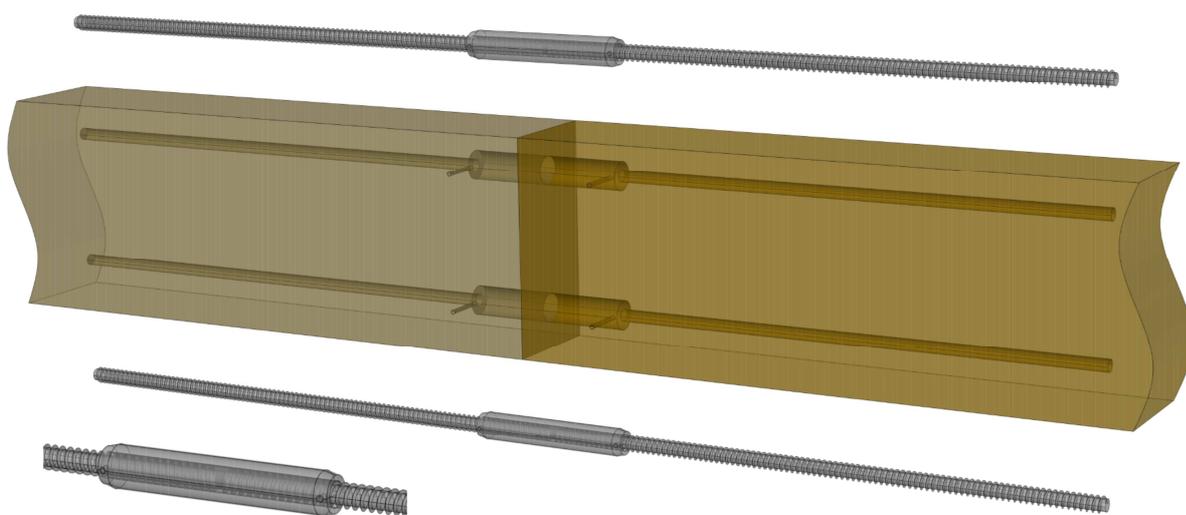
*Fig. 1: Layout of splice connection with long threaded rods and grout-filled couplers.*

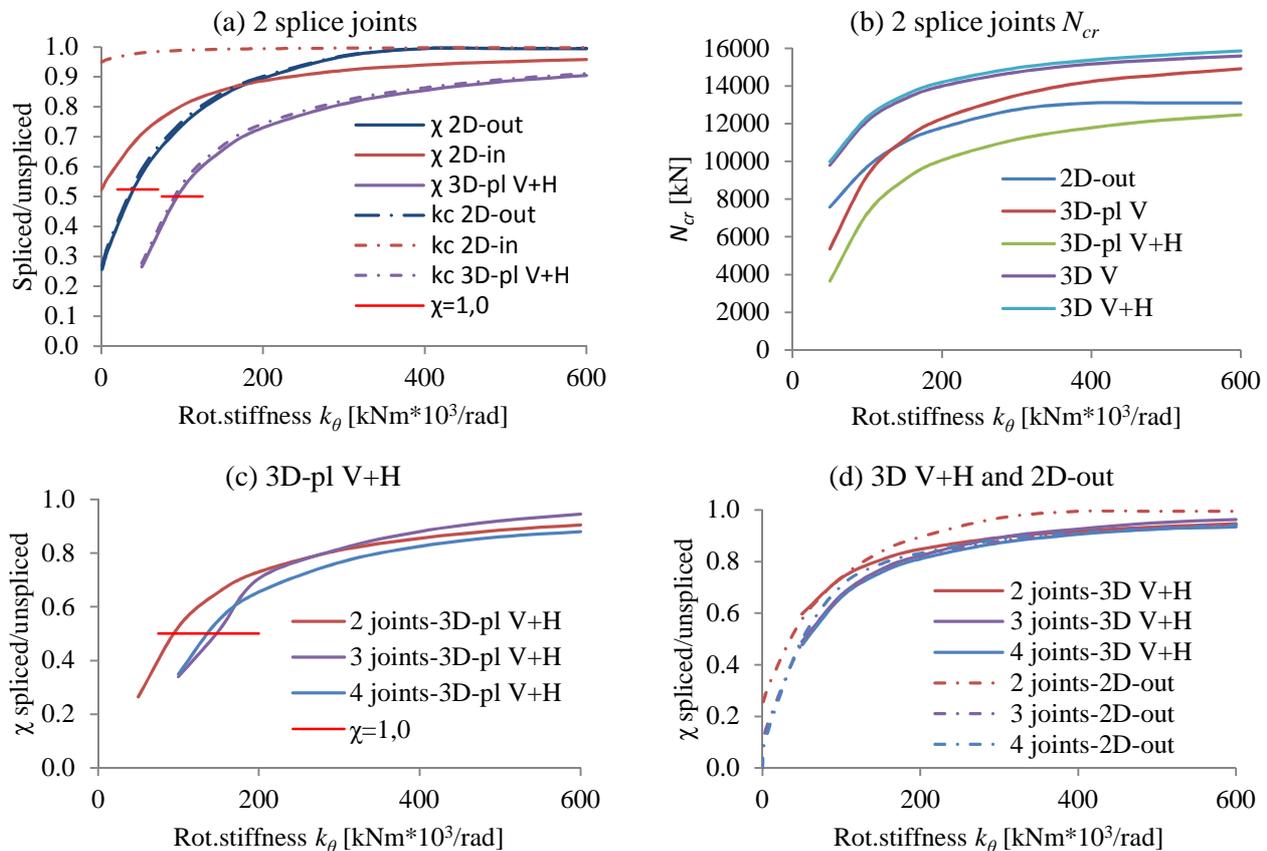
Fig. 7: Results from numerical models containing splice joints; for notation see Table 1.

Comparison of the results for the 2D in-plane, 2D out-of-plane and the 3D model is shown for the case of 2 splice joints in Fig. 7 (a). Same trends are also observed for the cases of 3 and 4 joints and the detailed results are therefore not shown herein. The comparison of cases with 2, 3 and 4 splice joints is shown in Fig. 7 (c). The results from the 3D model are shown for the case with pre-load and both vertical and horizontal loading, since this is the analysis yielding the lowest critical load, see Fig. 7 (b). The critical load obtained by the 3D model is nearly identical for the case of pure vertical loading and the case with vertical and horizontal loading in the analyses without pre-load. However, if the buckling analysis is performed on the deformed (pre-loaded) shape, the effect of the horizontal load becomes significant. From Fig. 7 (d), it is observed that the buckling behaviour of the arches with splice joints predicted by the simplified 2D out-of-plane model is similar to the results obtained by the 3D analyses without pre-load. Finally, no distinct difference is observed comparing the cases with 2, 3 and 4 splice joints. The buckling load is somewhat higher for the models with 2 joints especially for joint stiffnesses smaller than 200 000 kNm/rad. However, the buckling load factor  $\chi$  is in this range close to a unity, which is the stability limit. The results indicate that for the out-of-plane rotational stiffness larger than approximately 400 000 kNm/rad, a further increase of the rotational stiffness is insignificant.

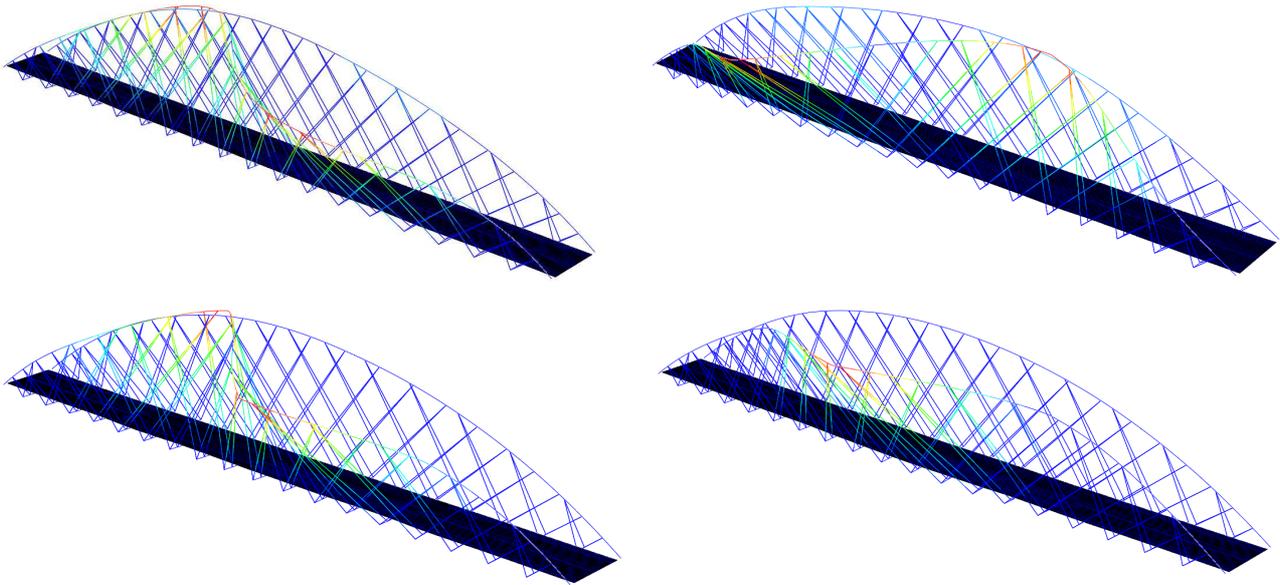
Fig. 8: Shapes of the first buckling mode: clockwise from the upper left corner: unspliced arches; 2 splices; 3 splices; 4 splices in each arch (plotted for models with  $k_{\theta}=200\ 000\ \text{kNm/rad}$ ).

are shown in Fig. 8. The rotational stiffnesses in-plane and out-of-plane were assumed equal in the 3D models. It is, however, clear from the results that the in-plane stability is large compared to the out-of-plane stability and even for very low values of the in-plane rotational stiffness, the critical load of the arch is governed by the out-of-plane buckling.

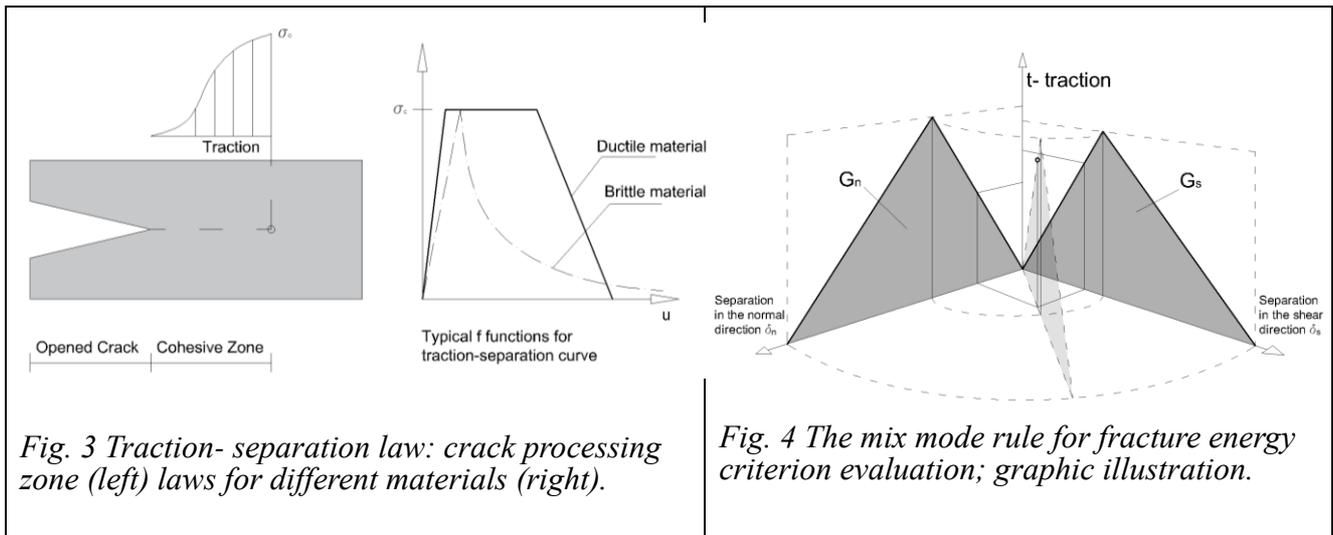
Fig. 3 Traction- separation law: crack processing zone (left) laws for different materials (right).

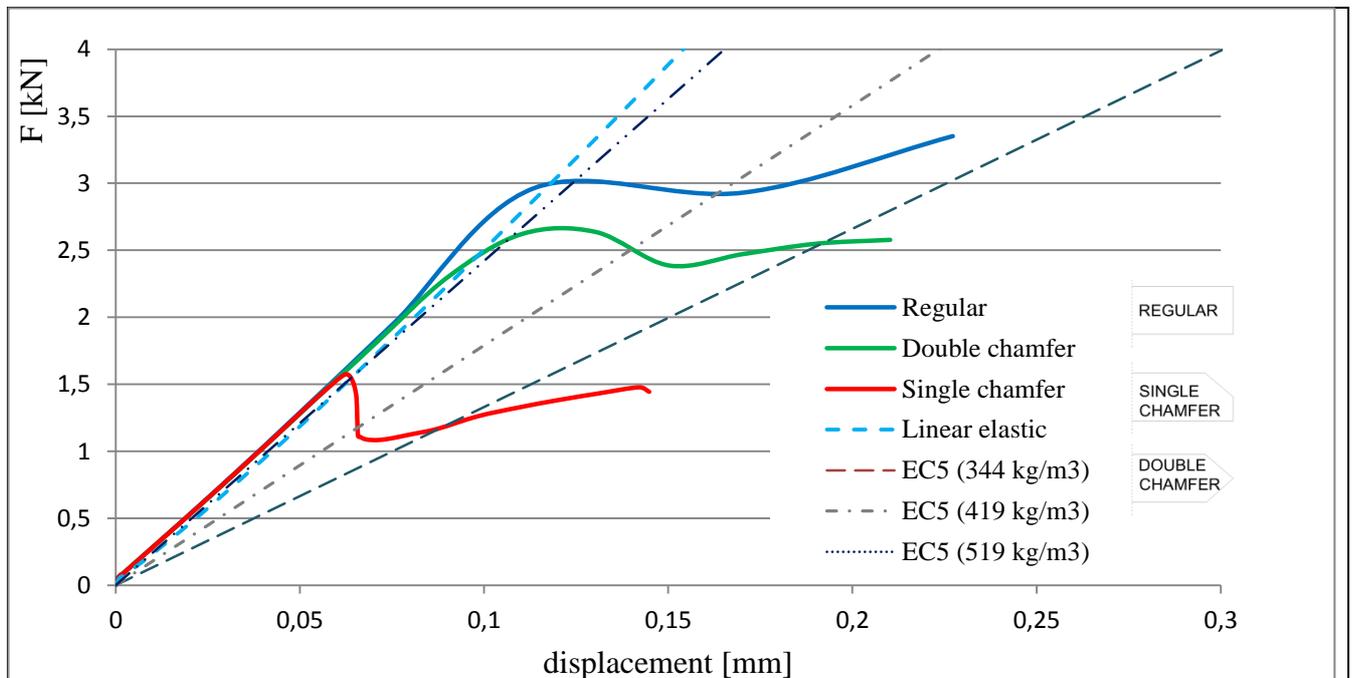
Figure 9. Force displacement curves for variants of chamfered end. Stiffness  $K_{ser}$  based on EC5 is presented for a range of densities.

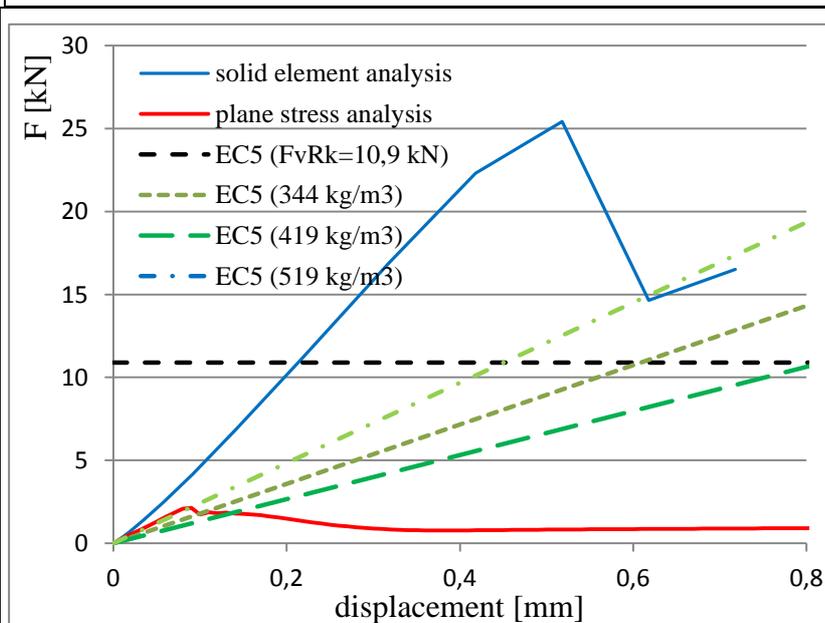
Fig. 12 Traction- separation law: crack processing zone (left) laws for different materials (right).

The comparison between analysis with solid elements and plane stress elements shows influence of three-dimensionality on the prediction of capacity – see Figure 12.

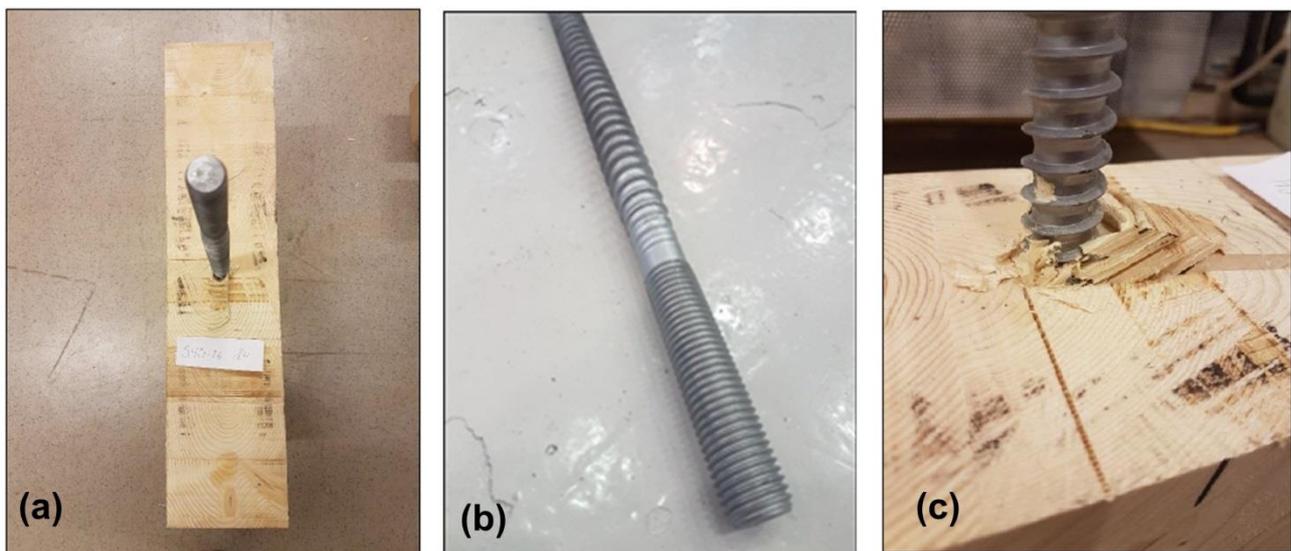
Fig. 2 Specimens for withdrawal tests [21]

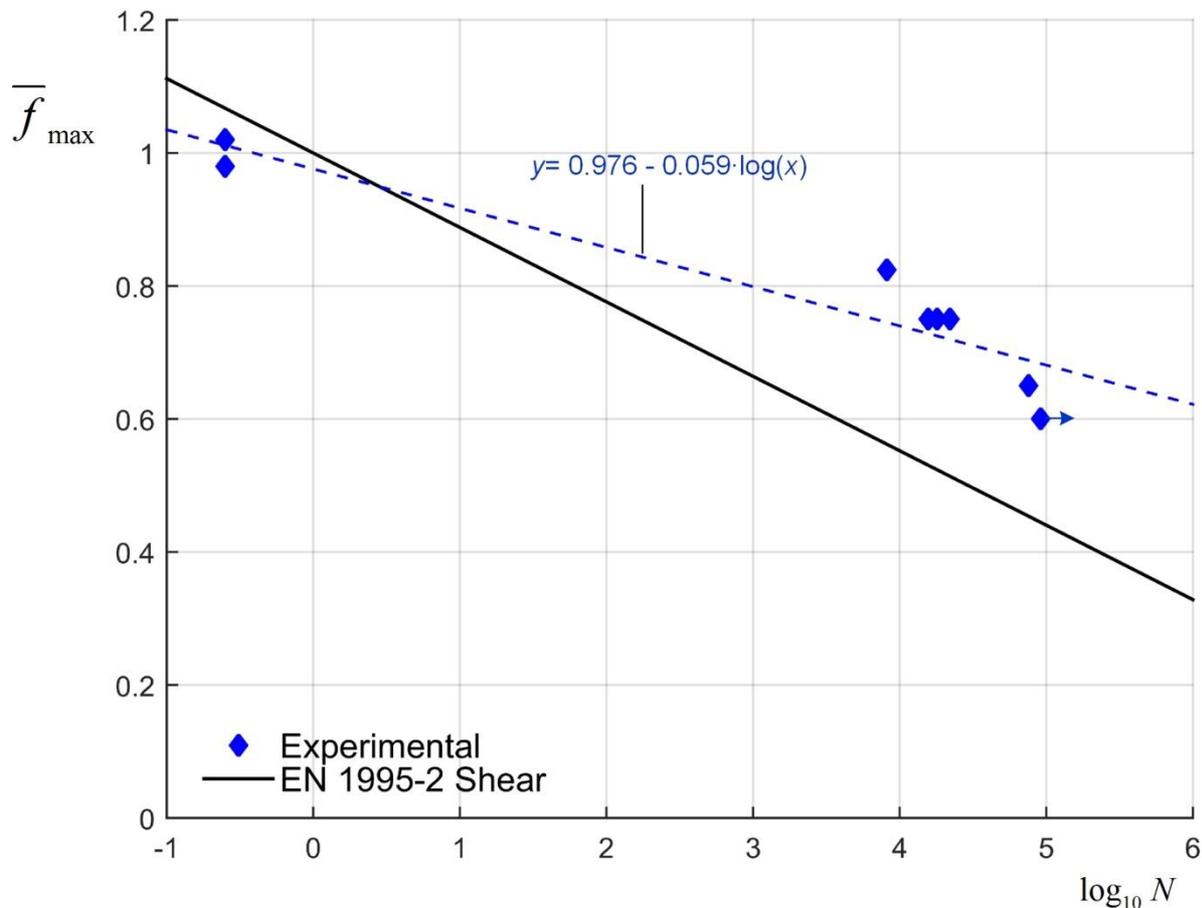
Fig. 3  $\bar{f}_{\max}$  -  $\log_{10}N$  curves for axially loaded threaded rods ( $R=0.1$ ); experimental results compared to shear loading curve obtained from [7]

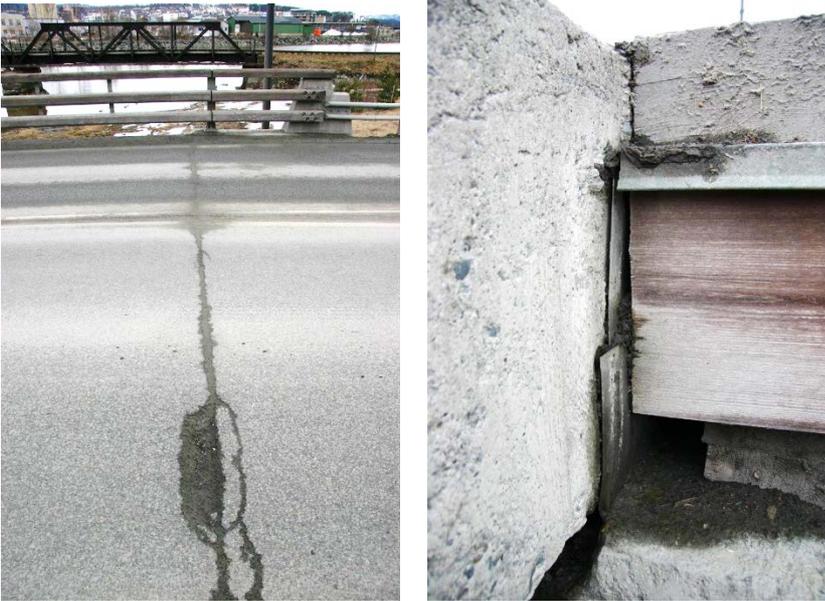
*Figure 17 At the transition between timber and concrete, rotation of the deck creates a gutter that leads water towards the end grain of the deck. Over time, dirt is gathered and moisture levels are heightened.*

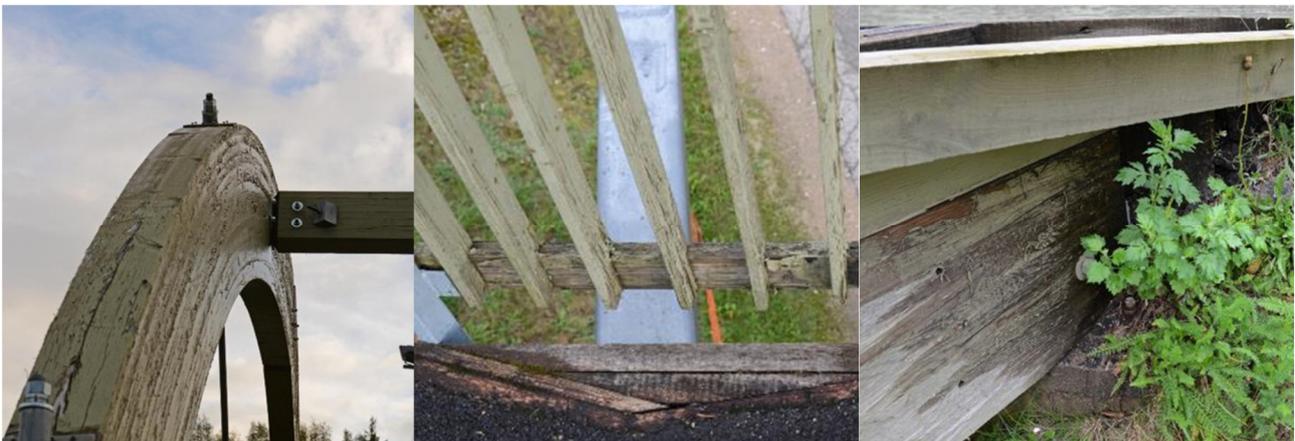
Arches need re-painting and covering on top      Railing needs replacement

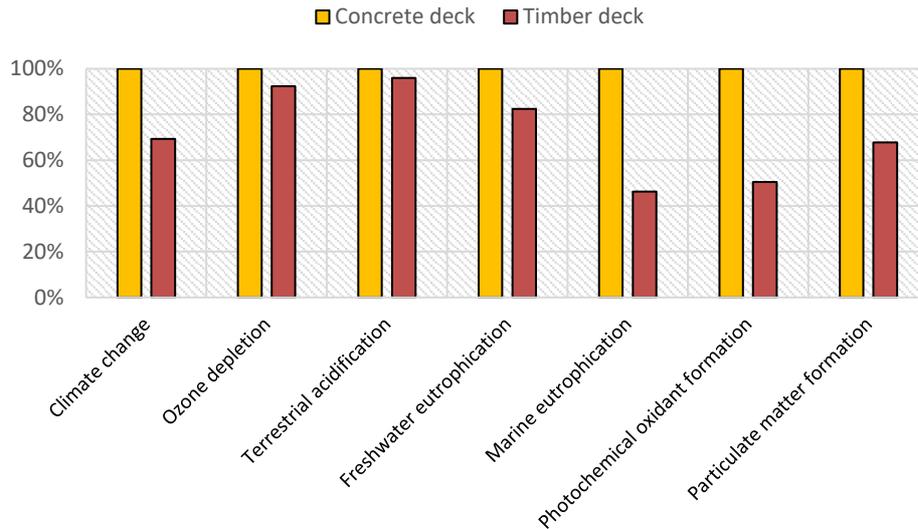
Figure 4. Oppstadåa Bridge comparative life cycle impact results

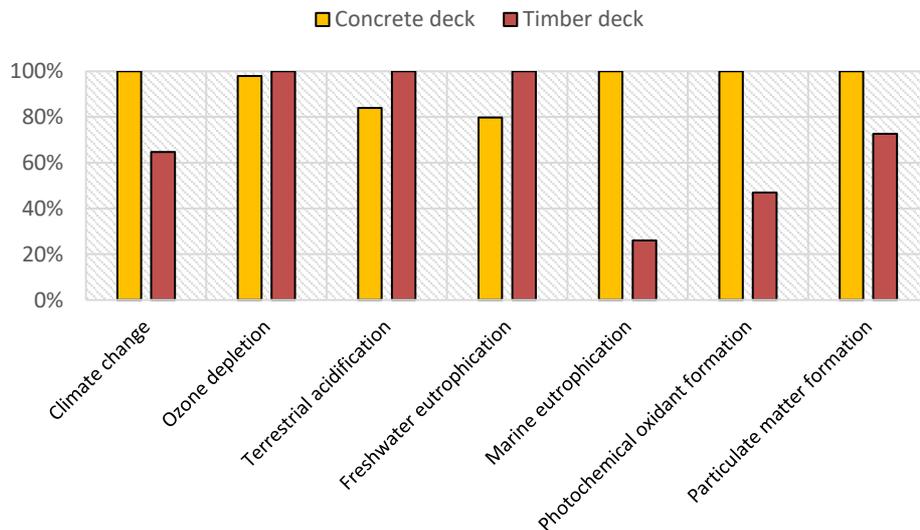
Figure 7. Vippa Bridge comparative life cycle impact results

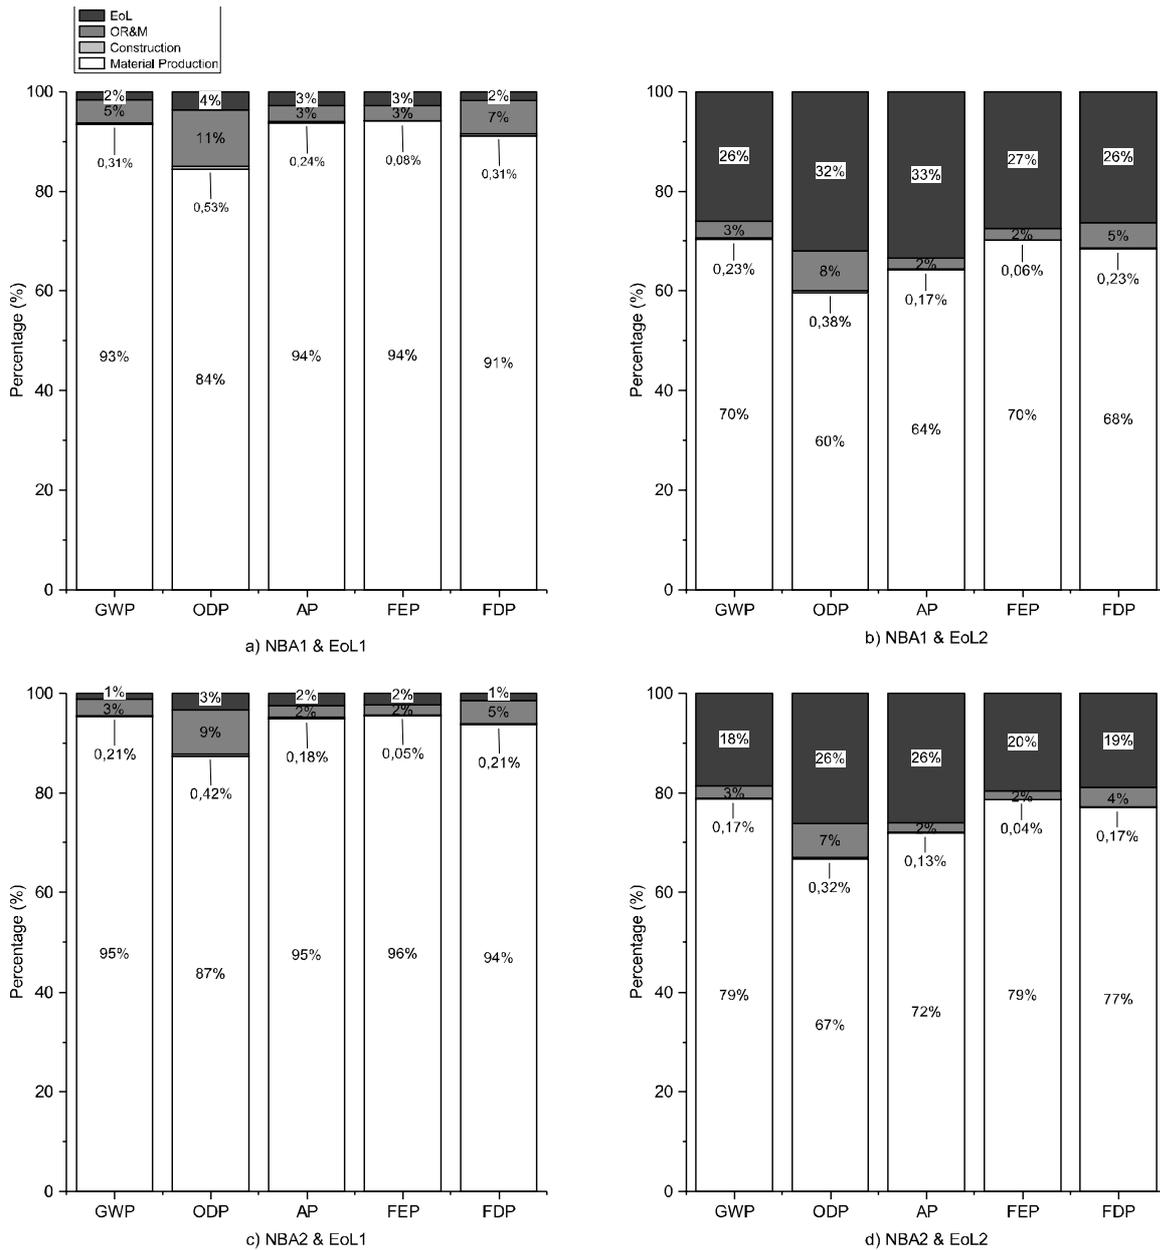
Fig. 3 Distribution of midpoint LCIA results for NBA1 and NBA2
