## Conference proceedings, ICTB 2017, 3rd International Conference on Timber Bridges

Conference proceedings from the conference ICTB 2017, the 3rd International Conference on Timber Bridges, 26-29 June 2017 in Skellefteå, Sweden.

SP Rapport 2017:26

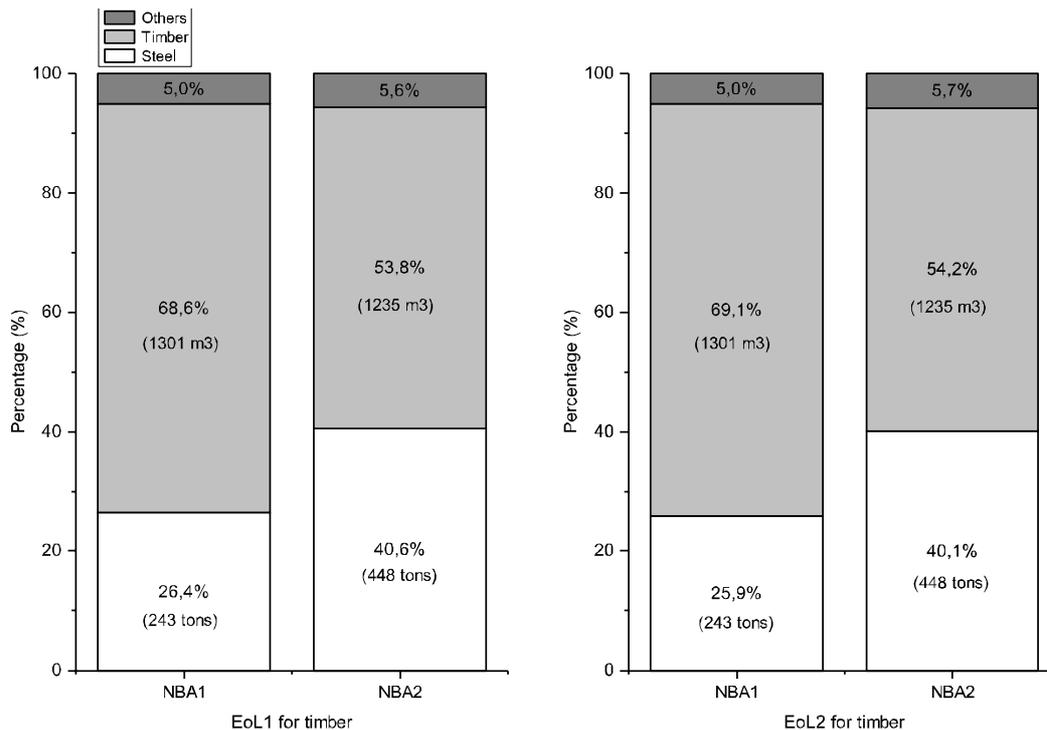
Fig. 4 Energy consumption of construction materials and others

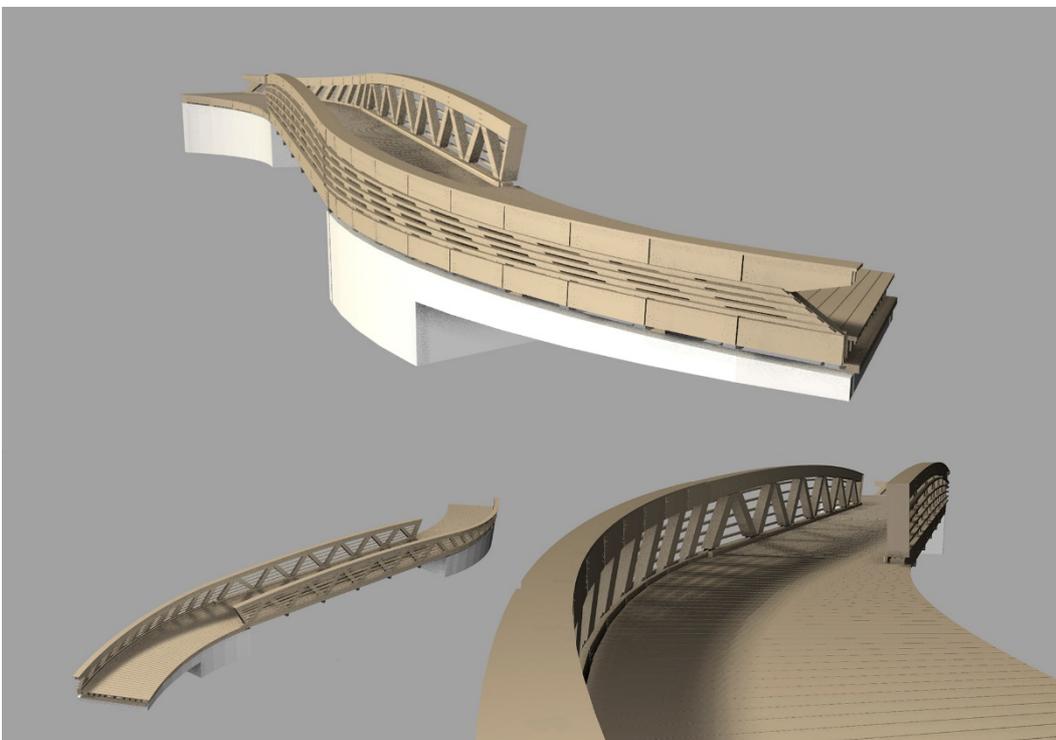
Figure 9: Sketches of Evjen bridge.

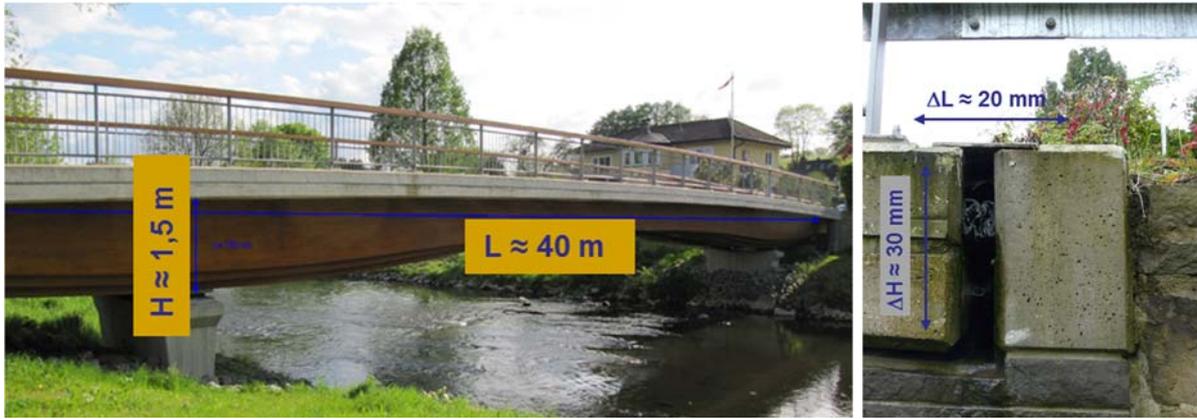
Fig. 5 Advanced and double axis elongation at larger timber bridges results in special demand for expansion joints

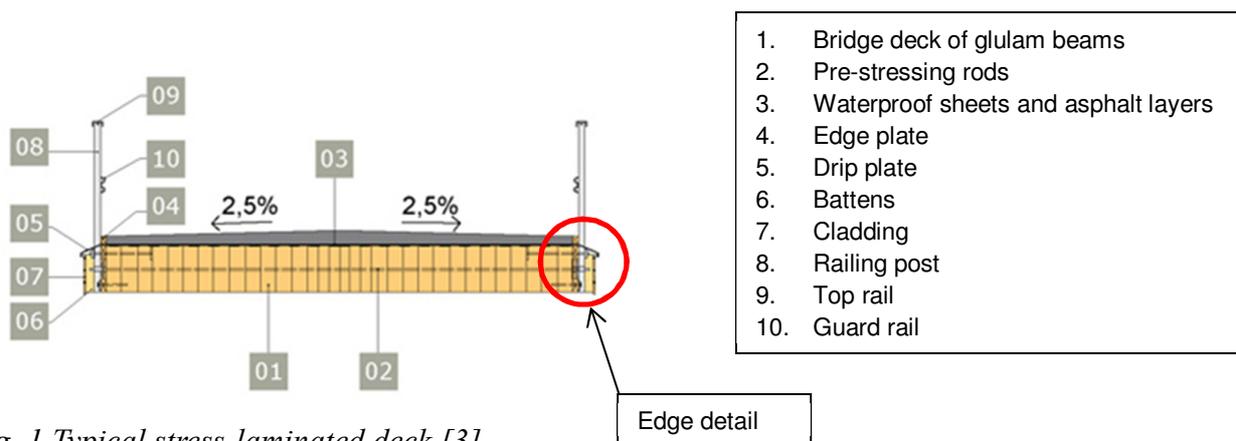
Fig. 1 Typical stress-laminated deck [3]

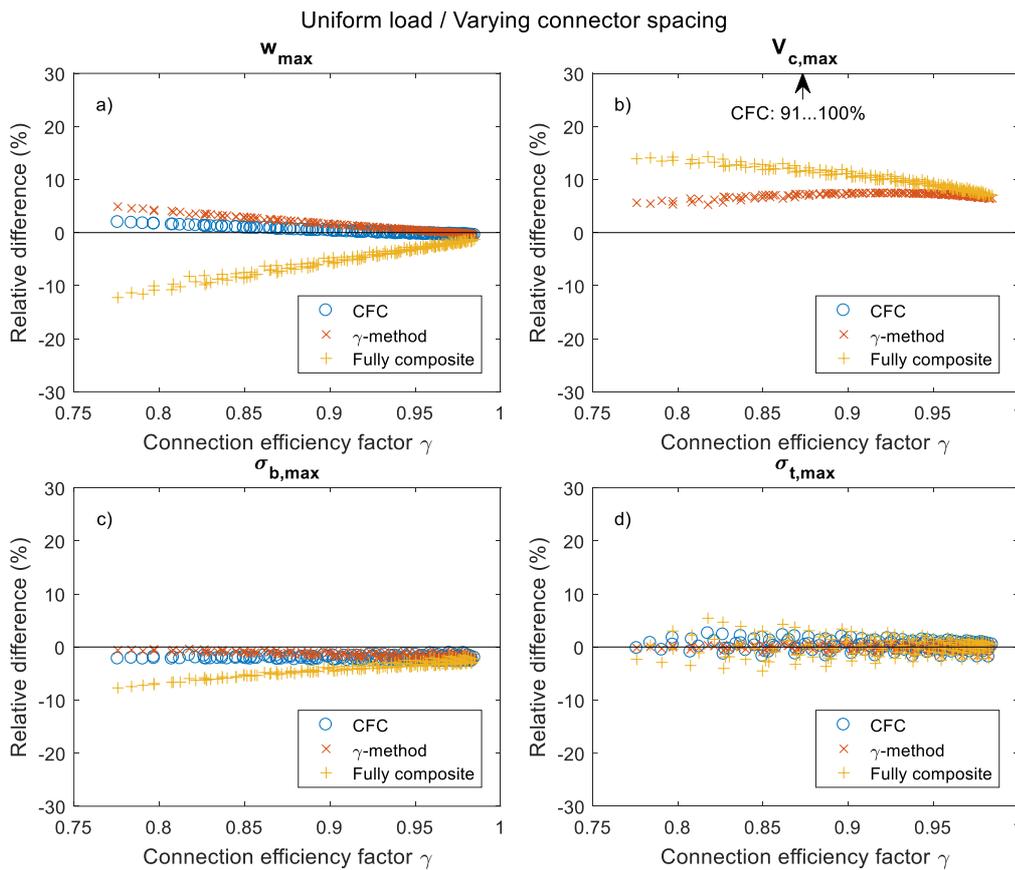
Figure 7. Differences in the Case with varying connector spacing and uniform load (Case 2a).

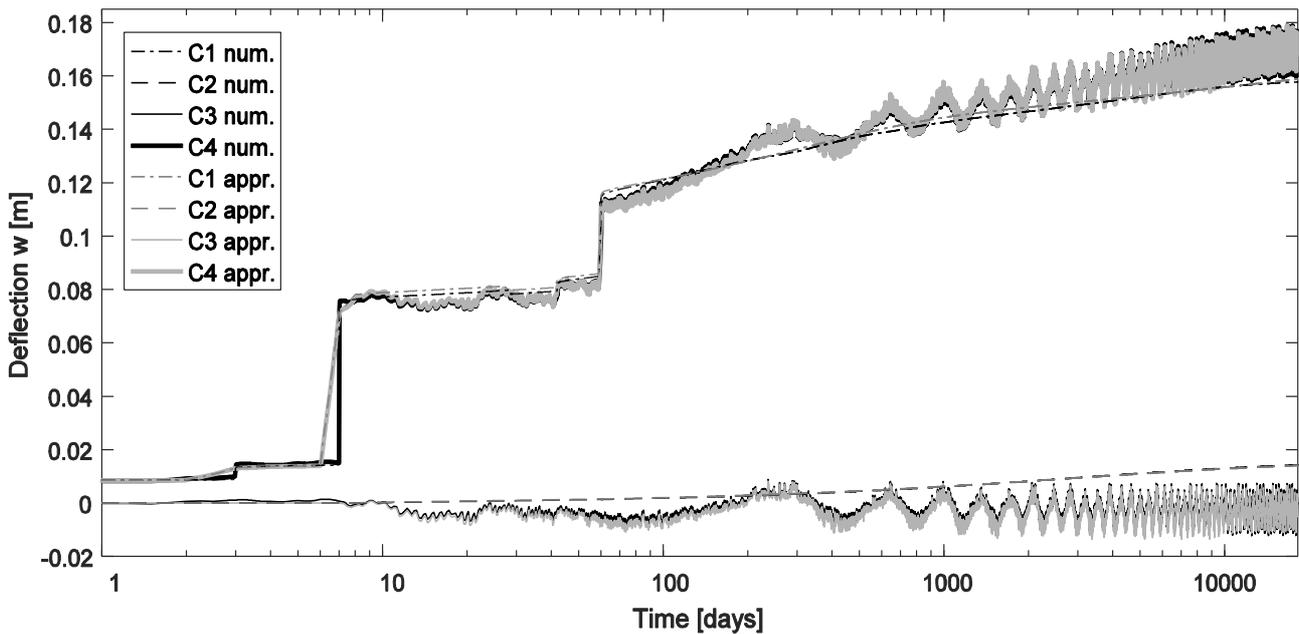
Figure 2. Deflections in the un-shored case.

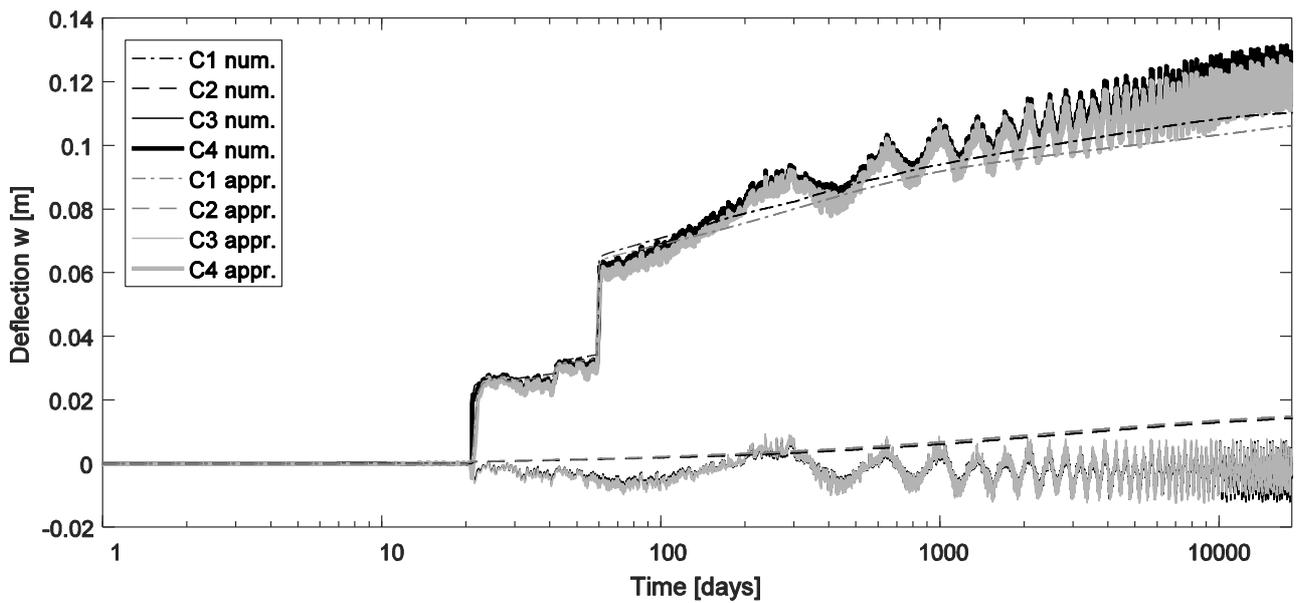
Figure 6. Deflections in the shored case.

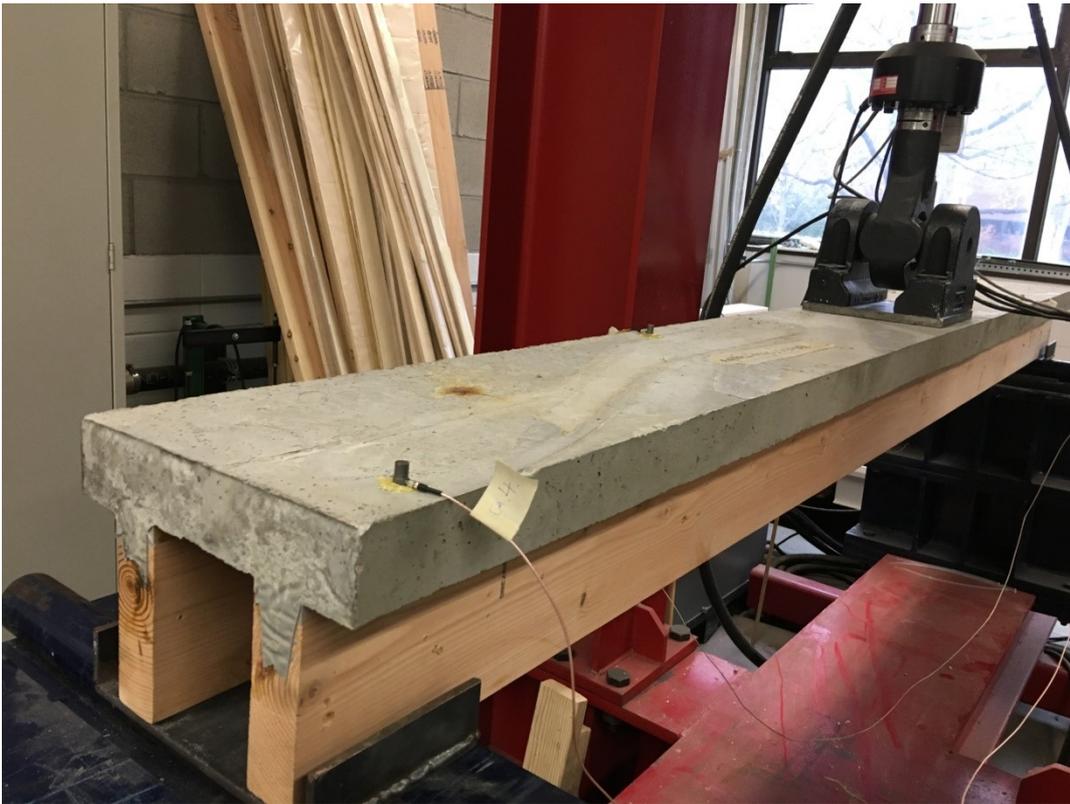
*Fig. 1 Typical test setup of an LTC specimen (BM3 shown)*

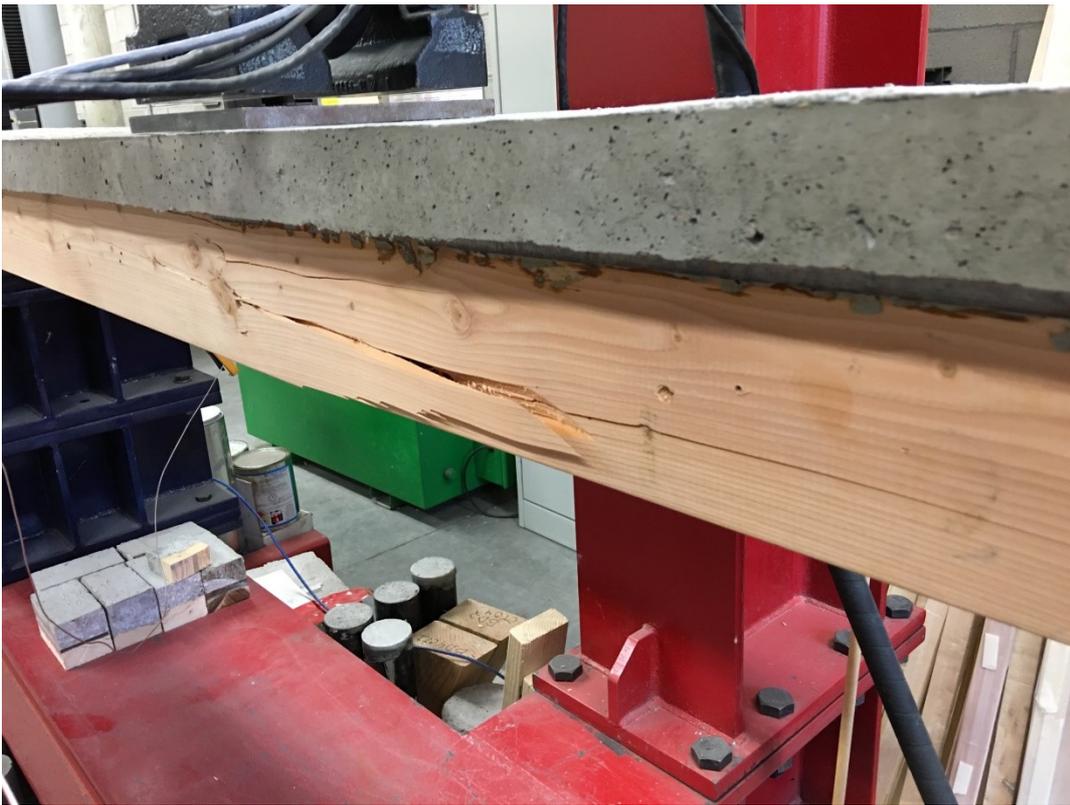
*Fig. 4 Failure of the timber in tension (LTC specimen BM3 shown)*

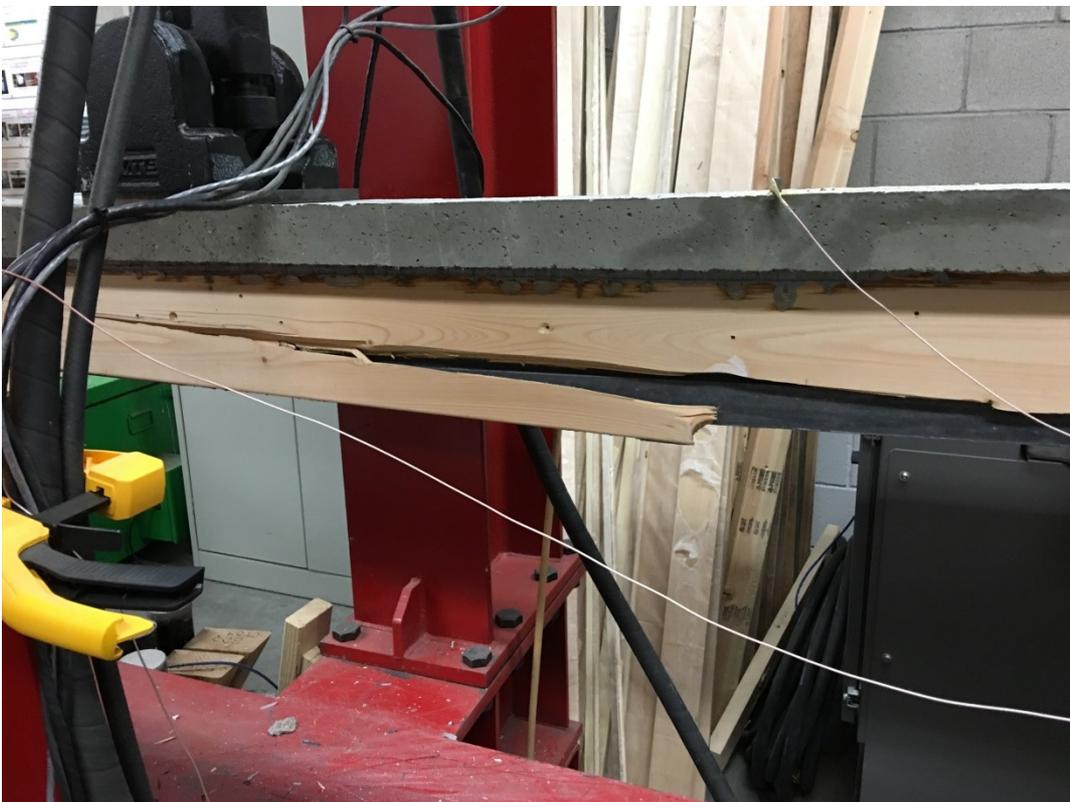
*Fig. 5 Failure of the timber in tension and delamination of the timber-steel bonding (S-LTC specimen BM4 shown)*

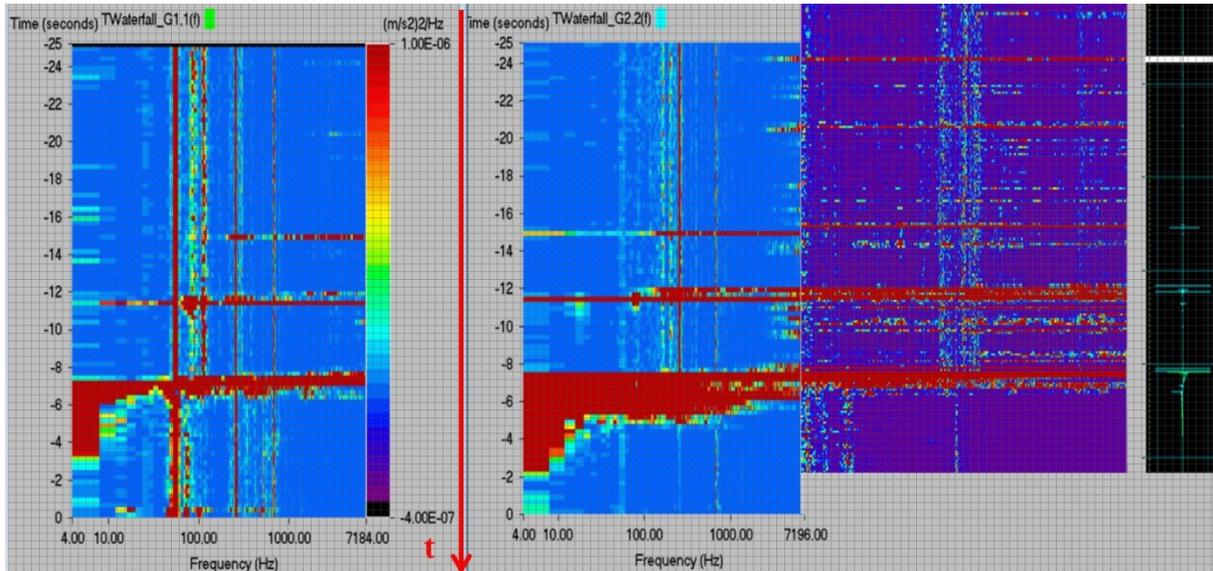
Fig. 6 Typical spectrogram of the AE activity during failure

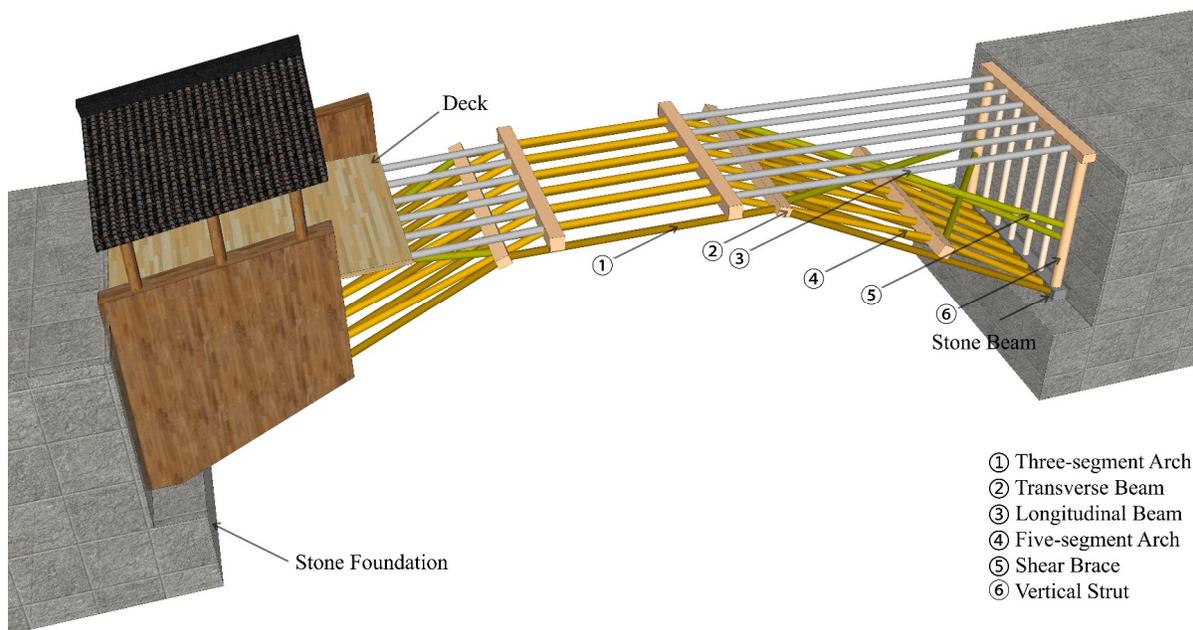
*Fig. 3 Elements of a woven arched covered timber bridge*

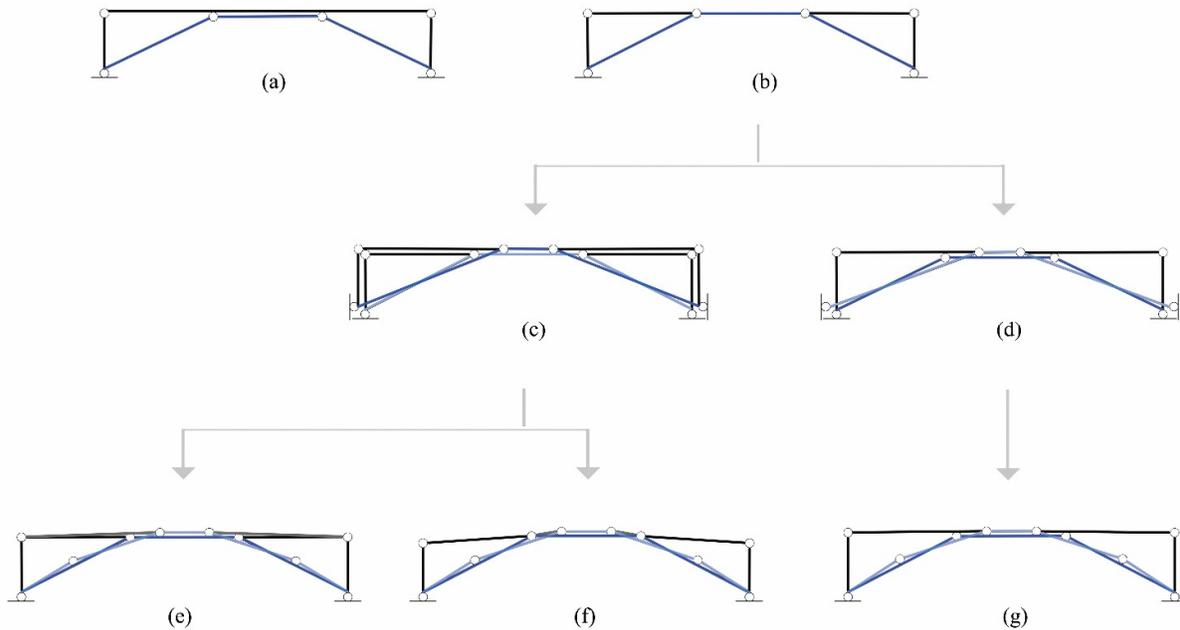
*Fig. 4 Arch configurations*

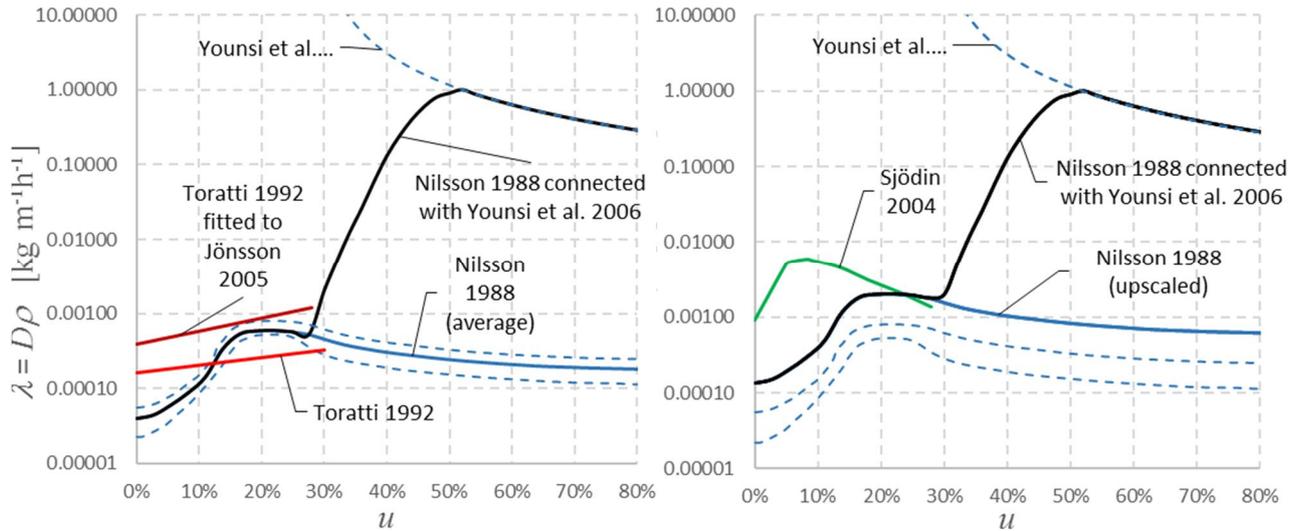
Fig. 1 Diffusion and permeability models perpendicular to the grain (left) and parallel to the grain (right)

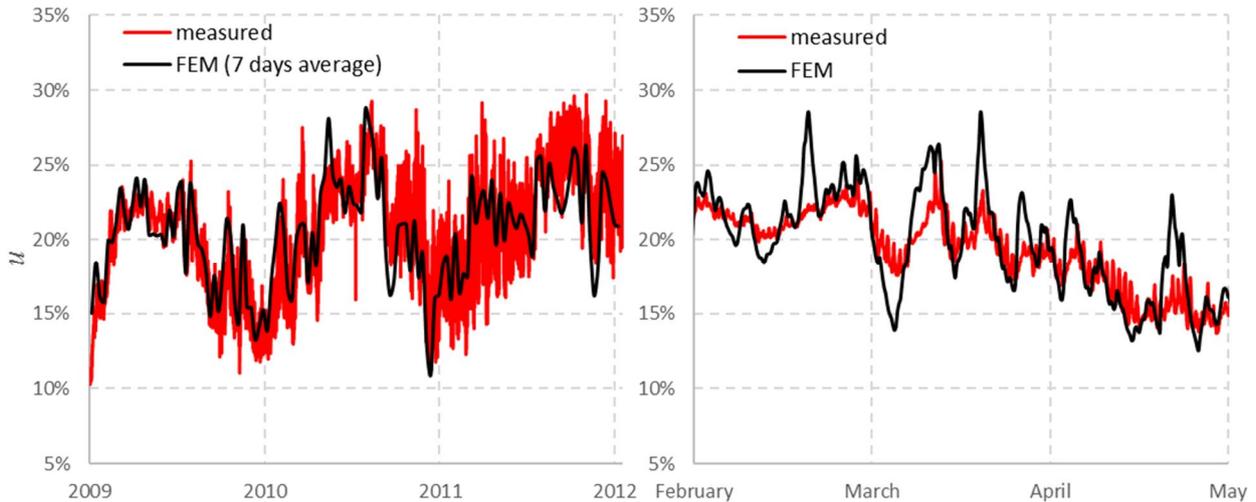
Fig. 8 Predicted moisture content in the middle of the board in the period of 3 years (left) and 3 months (right)

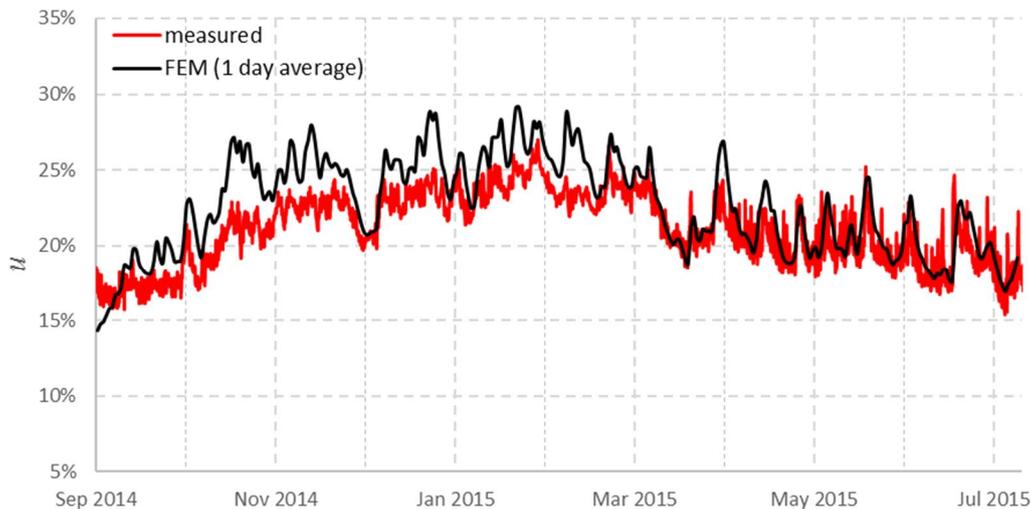
Fig. 9 Predicted moisture content 10 mm from the surface of the beam

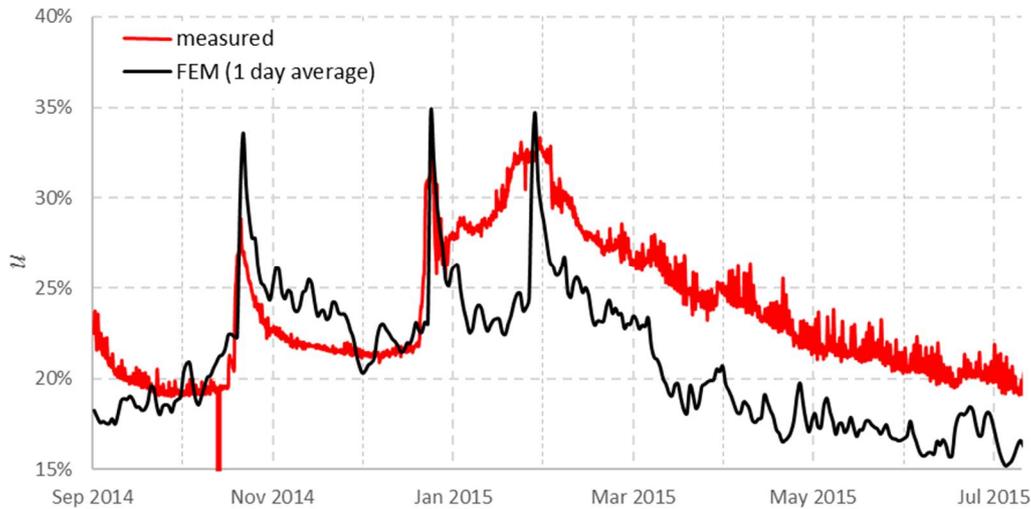
Fig. 10 Predicted moisture content 10 mm from the surface under the external plate

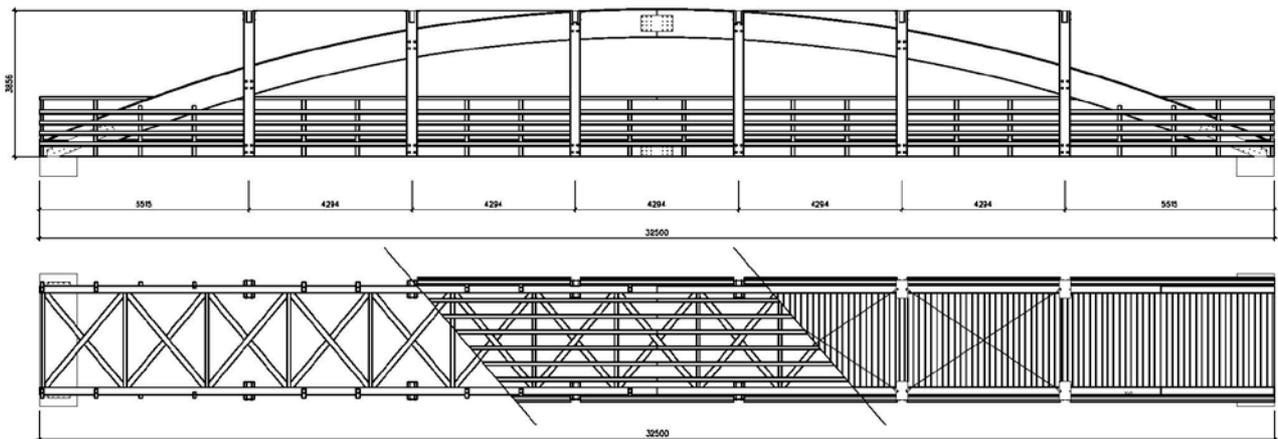
Fig. 4 Plan of the tide-bow bridge 32,5 m span and 3 m width

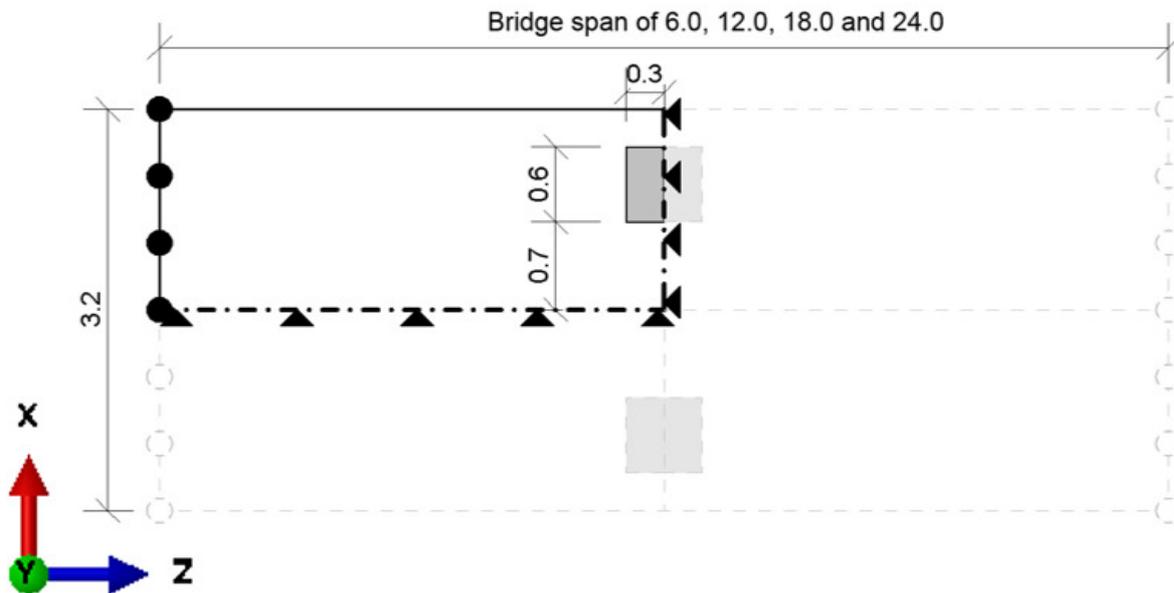
Fig. 2 Loading arrangement used in all simulations. Grey area illustrates the position of the load. Circles show the lowest edge that was locked for displacement in y-direction. Triangles illustrate the positions of the two symmetry conditions. Dash dotted lines show the lowest edges where the displacement was measured. Dashed lines and foggy area illustrates the full size of the simulated bridge deck. [m]

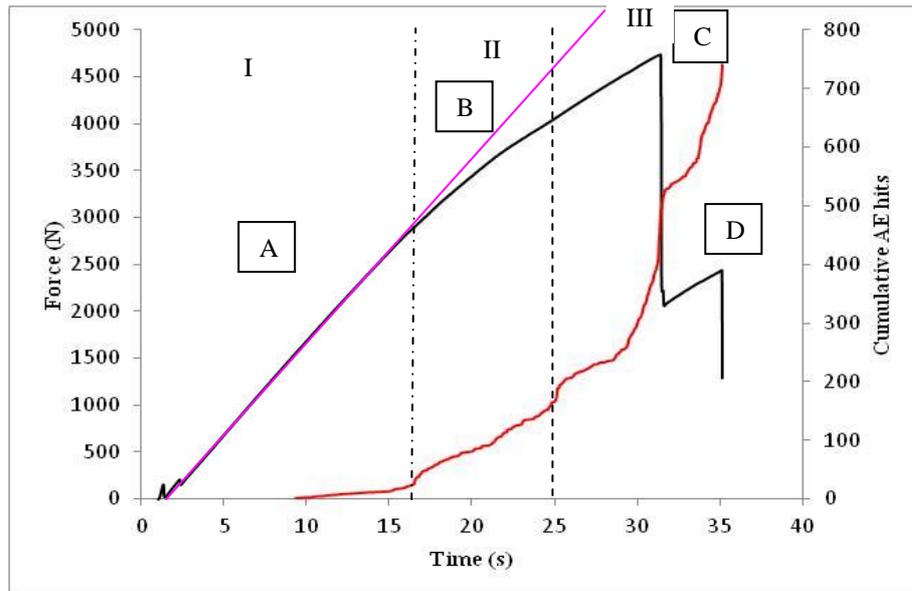
Fig.3 Load vs time, cumulative hits vs time for a representative Douglas fir specimen under tensile loading

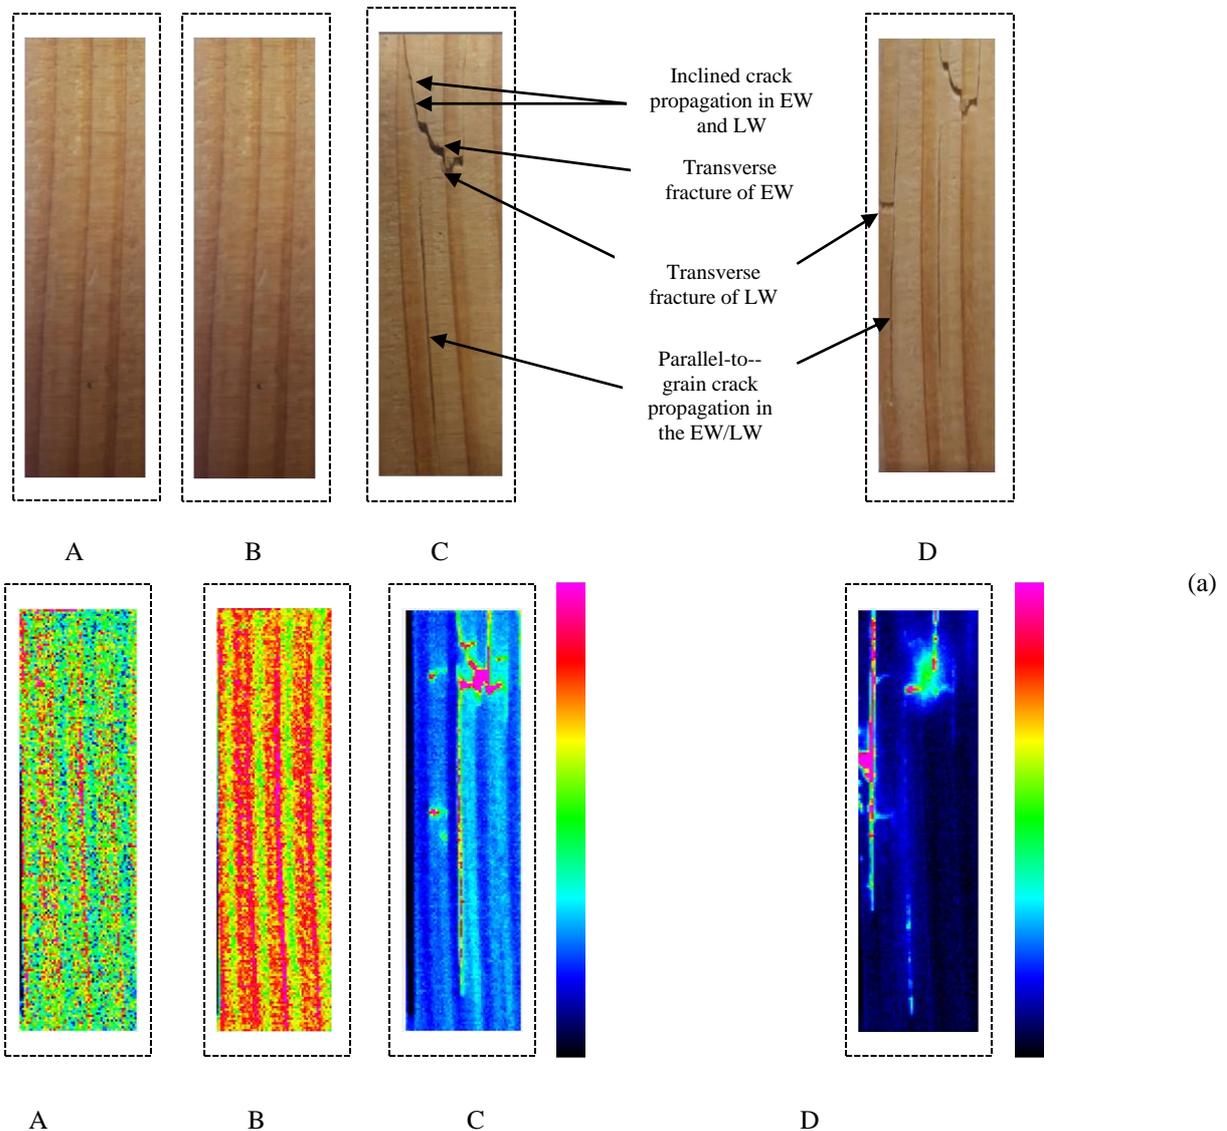
Fig.4 Damage in Douglas fir specimen under tensile loading: post-mortem observations and thermograms

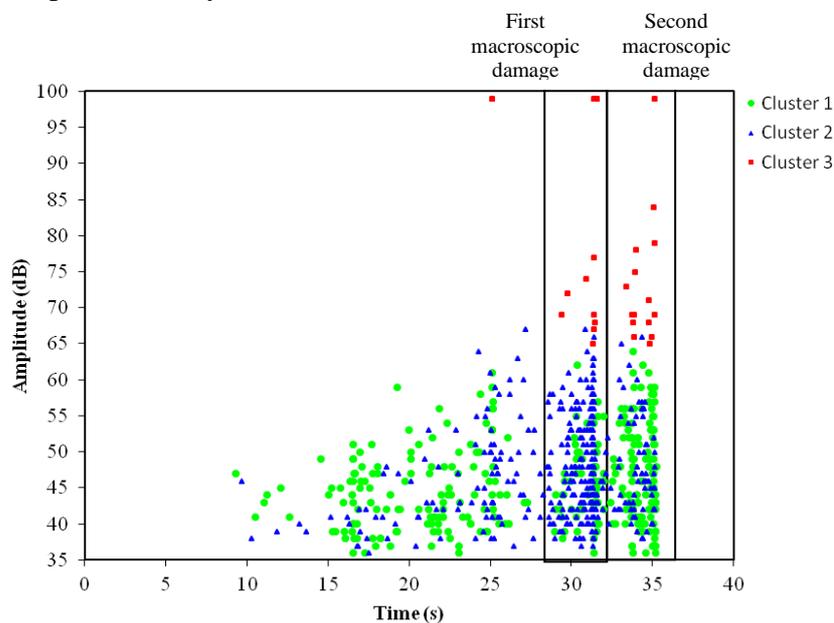
Fig.5 Cluster results: amplitude versus time

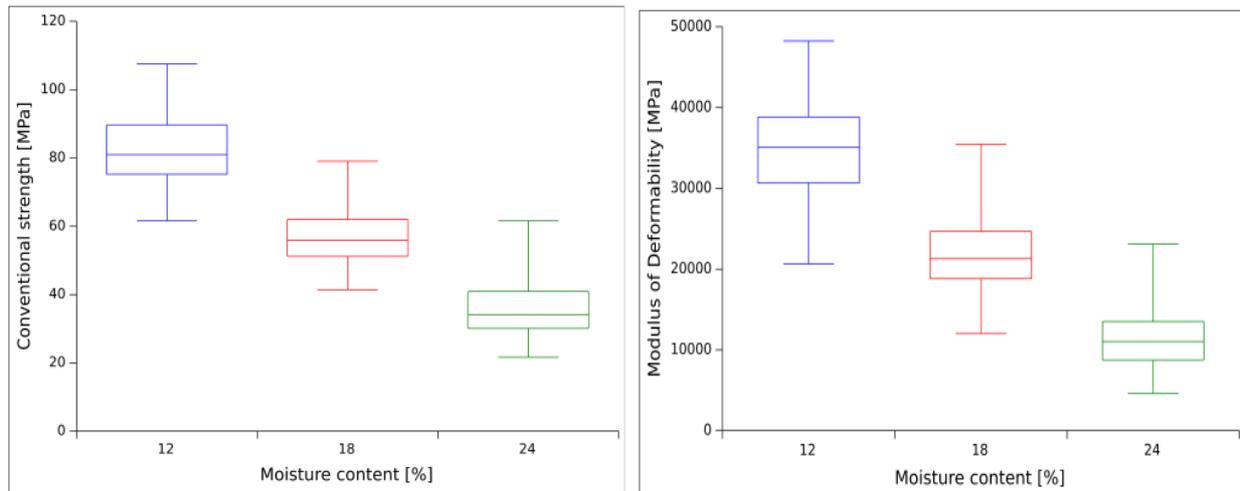
Figure 3 – Variability of Conventional strength (left) and Modulus of deformability (right) at 3 different moisture contents

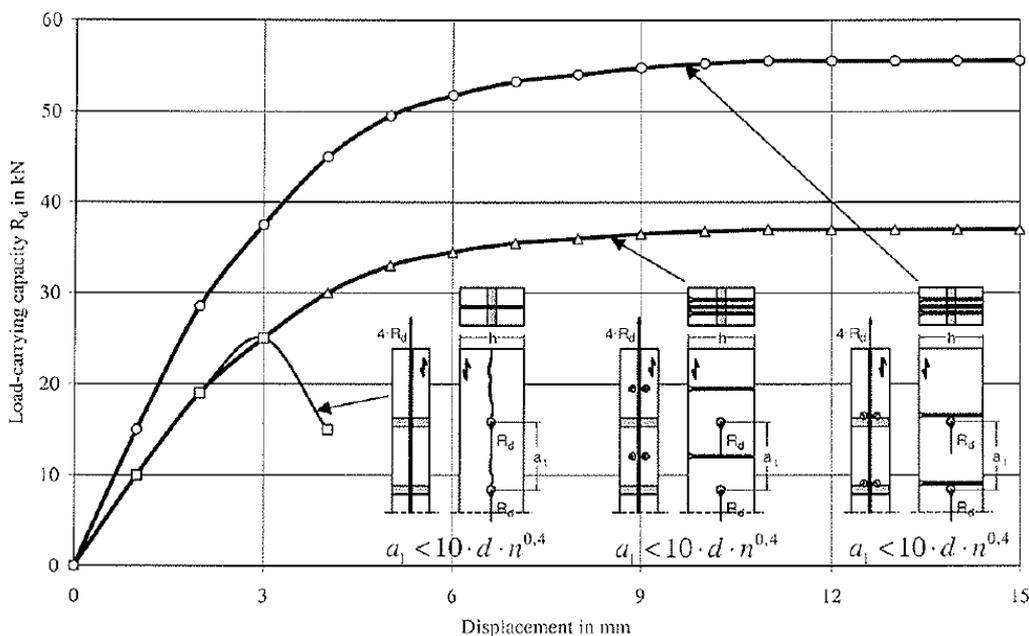
Figure 7 Different failure curves presented by Betkja and Blaß [4] showing unreinforced and reinforced connections with screws.

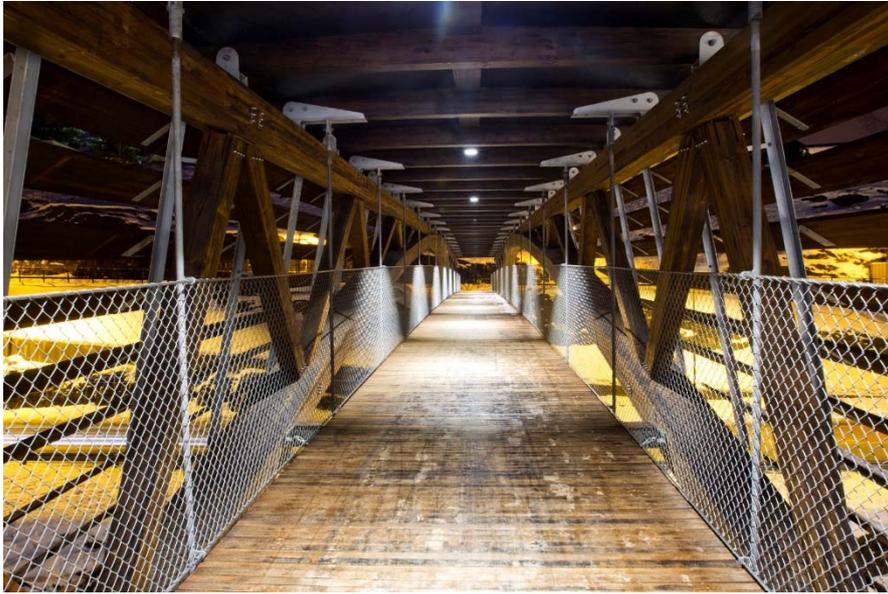
The wooden walkway is suspended by steel hangers from the roof beams. It has stainless steel wiremesh railing on both sides, and these are attached to the hangers.

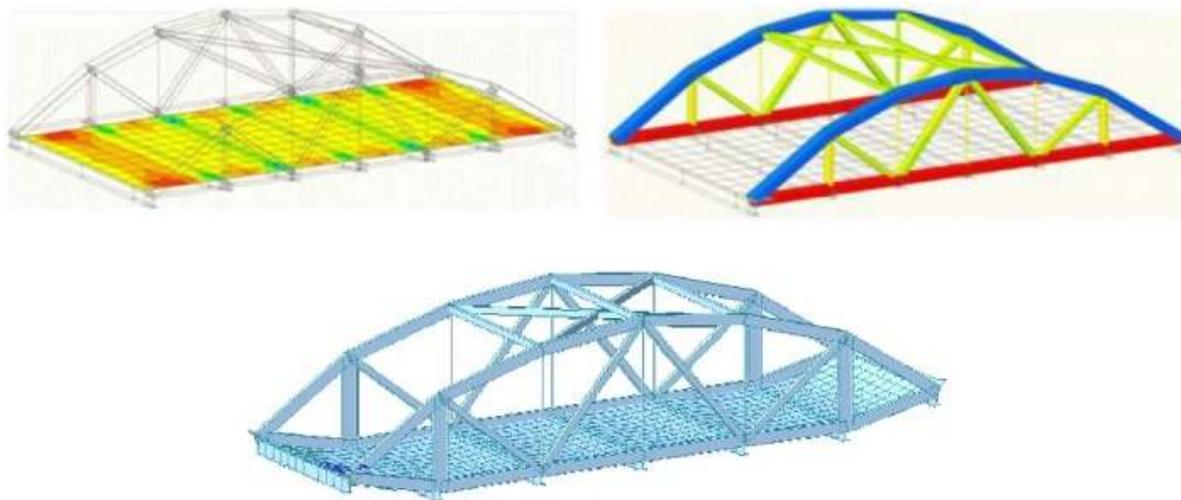
*Fig. 5 Results of finite element analysis (deck bending moment, truss axial force distribution and deflection shape)*

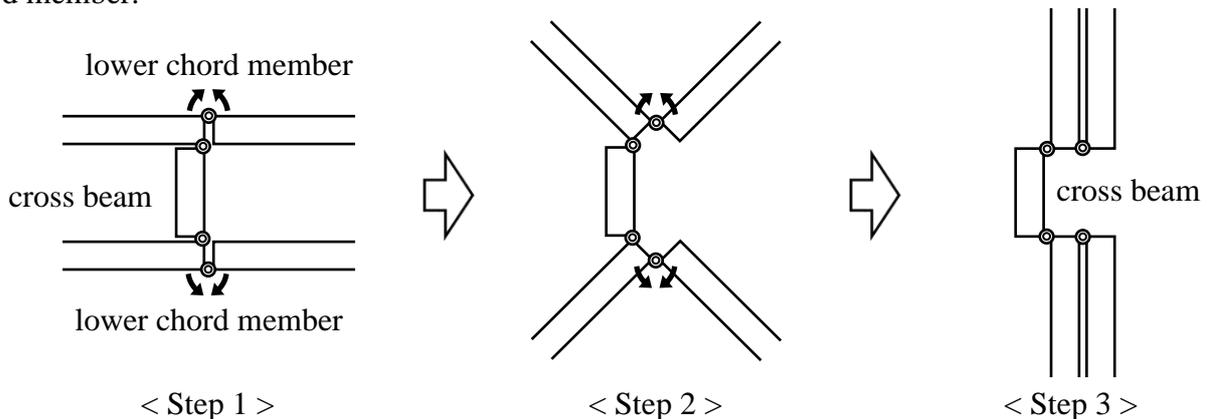
*Fig. 7 Folding process of Type-A*

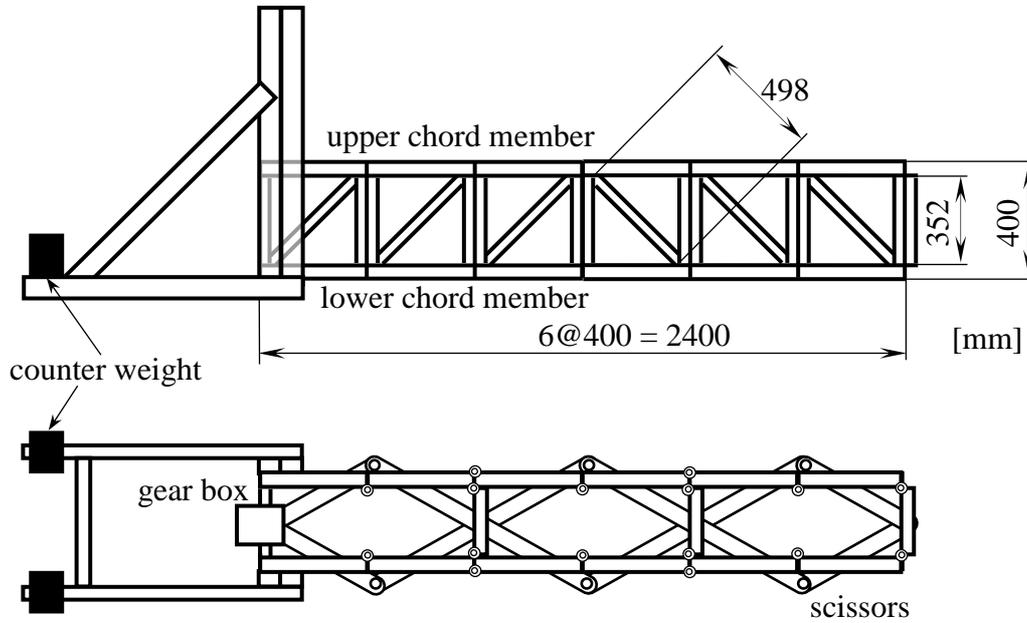
*Fig. 9* Bridge model in the unfolded condition

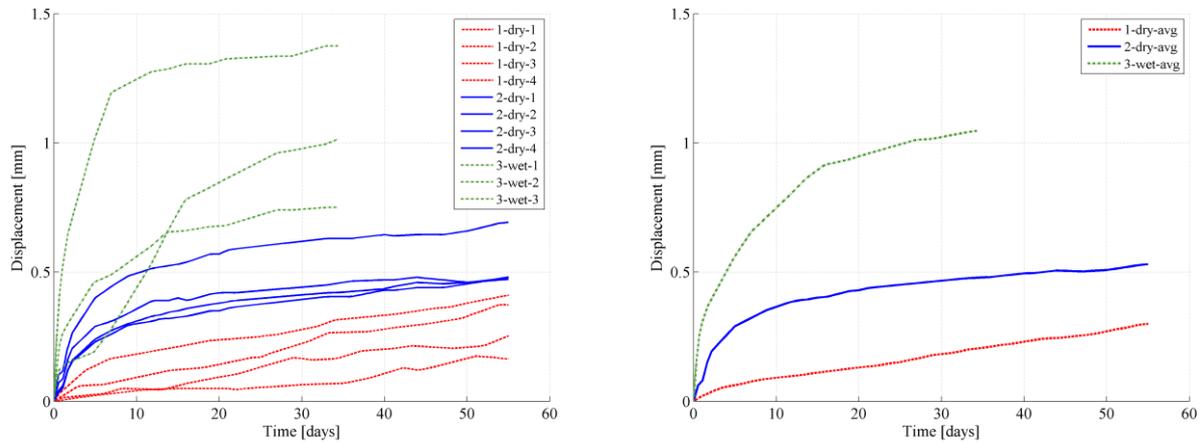
Fig. 3 Creep displacement measured for all samples (left) and averages made for clarity (right)

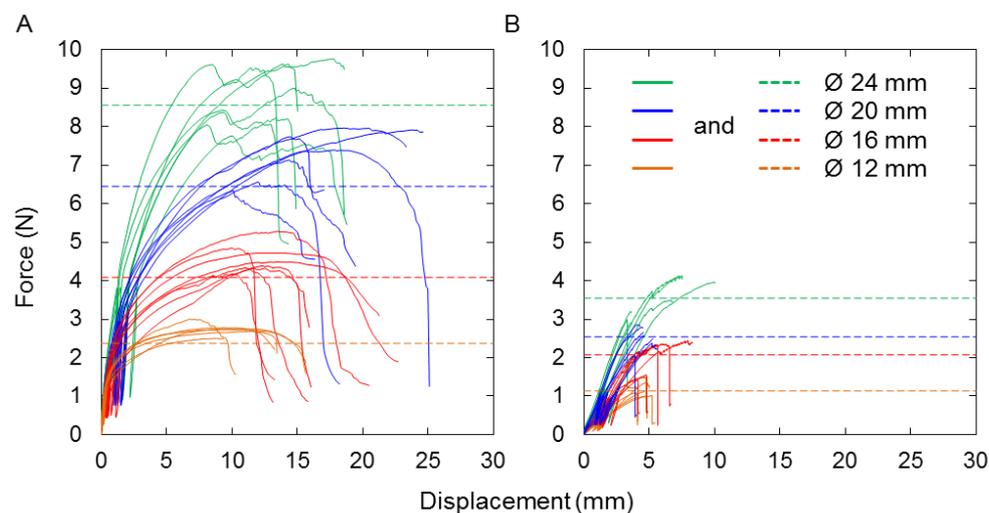
Fig. 3. The experimental results presented by load-displacement curves for dowel diameters 12-24 mm (full coloured lines). The theoretical coloured dashed lines represent prediction for appropriate mode failure which was observed in experiments according to Fig. 2; A - represents tensile parallel to grain; B - represents tensile perpendicular to grain.

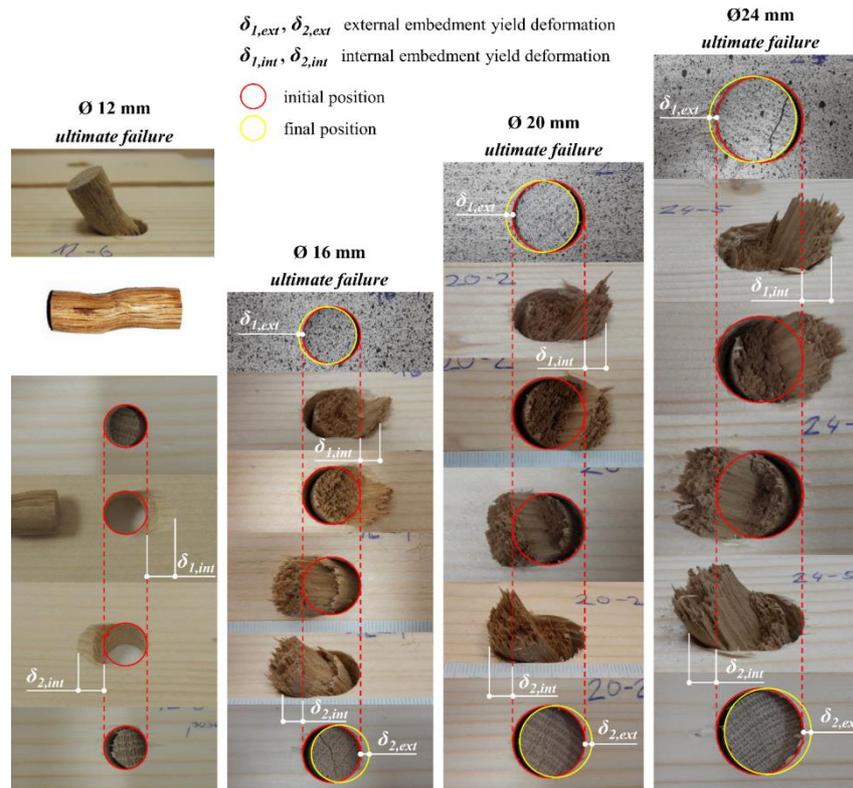
Fig. 4. The dowels deformation description when ultimate joints failure.
