UNIVERSITETET I AGDER

Condition Monitoring of Steel Wire Ropes

University of Agder, 2018

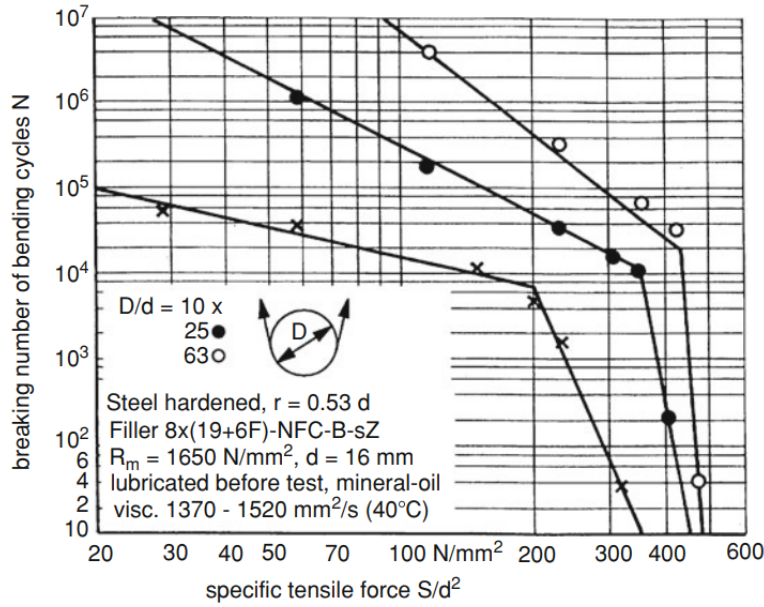
Figure 2.3: The breaking number of bending cycles as a function of specific tensile force, reproduced from [1, p. 220] with permission from copyright holder

The tensile force S and the ratio between the sheave and rope diameter D/d , have the most important influence on the number of bending cycles [1, p. 220]. According to [1, p. 220], the breaking number of bending cycles drops abruptly when the specific tensile force becomes equal to, or greater than, the Donandt force. The breaking number of bending cycles is the amount of bending cycles tested before

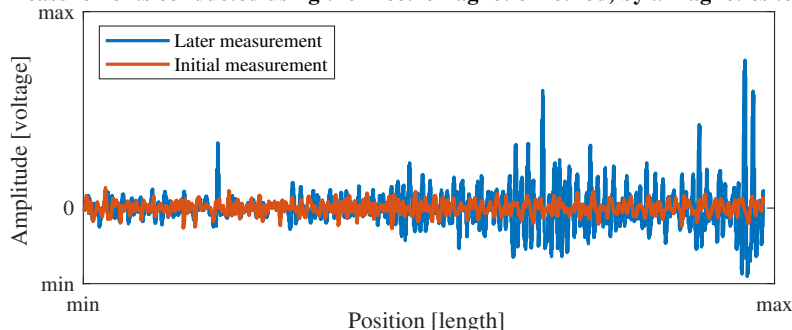
Figure 2.4: An example plot of the basic signal obtained by the use of a magnetics tester, which is a measuring instrument that uses the electromagnetic method, for an initial- and later measurement of a SWR

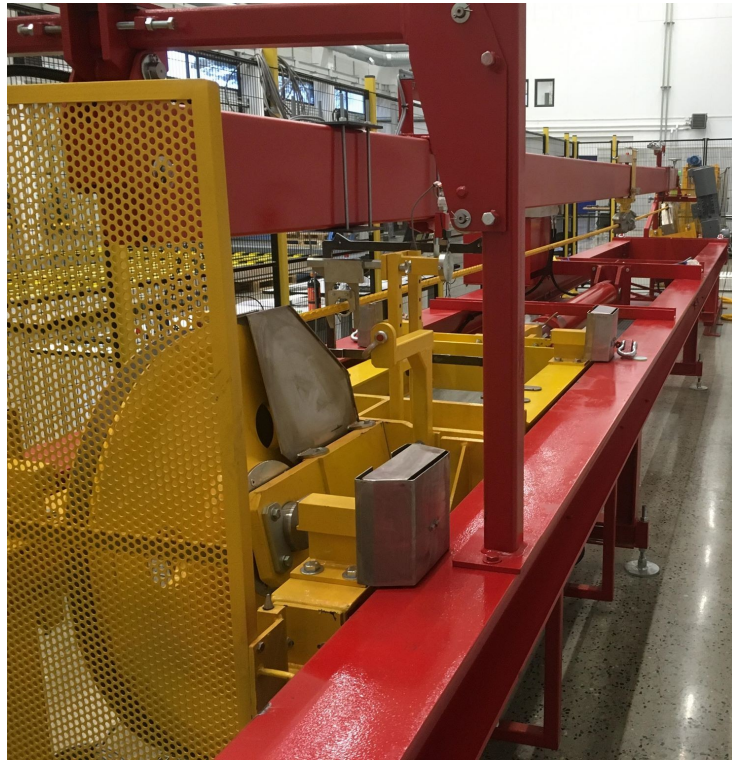
Figure 3.3: The CBOS rope testing machine shown from the backside. The test sheave is visible on the left side. As shown, a yellow fibre rope is mounted at the time this picture was taken

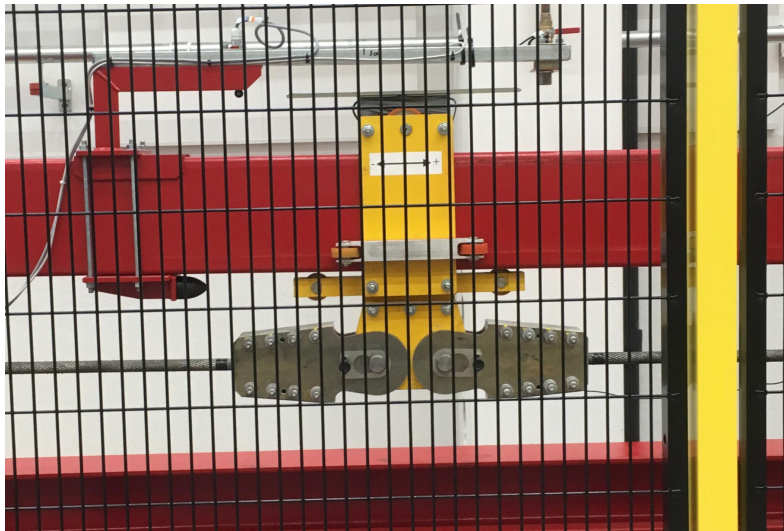
Figure 3.4: The trolley of the CBOS machine shown in its start position with a SWR mounted to it. The machine counts a cycle every time the trolley returns to this position

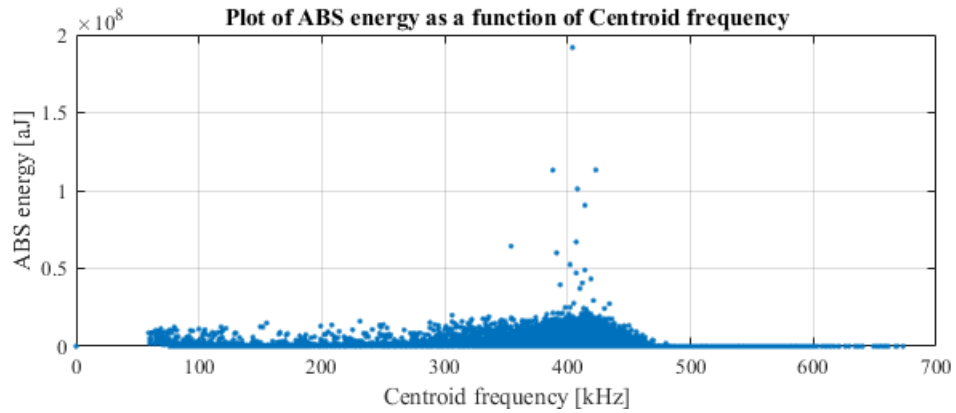
Figure 3.7: The ABS energy as a function of Centroid frequency, obtained from the measurement of the MISTRAS AE sensor system in the first test

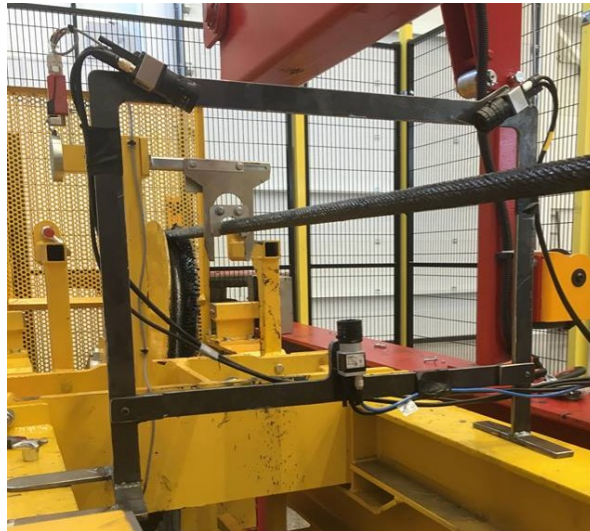
Figure 3.8: The camera system shown mounted to the frame its used with

The camera system used in this thesis is shown mounted to the frame its used with in Figure 3.8 and consists of three cameras which point towards the SWR at an approximate angle of 120° to each other. Thus, covering the whole circumference of the SWR. Specifications of the cameras are presented in Table 3.2. One of the cameras are delivered by BASLER, and the two other by Edmund Optics. For later reference, we will refer to the BASLER camera as camera 1, and the Edmund Optics cameras as camera 2 and 3. To improve the conditions of the cameras, additional special camera lights are installed together with a light-diffuser. The lights are light-emitting diodes (LED), have a 17W power draw with output comparable to a 150W Tungsten, and are delivered by Lightpanels. Three of these lights were utilised in this thesis and a picture of one of them is presented in Figure 3.9.

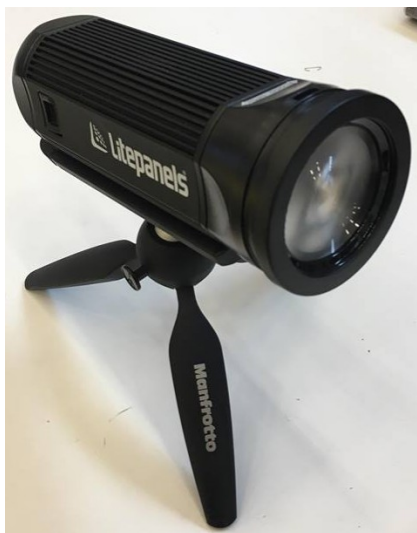
Figure 3.9: One of the three LED lights used to improve camera conditions in this thesis, shown with a tripod mount

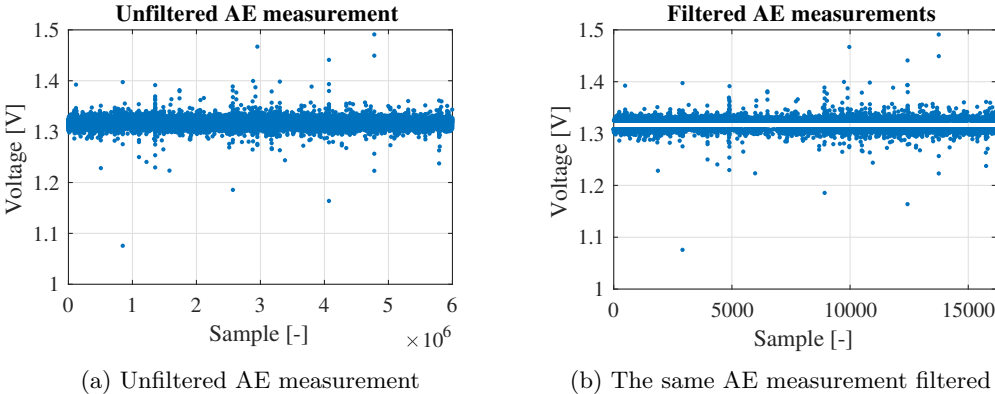
Figure 4.5: An example of how an AE measurements is affected by the chosen method of filtering

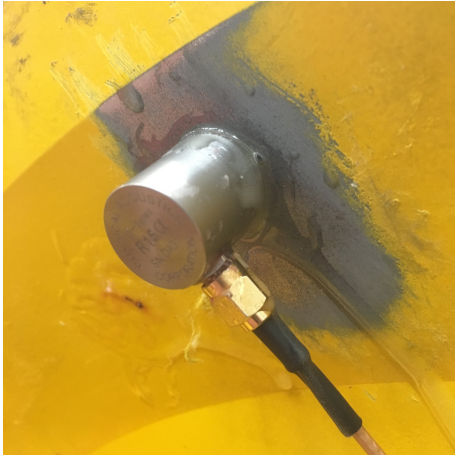
(a) The paint of the sheave is removed as it's believed to dampen AE signals

(b) The sensor is mounted at the location which is believed to have the shortest distance to the SWR since the material of the sheave is steel which is known to have a dampening effect on AE signal

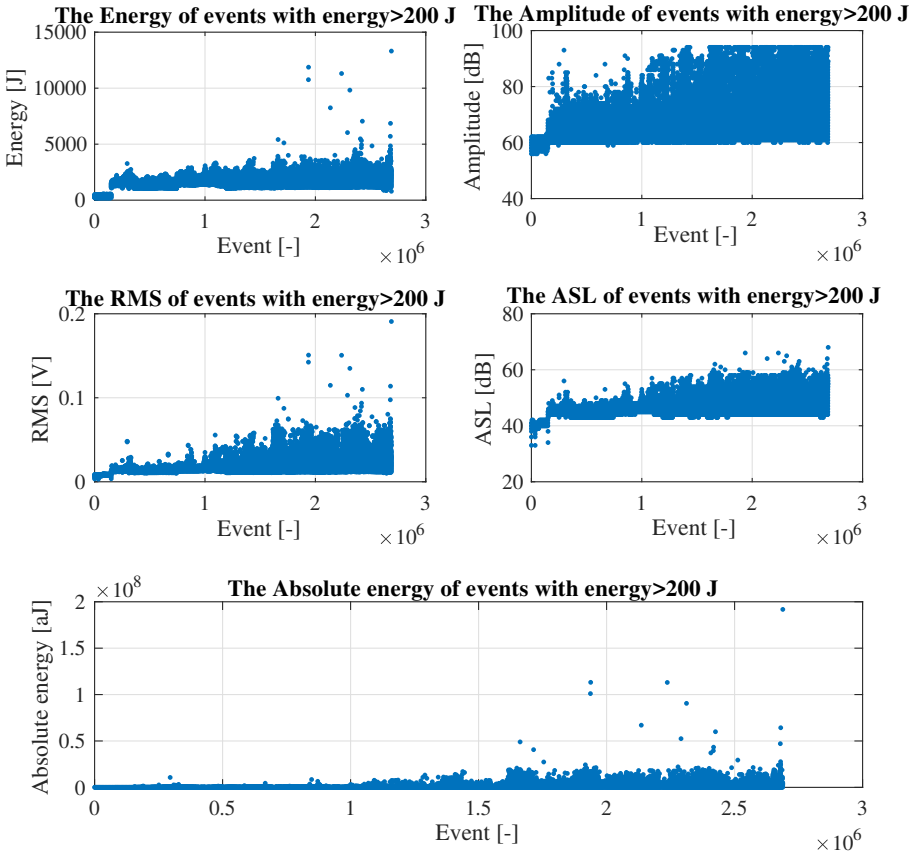
Figure 5.2: The AE variables of the first test which had a characteristic pattern through the fatigue life of the SWR, plotted against event number

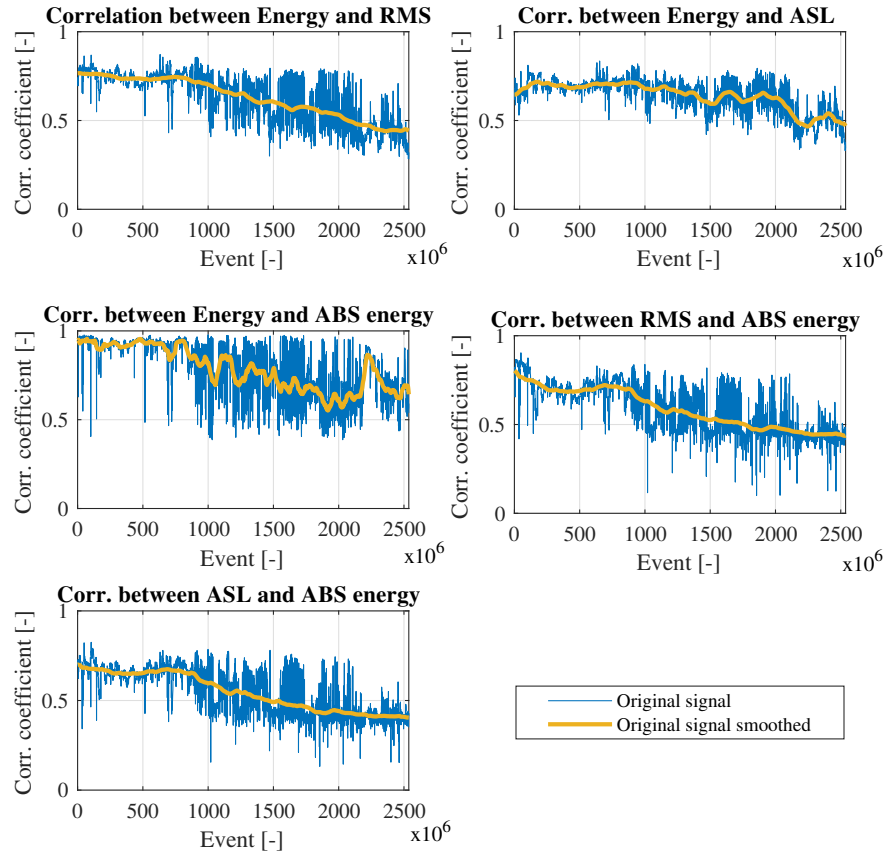
Figure 5.3: Correlation trends of the AE variables of the first test which had a characteristic pattern through the fatigue life of the SWR, i.e. the trends which also had a characteristic pattern through the fatigue life of the SWR, plotted against event number

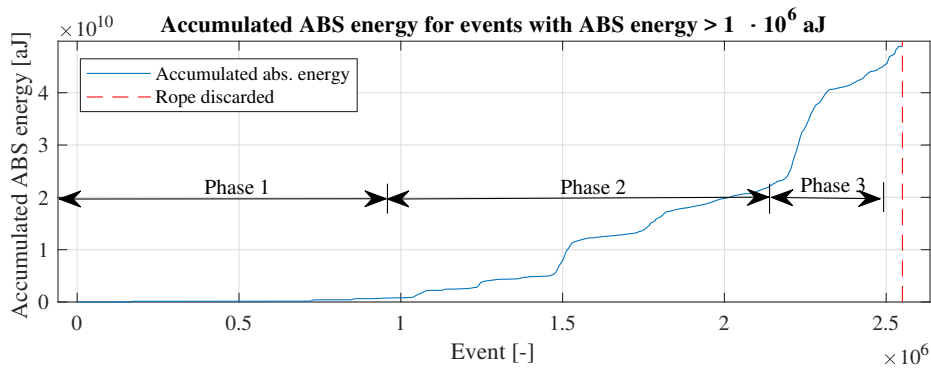
Figure 5.4: The accumulated ABS energy for events of the first test with ABS energy $1 \cdot 10^6 \text{ aJ}$

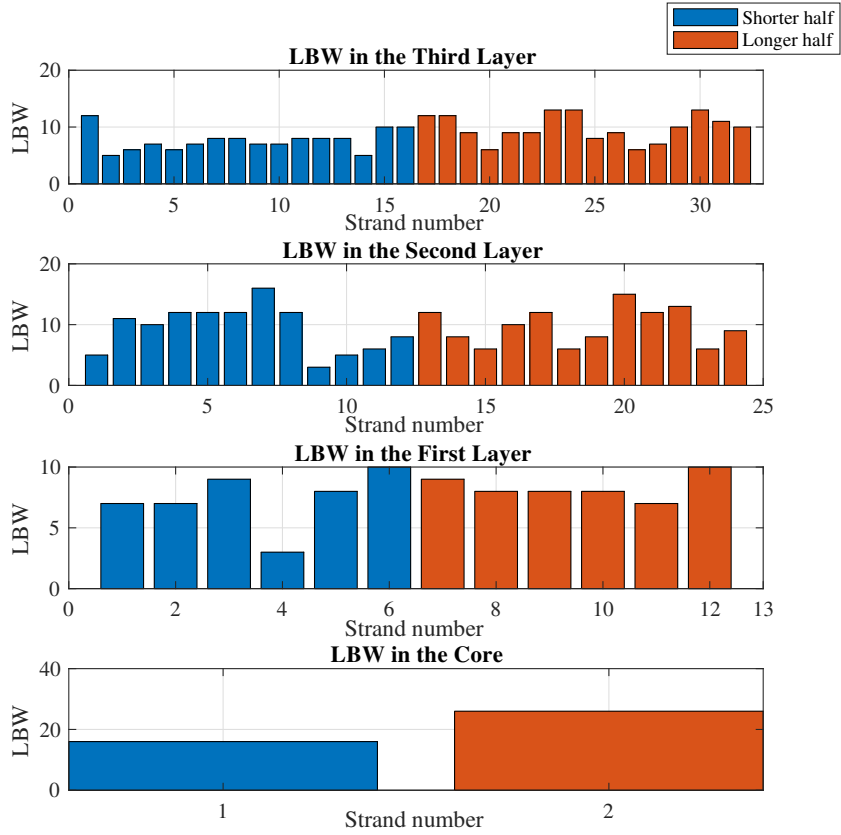
Figure 5.7: The counted number of LBW in each layer of the wire

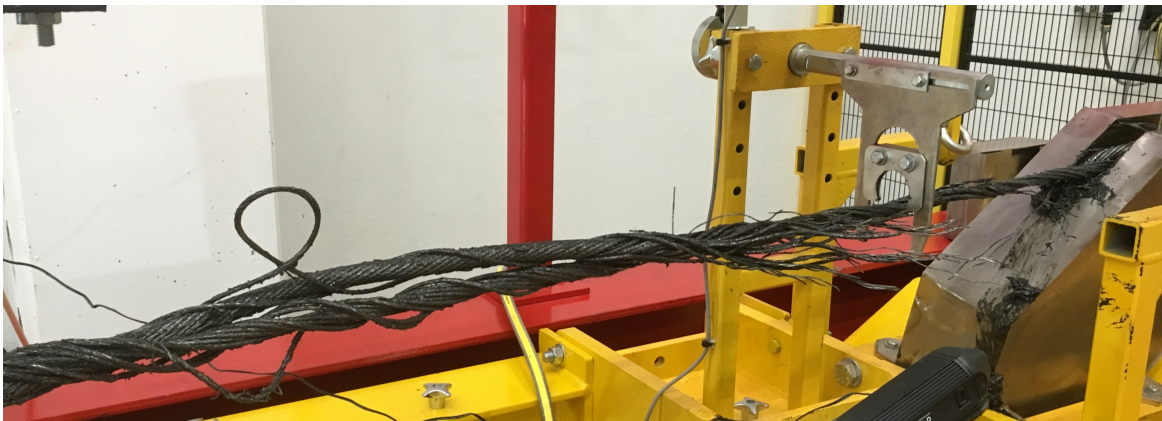
Figure 5.8: A picture of the second rope tested in this thesis subsequent to failure, the rope experienced a rapid and almost total rupture. Prior to this, the measurements of the magnetics tested revealed an exponentially increasing discontinuity, yet the outside of the rope didn't show any obvious signs of such a massive deterioration

The rope endured 115,574 cycles before a rapid, and almost total rupture occurred, as seen in Figure 5.8. The recorded and filtered AE data are presented in Figure 5.9 and a selection of magnetic measurements are shown in Figure 5.10. As diameter measurements were unsuccessful in the first test, they are not repeated in later tests. Due to poor camera settings and lighting conditions, which additionally were worsened by the water on the SWR from the static AE interface, it was impossible to perform lay length measurements. As seen in the AE data it appears that the 2nd channel somehow lost its signal at sample $5.5 \cdot 10^6$, further, although channel 1 and 2 have several significant fluctuations in voltage, neither of them shows any apparent signs of deterioration. Hence, the AE measurements aren't furthered processed. Figure 5.10 displays the raw measurements of the magnetic tester at four different cycles, notice the exponential increase in amplitude between the measurements of the later cycles. Figure 5.11 shows the processed magnetic measurements from the same test, i.e. the highest absolute amplitude-, the RMS-, and the integrated amplitude of each measurements as a function of cycle. As seen in the latter figure, the highest amplitude as a function of cycle reveals a sharp increase in amplitude at cycle 105,000 before the SWR ruptured. While the RMS as a function of cycle reveals deterioration already at cycle 60,000. The integrated amplitude as a function of cycle does not seem to reveal any information about deterioration which the highest- or integrated amplitude as a function of cycle has not announced in advance, with the exception of amplitude of the second coil being generally larger than that of the first coil. As opposed to the wires tested in the first, third and fourth test, not a lot of oil was released from the wire during the test, possibly because the oil's viscosity is increased as results of the cooling from the water. The water had a temperature of $9.2\text{ }^{\circ}\text{C}$ and the SWR around the traction sheave, which is defined in Figure 3.1, had a maximum temperature of $32\text{ }^{\circ}\text{C}$, which is higher than the maximal temperature of the SWR just outside the test sheave, which had a maximal temperature of $27.2\text{ }^{\circ}\text{C}$ as presented in Figure 4.6a. Thus, confirming the cooling effects of the water supplied by the AE static interface, as the rope temperature is expected to be higher at the test sheave than on the traction sheave.

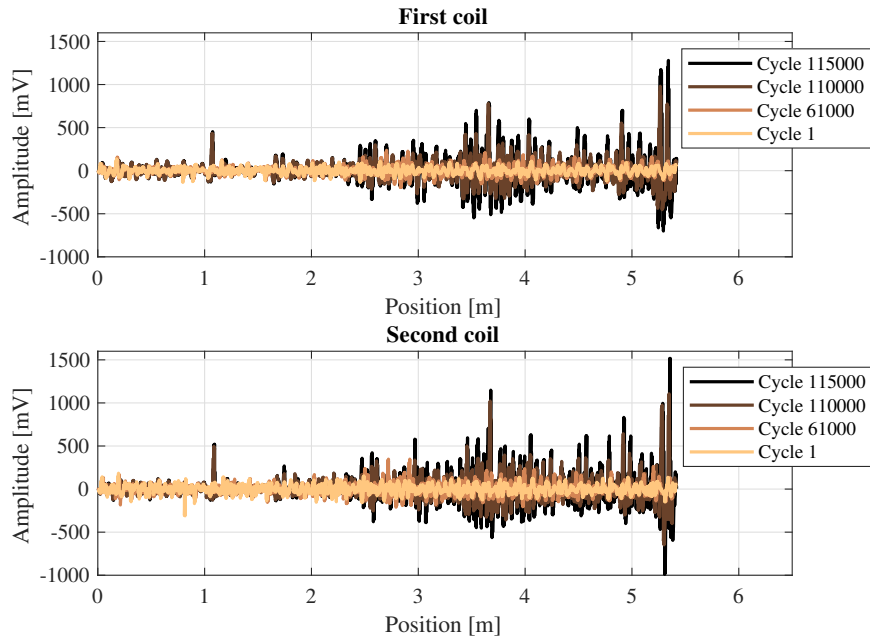
Figure 5.10: The raw measurements of the magnetics tester of the second test, shown at a selected number of cycles

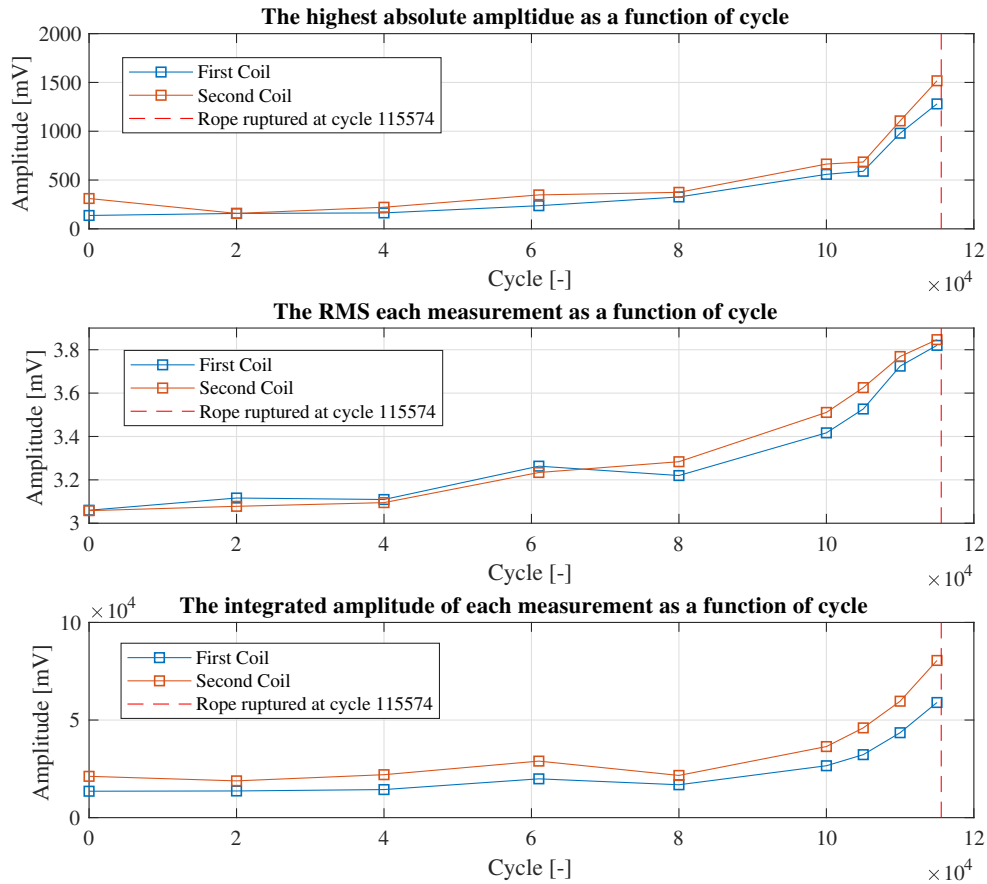
Figure 5.11: The processed magnetic measurements of the second test

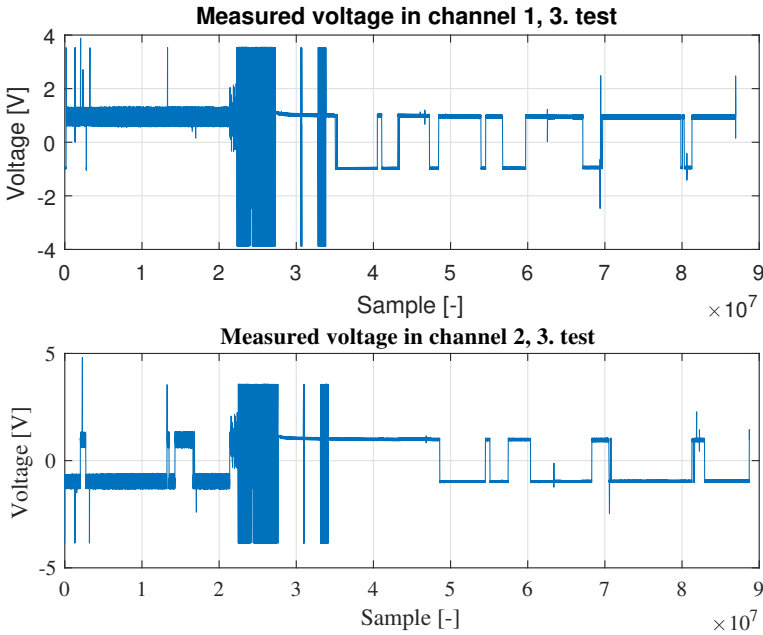
Figure 5.12: The recorded and filtered AE data of the third test

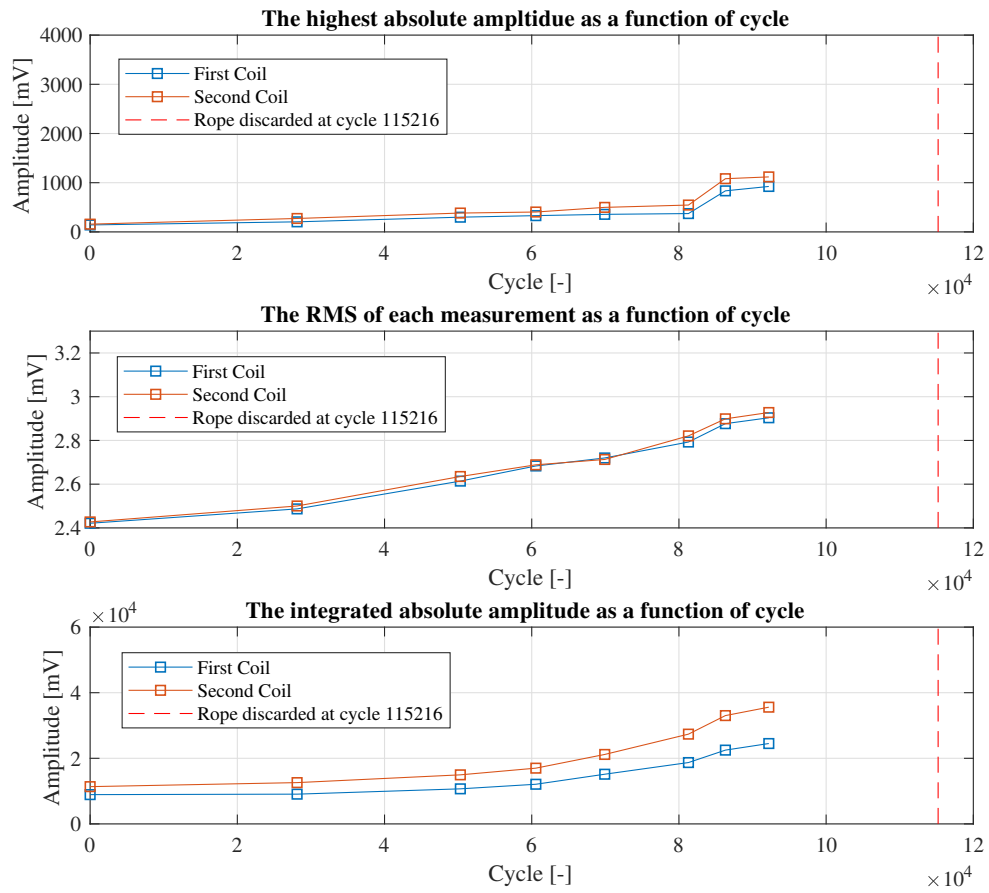
Figure 5.14: The processed magnetic measurements of the third test

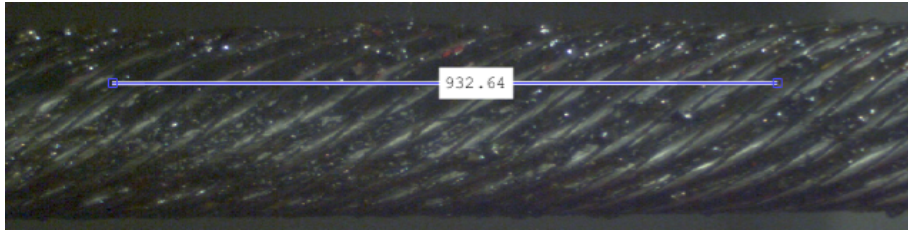
(a) Camera 3, cycle 1,000

(b) Camera 3, cycle 1,000

(c) Camera 3, cycle 114,000

(d) Camera 3, cycle 114,000

measurements with the magnetic tester before rope failure. The reason for this is that the doubt was raised towards our discard criterion as the SWR of the second test ruptured, thus, damaging the magnetic tester. As the magnitude of the magnetic measurements of the third test was closing up on the ones from the second test, to be on the safe side, a decision was made to unmount the magnetic tester before the SWR is discarded. In hindsight, the discard criterion resulted in a ruptured SWR only in the second test. Additionally, the magnetic measurements of the 24 and 26 mm SWR aren't directly comparable as they are conducted with coils of different size, as described in Section 3.2. Hence, a better decision would be not to unmount the magnetic tester. Lay lengths measurements based on data from the camera system are presented graphically in Figure 5.15, additionally, they are summarised in Table 5.4. Similar to the lay length measurements of the first test, the results of the third test show that the lay length is decreasing.

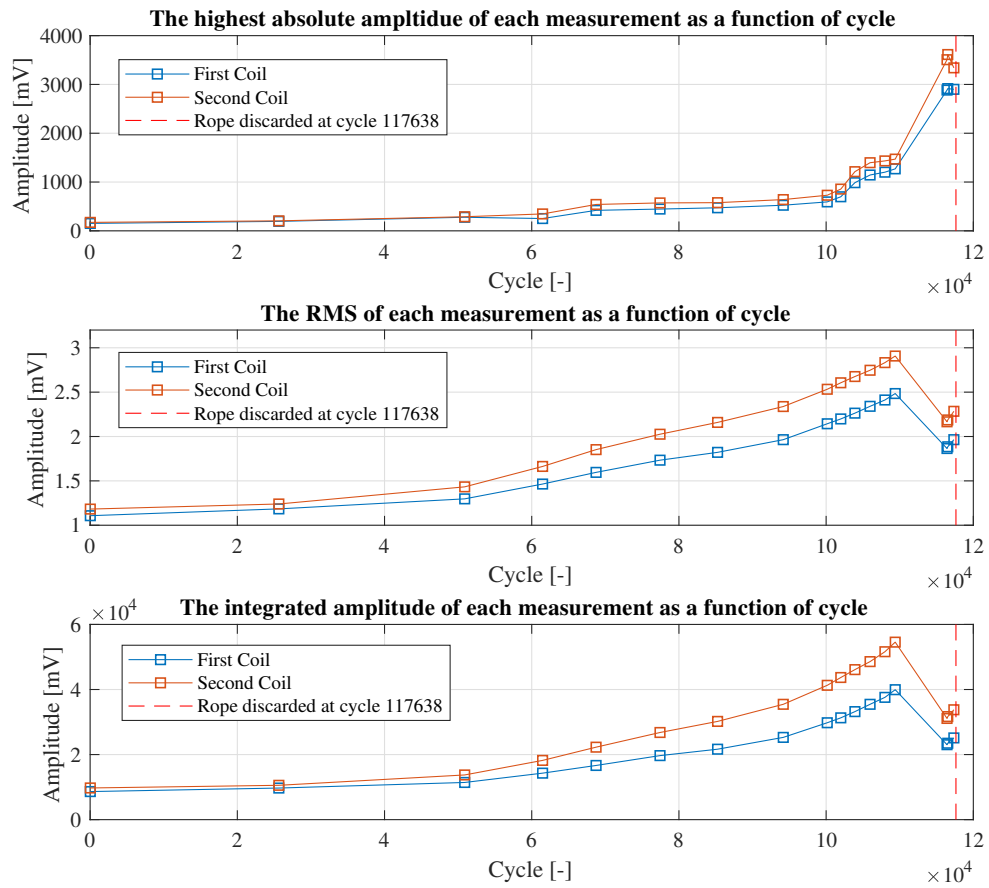
Figure 5.18: The processed magnetic measurements of the fourth test

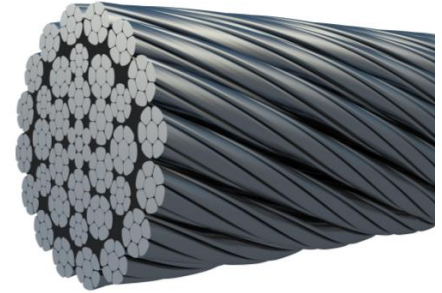
2. Rope Description	
Rope type:	Bridon Dyform 34LR
Rope Construction:	Dyform 34 x7 LR (16/6&6/6/1) Right hand langs lay (zZ)

3. Dimensions		
Rope nominal diameter:	d	26mm
Rope diameter tolerance:	d_{max}, d_{min}	+2% to +4%
Rope nominal length:	L	TBA
Rope length tolerance:	$L_{max}L_{min}$	+0 +1%

4. Strength		
Wire tensile strength (grade):	UTS	1960 N/mm ²
Nominal metallic area:	A	394 mm ²
Minimum breaking force:	F_m	63.5 tonnes
