OMAE2020-18017

**ON THE EFFECT OF VARIOUS HEAT TREATMENTS ON MICROSTRUCTURE OF AISI 4130
STEEL USED IN SOUR SERVICE PIPES**

Dmitry Vysochinskiy
Department of Engineering Sciences
University of Agder
Grimstad, Norway

Dmitri Rybakov
MHWirth
Kristiansand, Norway

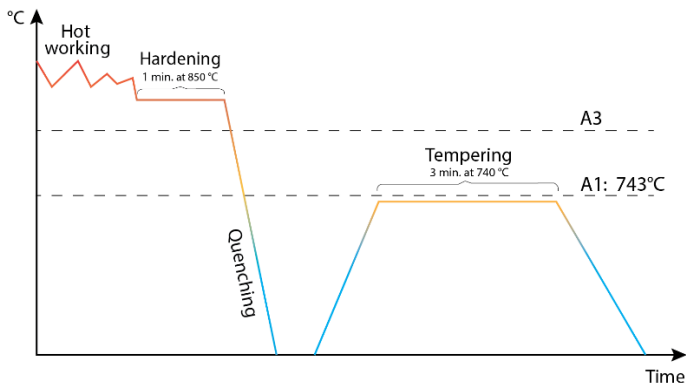
Figure 1. Heat treatment of supplied AISI4130 according to material certificate.

The material certificate states that the supplied steel has yield strength of 645 MPa, the tensile strength of 745 MPa and 32% elongation at fracture. The material certificate also describes the heat treatment as following: hardening at temperature 850°C with 1-minute holding time, cooling in water, tempering at temperature 740°C with 3 minutes holding time,

cooling in air. The heat treatment during production is illustrated graphically in Figure 1. The indicated lower critical temperature A1 was calculated based on the chemical composition using the following empirical formula available in e.g. [4]

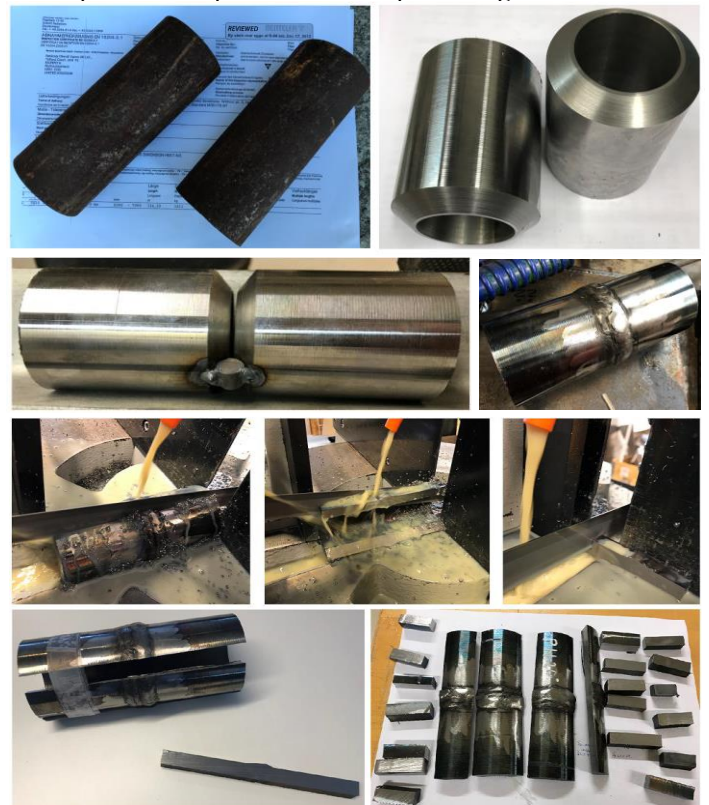
Figure 2. As-received pipe, welding preparation and sample cutting

Two 150 mm (5.90 inches) long sample pipes were used, Figure 2. Each sample was cut in two and joint together again using shielded metal arc welding (SMAW). Butt weld end preparation was done in accordance with ISO 9692-1 standard [5]: groove angle is 60°, root gap is 3 mm and root face is 2 mm. ASME B31.3 standard [2] dictates a mandatory preheating, thus one of the samples was preheated to temperature of 120° C prior to welding. The second pipe sample was not preheated, allowing to compare the samples and see how preheating effects the weld.

The hardness test samples were cut out using a band saw as illustrated in Figure 2. The samples were prepared in accordance with ISO 6507 standard [7]. Milling ensured samples surface flatness and parallelism, which was confirmed with digital leveling equipment to be less than 0,005mm. Polishing was done in following steps: P320, P800, P1200, P2400, ensuring roughness of less than 0,05 μm . For etching, nitric acid (Nital) was used.

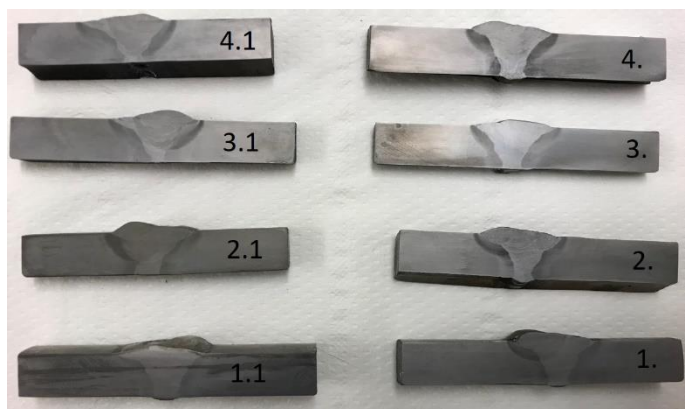
Figure 4. Etched samples for hardening testing

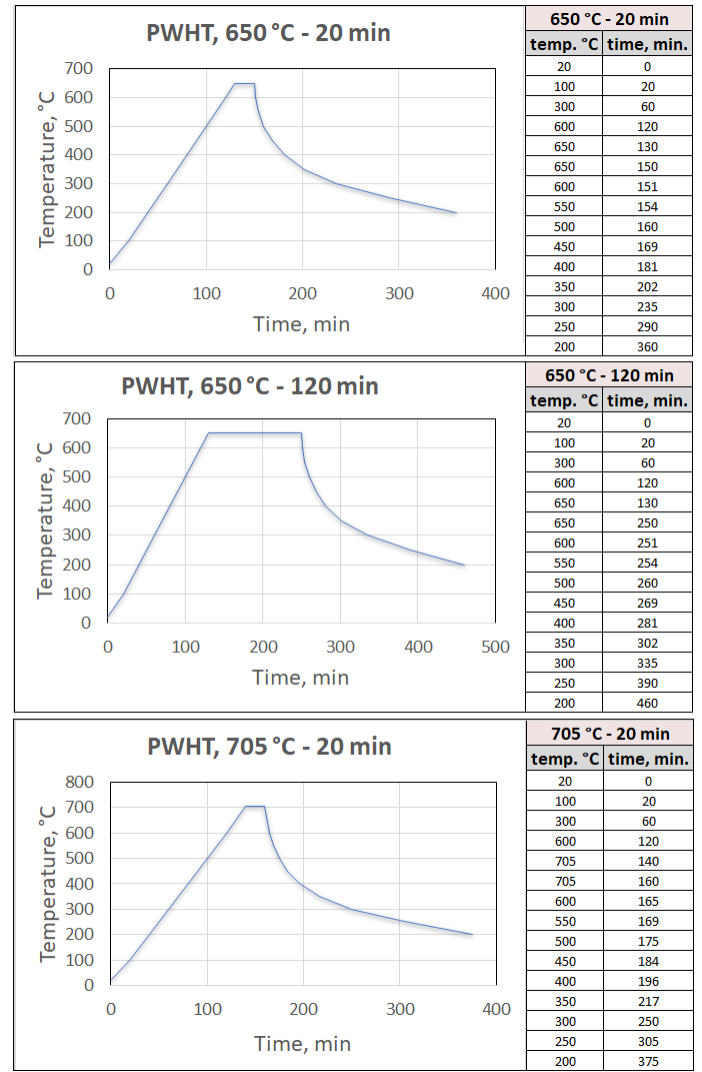
Figure 5. PWHT temperature profiles

It total four hardness test samples were produced out of each welded pipe. Table 2 gives an overview of the samples. The samples that were subjected to preheat were also subjected to post weld heat treatment in the furnace. One sample was kept untreated for the reference, while three others were subjected to three different heat treatments, as indicated in Table 2. A programable box-type furnace was used. The heating rate was set to 250° C/hour, while the cooling was performed by simply turning off the furnace and letting the samples to cool with the furnace. Figure 5 illustrates the heat treatment profiles.

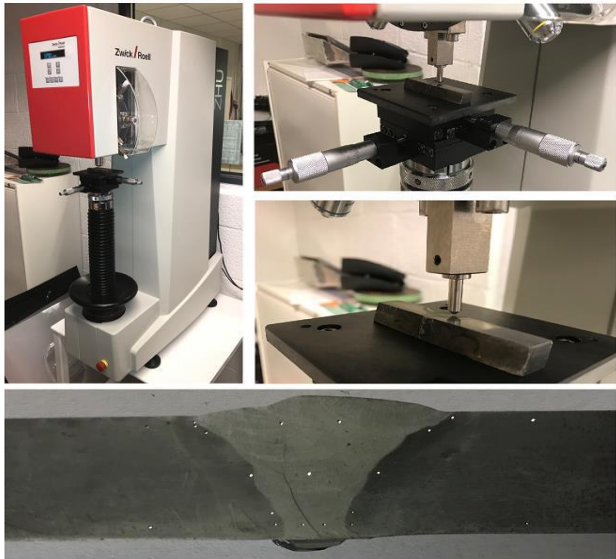
Figure 6. Hardness testing and a sample with indentation marks

Vickers HV10 hardness tests of the welded samples were performed in accordance with international standard ISO 15156-2 [8]. Testing was done using ZHU250CL testing machine from Indentec. The picture of the hardness testing machine and the tested specimen is shown in Figure 6.

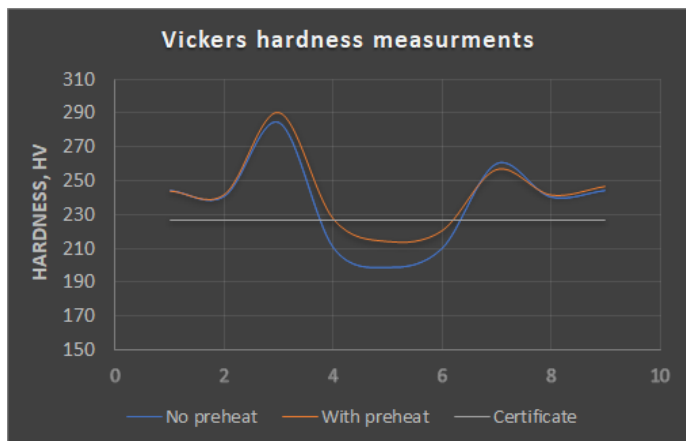
Figure 7. Effect of preheat on the hardness, average over all samples

Figure 7 illustrates comparison of average hardness for preheated and not preheated samples. A grey line in Figure 7 indicates the base material hardness stated in the material certificate. As can be seen from the figure the hardness is nearly identical in base material and HAZ, while some difference in hardness is observed for the fill material. No observable difference in hardness profile indicates that preheat has no significant effect on microstructure in HAZ at given condition. Note that preheat is usually required of other reasons, such as mitigation of residual stresses in the root string due to material contraction during cooling.

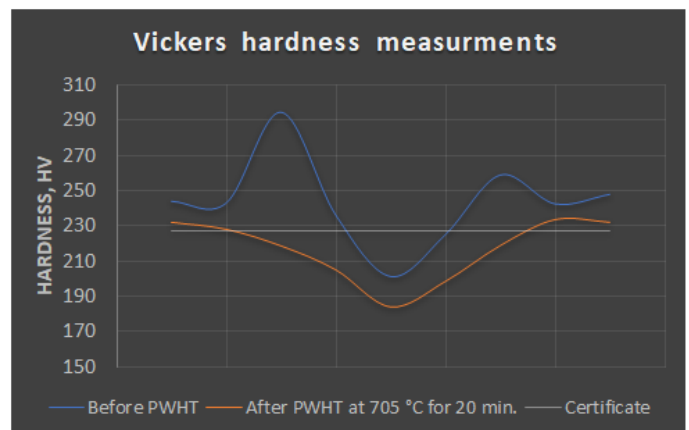
Figure 8. Hardness profiles for Sample 4,1

Table 3 illustrates the comparison of hardness values before and after PWHT while Figure 8 gives a graphical representation

of the hardness profile for the sample 4,1. The maximum allowable hardness value after PWHT is HV 250 according to ISO 15156-2 [8]. As can be seen from Table 3, PWHT at 650°C for 20 minutes does not allow to achieve the desired reduction of hardness in HAZ. After PWHT at 650°C for 120 minutes, the desired hardness is achieved nearly everywhere except one point, which is 253 HV. That is just 3 HV or 0,3 HRC above the limit, which is considered acceptable in accordance with permitted individual HRC reading exceeding of 2 HRC [8]. The heat treatment to 705°C for 20 minutes causes more severe hardness reduction; not only it causes hardness of HAZ to drop significantly below the level of base metal, but the hardness of base metal itself appears to be reduced, which might indicate weakening of the material. This hardness drop can be seen in Figure 8.
