Safety against quick clay landslides

An area stability assessment in accordance with NVE veileder 1/2019

University of Agder, 2023
Faculty of Technology and Science
Department of Engineering

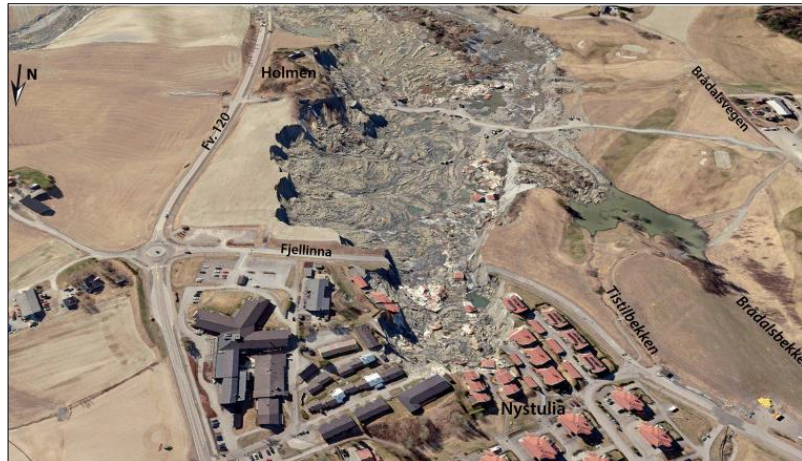
Figure 2.1: The area of Ask municipality in Gjerdrum after the quick clay landslide [5]

Evaluations and investigations conducted subsequently revealed that the landslide originated from a slope that had been subjected to erosion caused by a stream. The landslide developed backward and sideways and from Holmen and further to the Nystulia residential area as illustrated in Figure 2.1. Further assessments indicated that the slope had been highly susceptible for an extended period, and the erosion had further weakened its stability. It was determined that the erosion was primarily induced by human interventions, which had impeded the flow of water in several areas of the stream, resulting in increased water velocity and subsequent erosion [5].

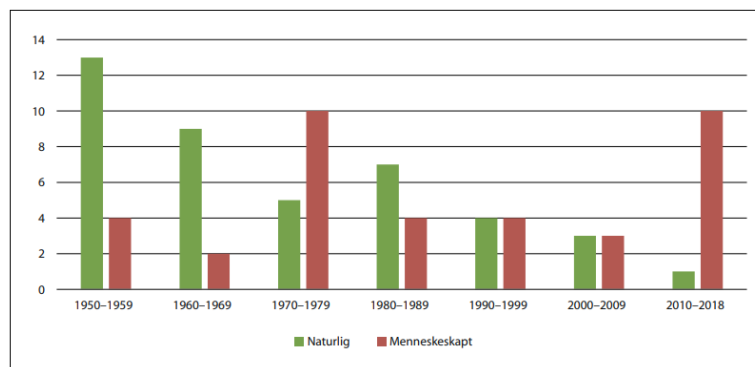
Figure 2.2: Distribution of landslide based on natural causes and human interventions [5]

Some studies highlight that quick clay landslides are mainly triggered by either human interventions or natural causes [6, 7]. Natural causes are typically elevated pore pressure or erosion along watercourses. Human interventions include excavations at the bottom of slopes, fillings at the top, and other terrain loads that can worsen stability. According to Heureux et al [8], 90 % of the landslides from 2010 to 2018 have been triggered by human interventions as illustrated in Figure 2.2.

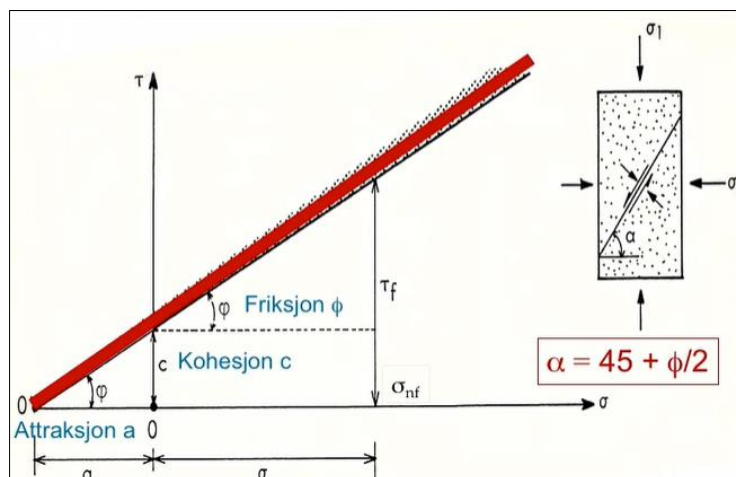
Figure 3.5: Shear strength in effective stress analysis – obtained from lecture at NTNU [32]

Attraction a is a curve size and may also be defined as a negative tensile strength of a material [32, 35]. The linear shear strength in effective stress analysis is defined by Figure 3.5 and the linear relationship between cohesion c' , attraction a and the angle of friction ϕ' , and can be further expressed by the following equation [21]:

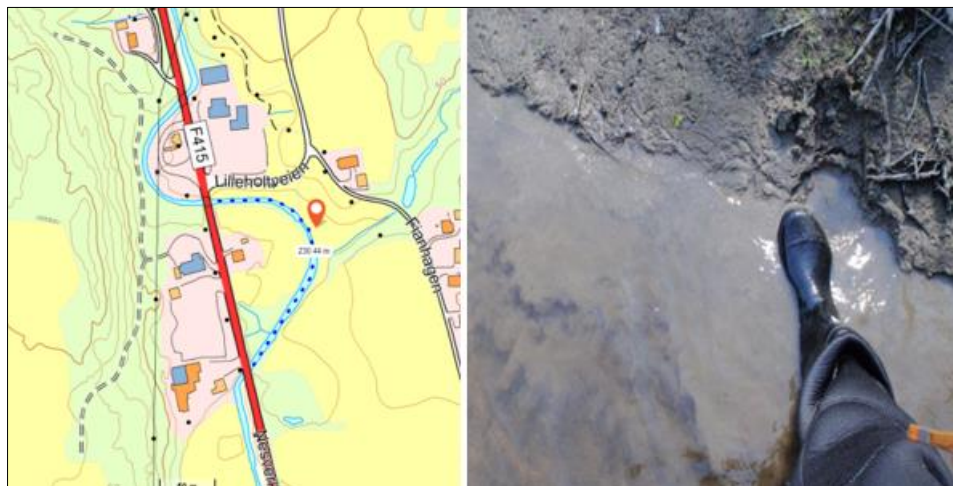
Figure 5.3: Raster map (left) & part of riverbed (right) [37, 40]

The area between Lilleholtveien and the river, as demonstrated in Figure 5.3 (left), is only designed for grazing and thus unsuitable for the use of machinery. Here the slope is steep from the road and towards the river, but of less importance in an agricultural context. In general, the entire river stretch is characterized by erosion and the existing protection against erosion has slipped into the river course. The riverbed contains of weak masses such as silt and clay as shown in Figure 5.3 (right). Furthermore, the stretch is significantly affected by erosion damage to the sides and bottom as shown in which causes the river to excavate new side courses which in turn can cause damage to the terrain.

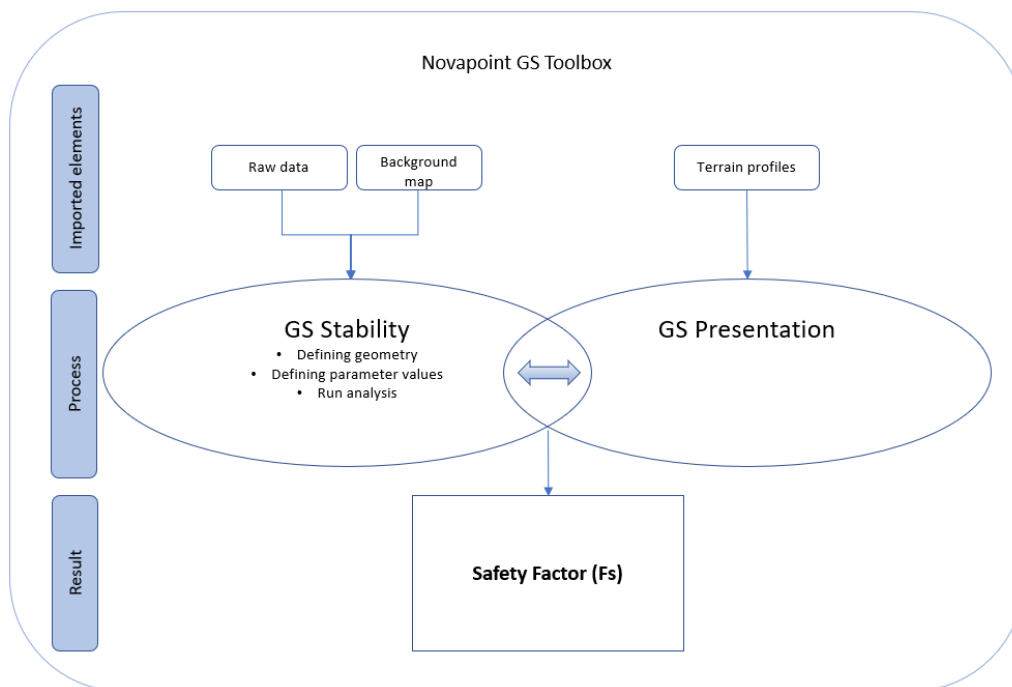
Figure 6.1: Methodology for Stability analyses in GeoSuite

Stability analyses have been conducted by applying the GS Toolbox, which includes two modules: GS Stability and GS Presentation. The methodology applied for the analyses is illustrated in Figure 6.1 and a review of this methodology will be provided in the following sections. The purpose is to calculate the safety factor F_s through undrained (total stress analysis, F_{cu}) and drained (effective stress analysis, $F_{c\phi}$) analyses of the current situation and after measured have been implemented. This is to verify if the value of F_s meets the requirements in Table 3.1 and to document the safety of the slopes that are nearby the river in the selected case-area. It should be noted that the applied modules are interdependent, meaning that both modules are required to carry out the analyses as illustrated in the figure below.

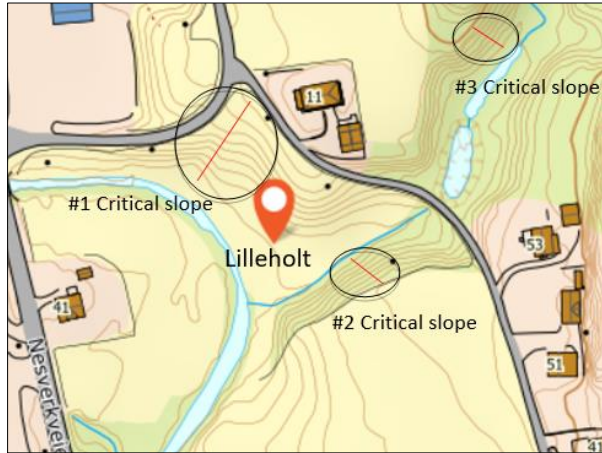
Figure 7.1: Overview of identified critical slopes [44]

Figure 7.1 present identified critical slopes
