# Solar cell degradation: the role of moisture ingress

Doctoral Dissertation for the Degree *Philosophiae Doctor (Ph.D.)* at  
the Faculty of Engineering and Science, Specialisation in Renewable Energy

University of Agder  
Faculty of Engineering and Science  
2023

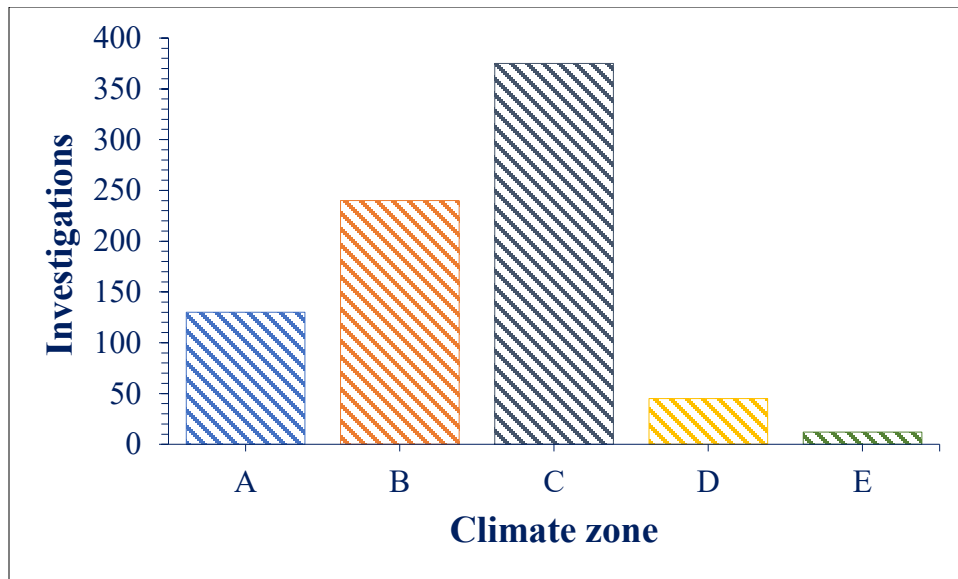
**Figure 1. 4.** Distribution of reported failure data on PV modules installed from the 1970s to the year 2015. Data is based on investigations that were done on the entire PV module as a unit. Extracted from Halwachs et al. [35], refer to Paper A.

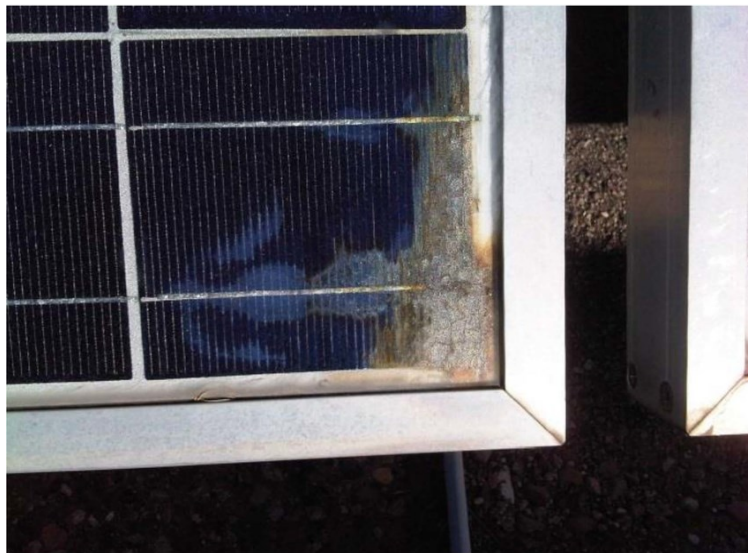
**Figure 3. 1.** Effect of moisture ingress on a solar PV panel from the perimeter. Adapted from Wohlgemuth et al. [32], also refer to Paper B.

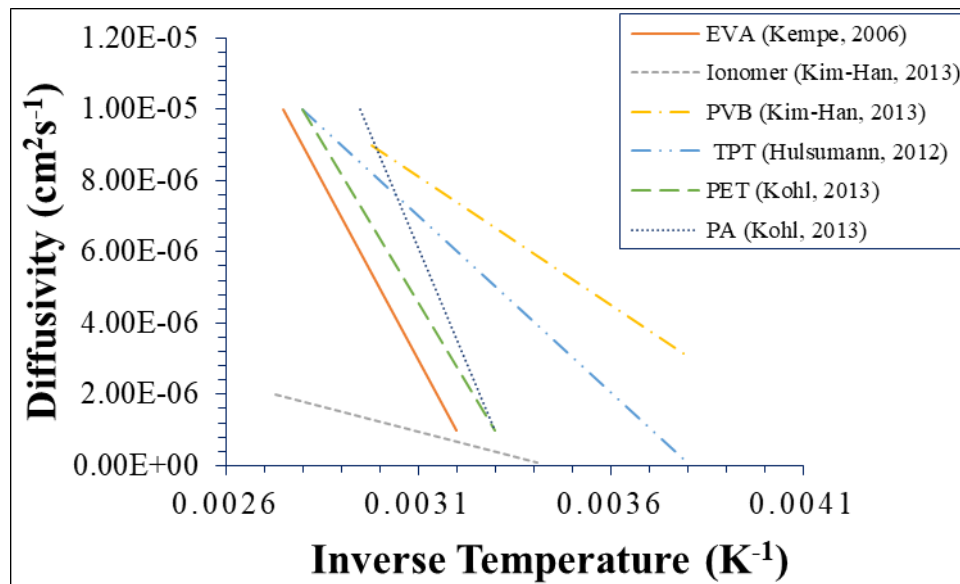
**Figure 3. 4.** Moisture diffusion as a function of temperature in different encapsulation materials. Adapted from Paper B, Segbefia et al. [33].

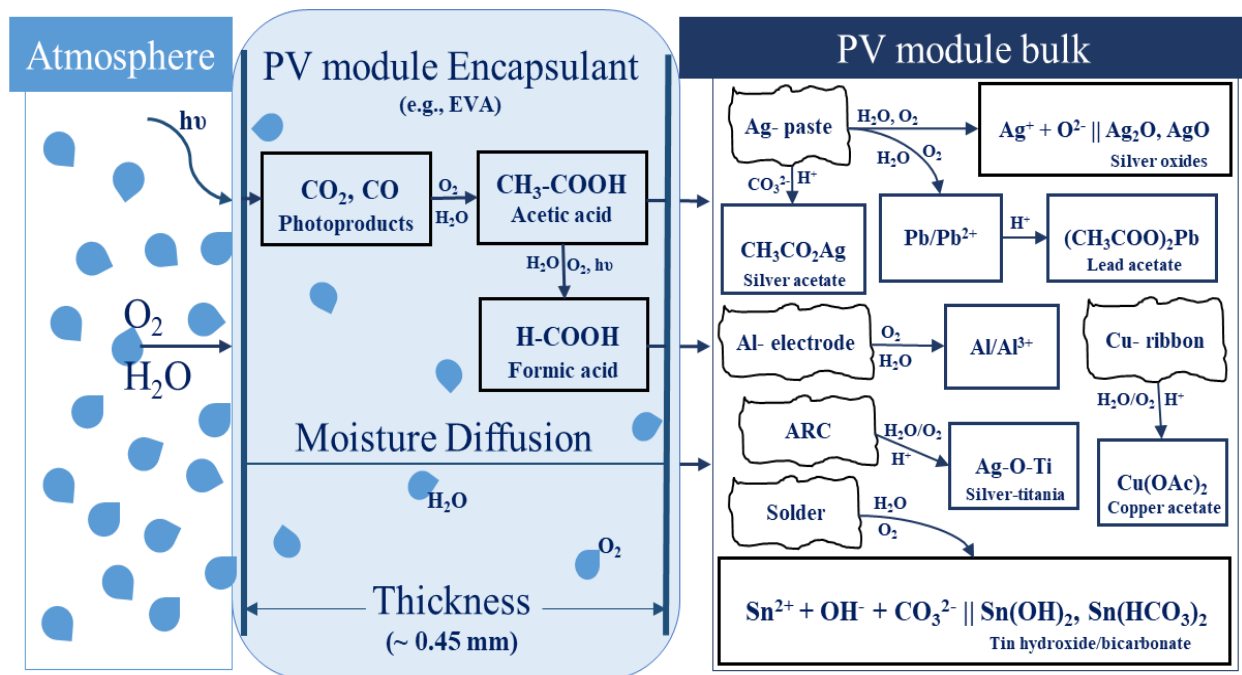
**Figure 3. 5.** Moisture ingress mechanism and the associated degradation mechanisms in solar PV devices. MID products (e.g., acetic acid) attack the components of the solar PV module, which lead to degradation. Adapted from Paper B, Segbefia et al. [33].

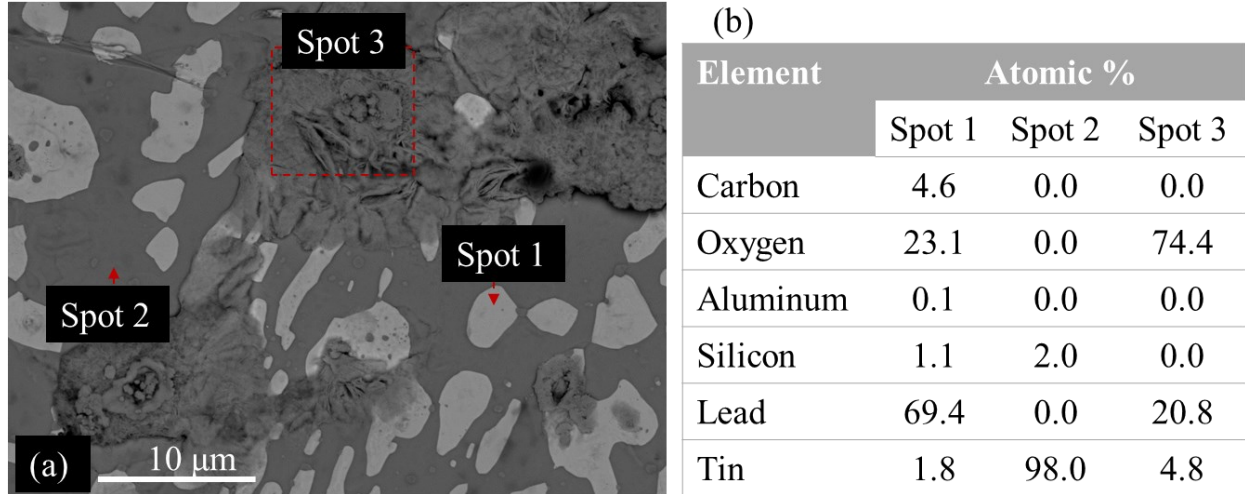
**Figure 3. 15.** Moisture induced degradation of the solder bond in a solar cell extracted from a field-aged PV module. (a) SEM micrograph and (b) corresponding EDS analysis.

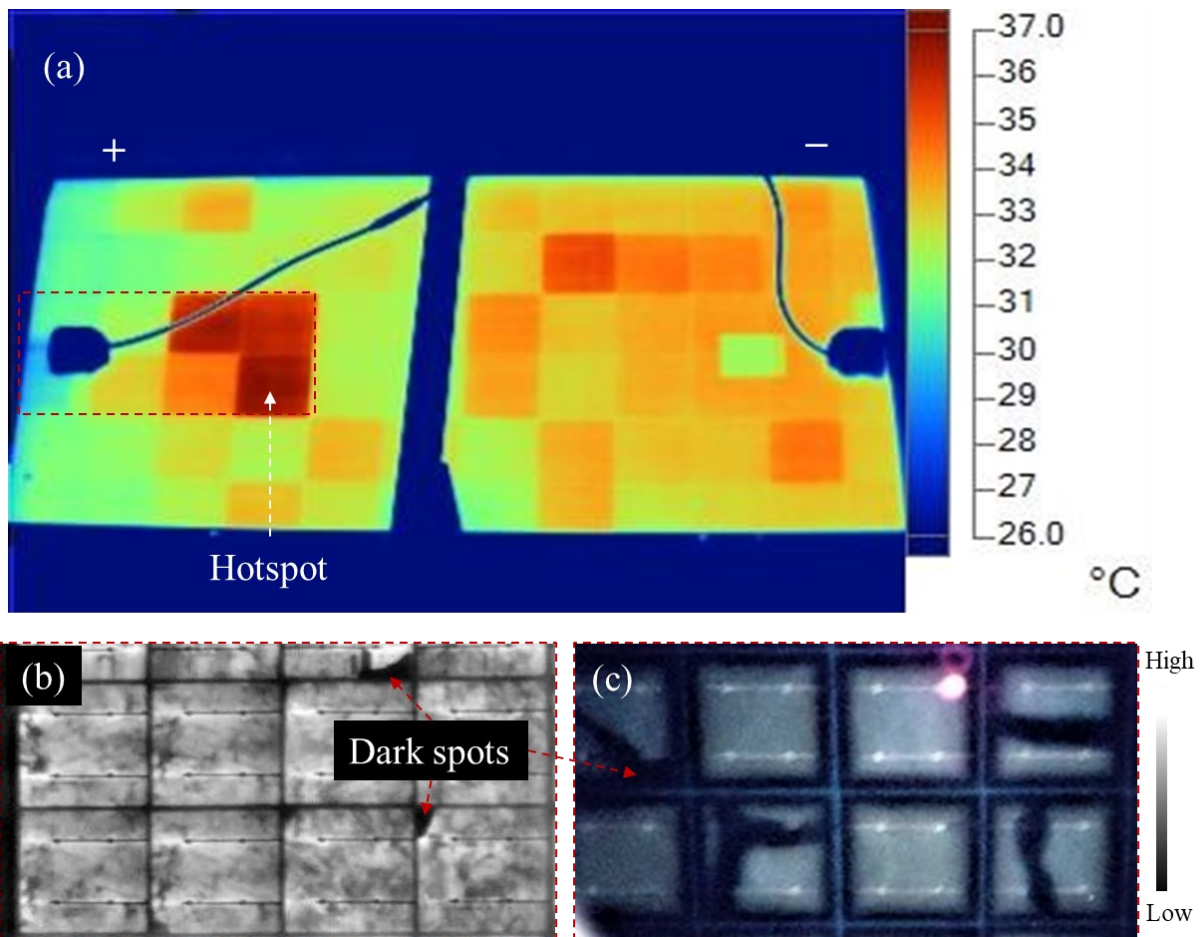
**Figure 3. 16.** (a) IR thermography of a field-aged solar PV module. Corresponding (b) EL image and (c) UV-F image of the marked-out hotspot area in (a), from Paper D.

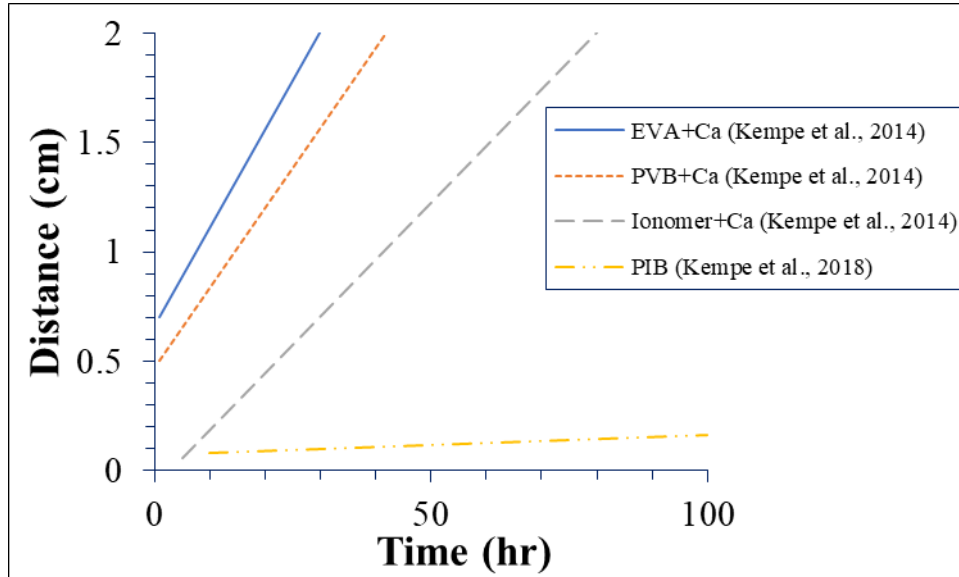
**Figure 3. 17.** Moisture barrier resilience of some edge sealants. Data extracted from Kempe et al. [64] and Kempe et al. [65]. Adapted from Paper B, Segbefia et al. [33].

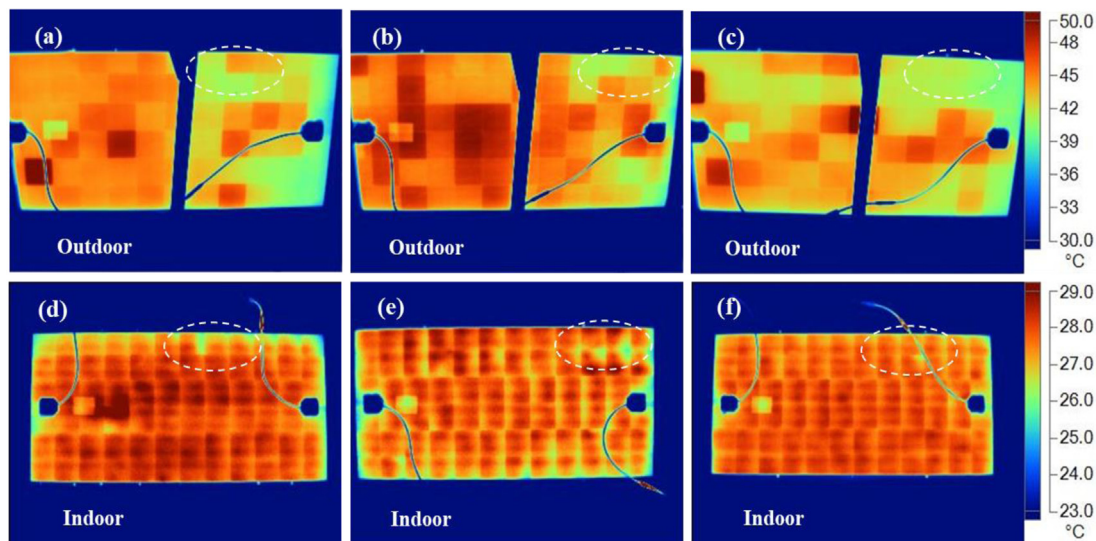
**Fig. 9.** IR thermal images acquired under (a)–(c) clear sky outdoor and (d)–(f) indoor forward bias  $I_{sc}$  conditions. Outdoor images were acquired after the modules were soaked in the sun for at least 15 min and the indoor images were taken 5 min after the forward bias current was initiated. The white marked areas show corresponding defective areas. The emissivity of the front glass (indoor measurements) and the TPT backsheets (outdoor measurements) was set at 0.9 and 0.85, respectively. The supporting frame (behind the PV module) in (a)–(c) and the cables show corresponding blue traces in the IR thermal images. (For interpretation of the references to colour in this figure legend, the reader is referred to the web version of this article.)

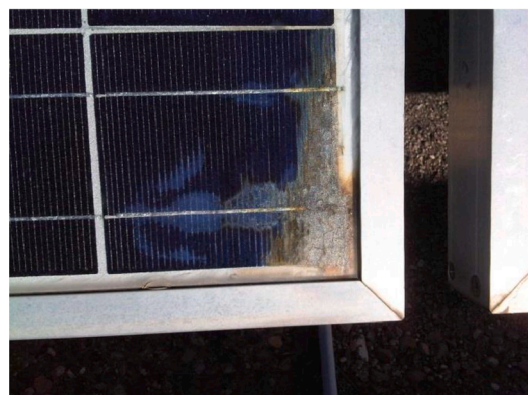
Fig. 2. A typical moisture ingressed PV module showing signs of corroded metal grids, delamination and discolouration of encapsulants. . Adapted from Wohlgemuth et al. (2015)

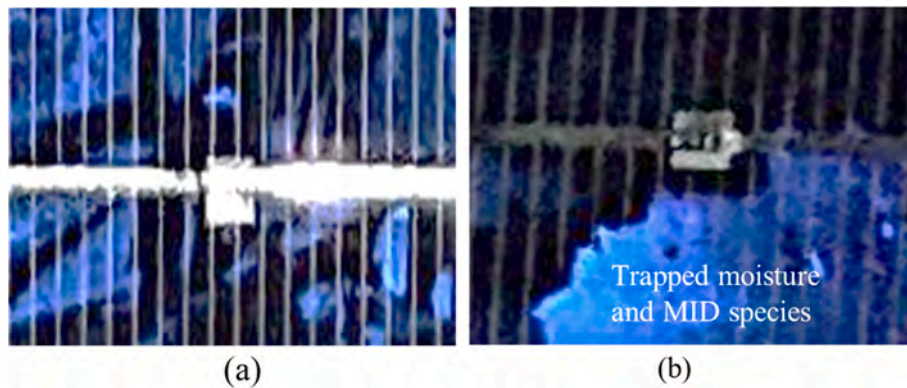
**Fig. 4.** Part of a solar cell and degraded copper ribbon showing signs of moisture ingress. Images were acquired under (a) clear sky outdoor and (b) optimized light exposure dark room conditions from the same area of the solar cell.

been reported for the migration of these ions to sensitive areas such as the emitter of solar cells [46]. Hence, it is likely that PV Module X is suffering from PID as well due to moisture ingress, as will be demonstrated with the EL, IR-T, and SEM-EDS characteristics.

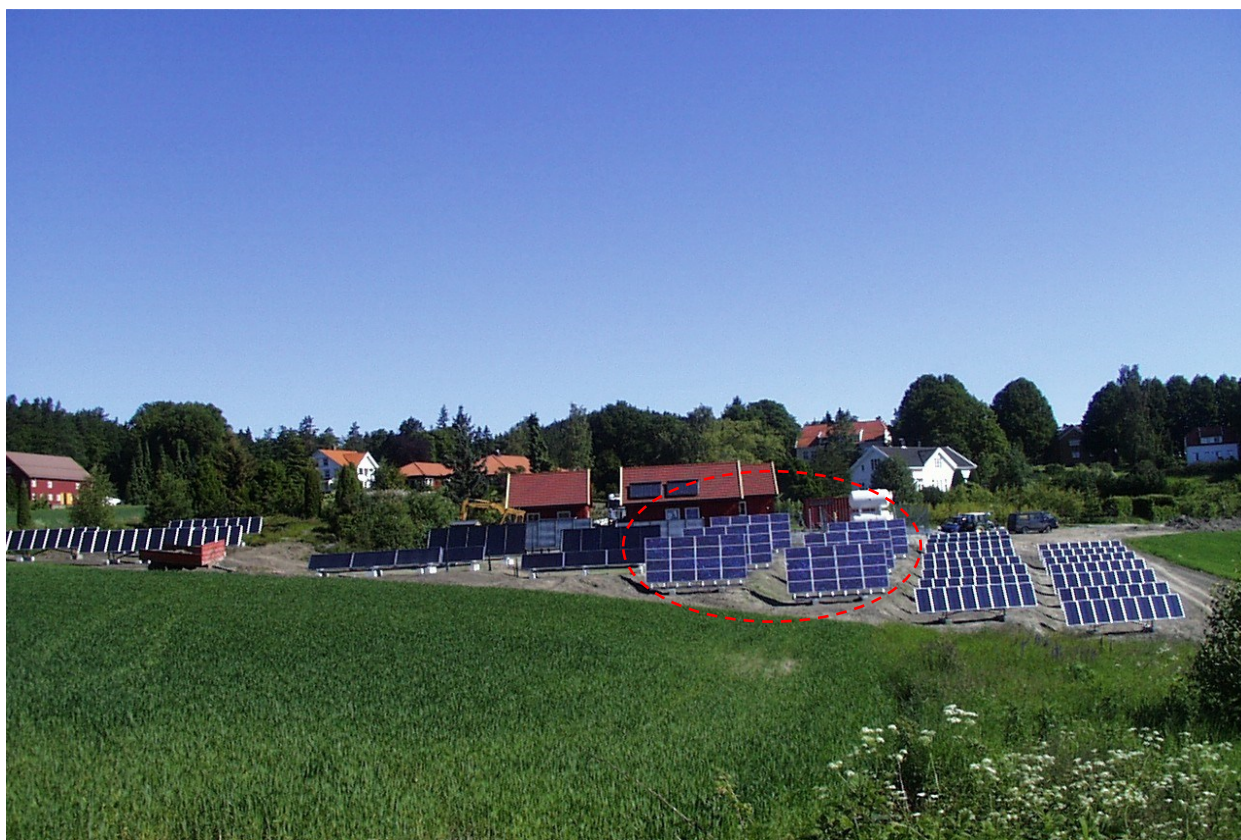
151  
152 **Fig. 3.** The Renewable Energy Park located at Dømmesmoen. The mc-Si PV modules under study  
153 are shown in a red circle.

142 In Summer of the year 2000, the Renewable Energy Park located at Dømmesmoen (58.3447° N,  
143 8.5949° E) in Norway was commissioned as a resource center for research and education in  
144 renewable energy. The Park contained 96 NESTE NP100G12 mc-Si PV panels (in a red circle),  
145 as well as amorphous silicon (a-Si) panels (extreme right and left) and thermal collectors  
146 (immediate left) as shown in Fig. 3. The mc-Si panels were rated 100 watts each [33]. However,  
147 in 2011, the park was decommissioned, and the PV panels were kept securely indoors for research  
148 purposes. At the time of decommissioning, the maximum power of the mc-Si panels had dropped  
149 to ca. 90 % [34]. In an earlier reports on the field-aged modules, about 90 % of the mc-Si panels  
150 have been affected by optical degradation [5].
