**PRESERVING THE PAST,
POWERING THE FUTURE:
ENERGY EFFICIENCY AND RENEWABLES
IN NORWAY'S WOODEN CHURCHES**

A Master's Thesis on Strategies for Improved Energy Efficiency and Renewable Integration in Three Historic Wooden Churches: Preserving Cultural Heritage and Paving the Way for a Greener Future

University of Agder, 2023
Faculty of Engineering and Science
Department of Engineering Sciences

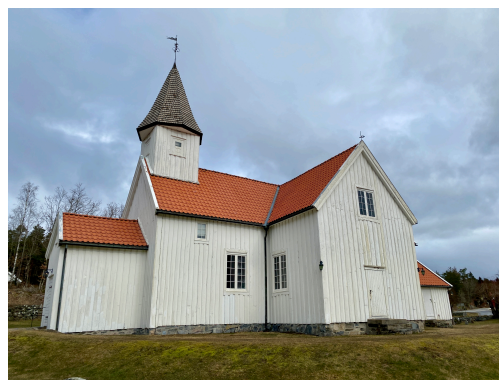
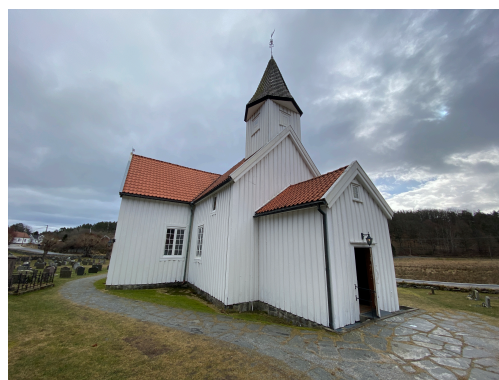
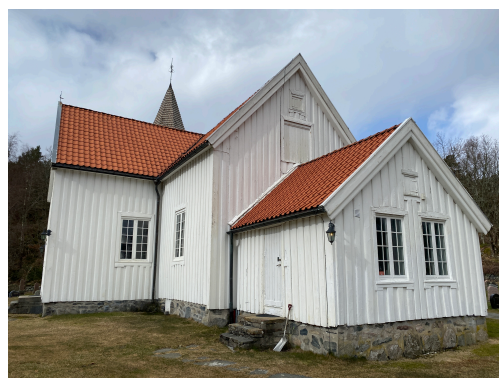
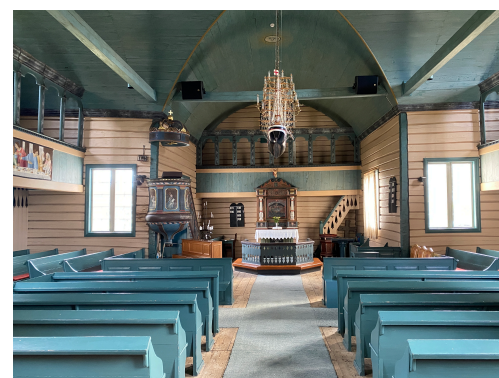
Figure 3.3: Eide Church

(a) Exterior View from South

(b) Exterior View from West

(c) Exterior View from East

(d) Interior View

The ceiling in the main seating area is insulated with 10-15 cm of mineral wool. However, a report from 2016 mentions heat losses due to unevenly laid insulation. The floor is reportedly not insulated and consists of relatively thick floorboards and timber framing above a crawl space. The exterior walls are not insulated but have been later clad with vertical paneling. As for the windows, the original single-pane windows have been complemented with secondary glass mounted on the inside to reduce heat losses. The church underwent restoration in the 1960s and 1970s, with the aim of returning it to its original form and appearance.

Nearly all traditional incandescent light bulbs in Eide have been replaced with energy saving LED bulbs.

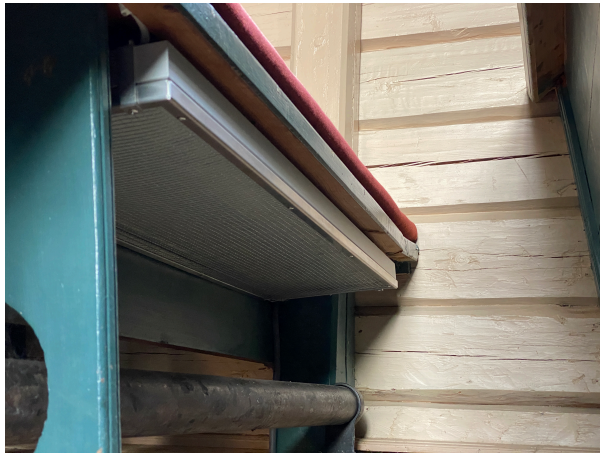
(a) Pew-mounted Heating Panels

In 2014, Eide Church underwent a major upgrade of its heating system. All floor-mounted tube heaters were replaced with pew-mounted infrared heating panels, accompanied by infrared heating panels mounted in the ceilings underneath the galleries shown in Figure 3.4. All the heating panels are shown in red in Figure 3.5. This heating system has a total installed capacity of 28.4 kW. Considering the total area of 221 m² and the total volume of 909 m³, the heating system can deliver 31 W/m³, supposedly enough to intermittently heat the church, as per KA's recommendation [45].

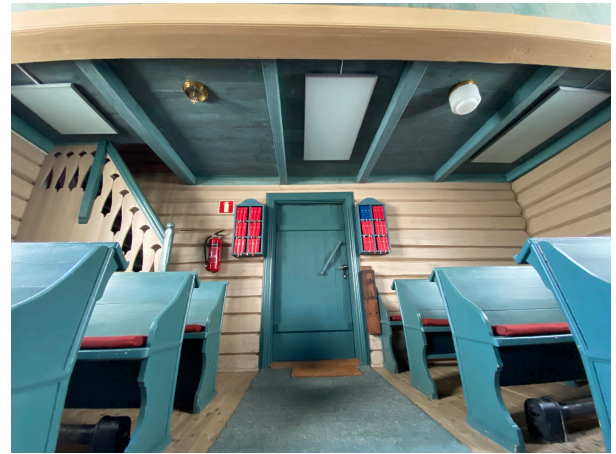
(b) Ceiling-mounted Heating Panels

Figure 3.4: IR Heating Panels in Eide church

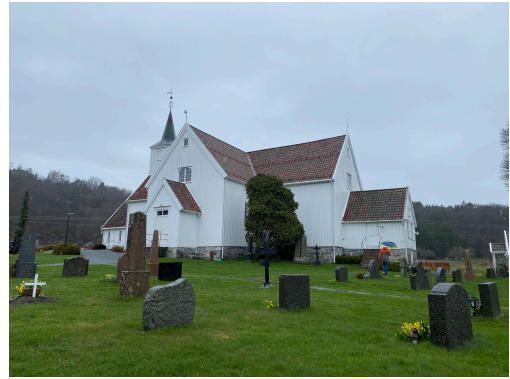
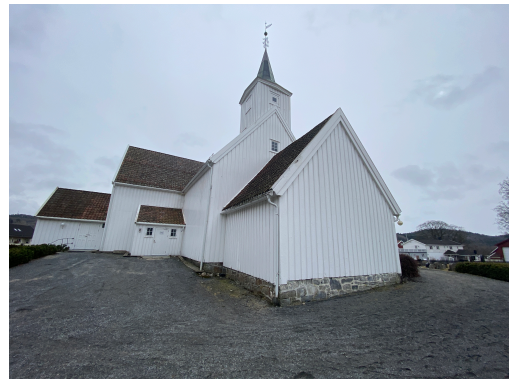
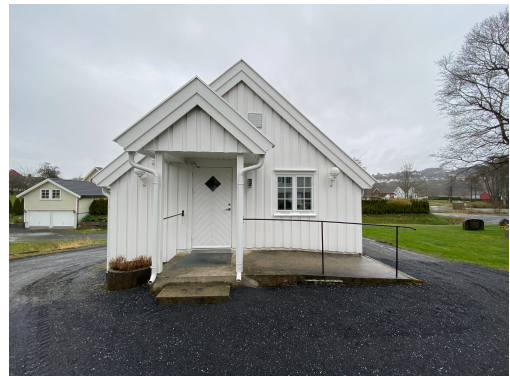
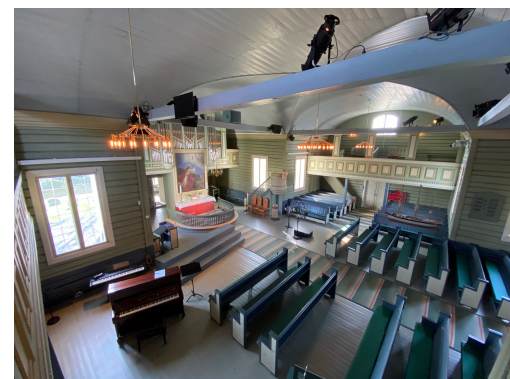
Figure 3.6: Landvik Church

(a) Exterior View from Southeast

(b) Exterior View from West

(c) Annex (Kirkestue)

(d) Interior View

As for the rest of the church, the insulation level is relatively low. Similar to Eide church, Landvik's walls are not insulated, with only a layer of vertical paneling mounted on the exterior walls. The ceiling in the main seating area is insulated with 10-15 cm of mineral wool. Though not insulated, there are several layers of flooring. In the 1940s and 50s, the church underwent restoration: the windows received an additional layer of glass, and an electrical heating system was installed. The church has three galleries, with the organ situated on its own gallery behind the altar.

The lighting in Landvik Church primarily consists of incandescent bulbs.

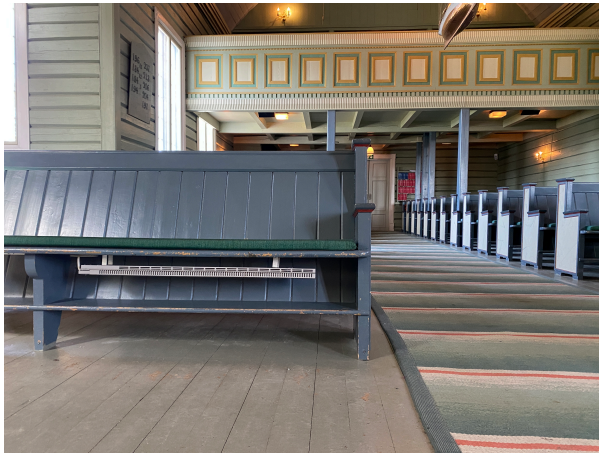
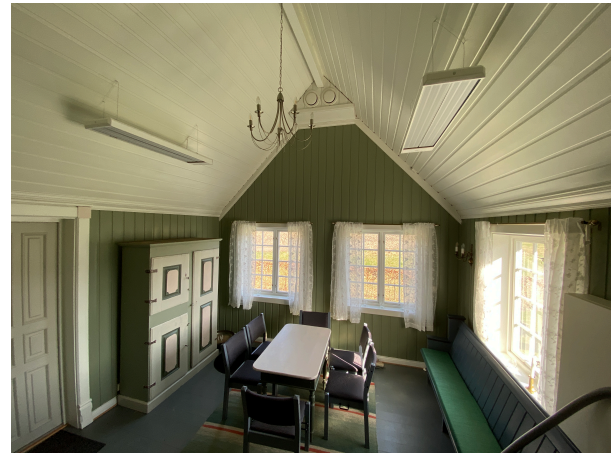
(a) Pew-mounted Bench Heater, 250W

(b) Heating Panels Hanging from Ceiling, 1700W

The current heating system predominantly features bench heaters discretely mounted underneath the benches shown in Figure 3.7a. Additionally, there are a few infrared ceiling-mounted heating panels similar to those found in Eide church, as well as some tube heaters mounted low on the wall by the choir and around the altar. In the narthex and northern sacristy, ceiling-hung heating panels as shown in Figure 3.18b are used. All heat sources in the church are marked with red in Figure 3.8. The church has a total installed heating capacity of nearly 43 kW. With an area of 377 m² and a volume of 2012 m³, the church's heating capacity is 21.3 W/m³, insufficient for adequately heating the church intermittently according to KA's guidelines [45].

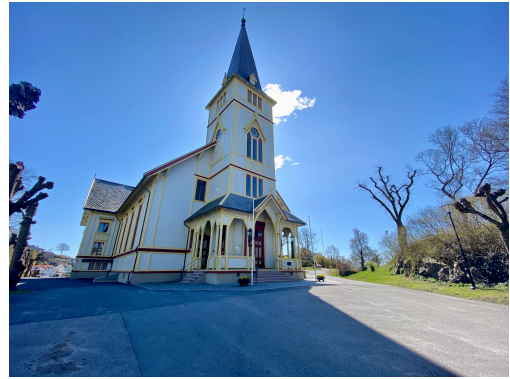
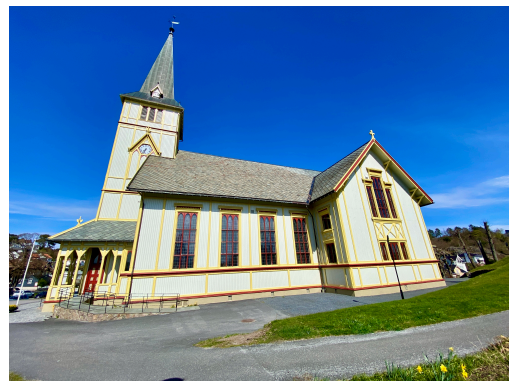
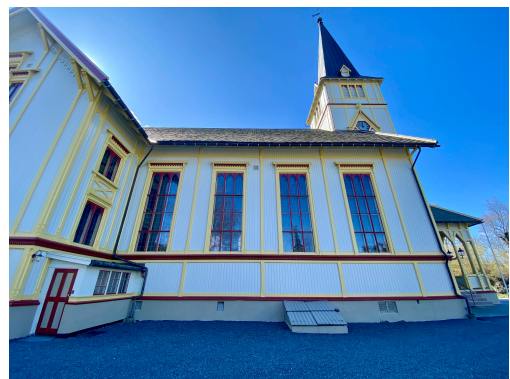
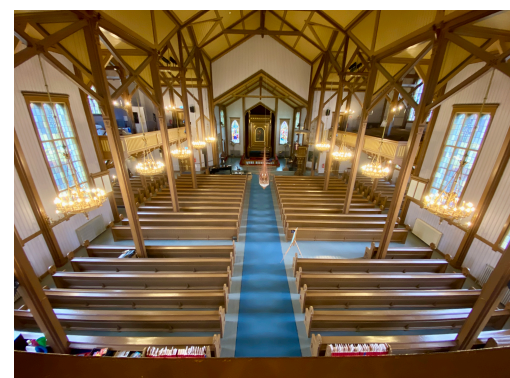
Figure 3.9: Grimstad Church

(a) Exterior View from West

(b) Exterior View from South

(c) Exterior View from North

(d) Interior View

Another notable difference between Grimstad church and the other two churches is the heating system. Grimstad church utilizes a hydronic heating system, featuring wall-mounted radiators. The system derives its heat from a boiler burning bio-fuel oil. The burner itself is rated at 178 kW, while the boiler is rated for 160 kW.

The church has primarily opted for LED lighting, providing energy-efficient illumination throughout the building.

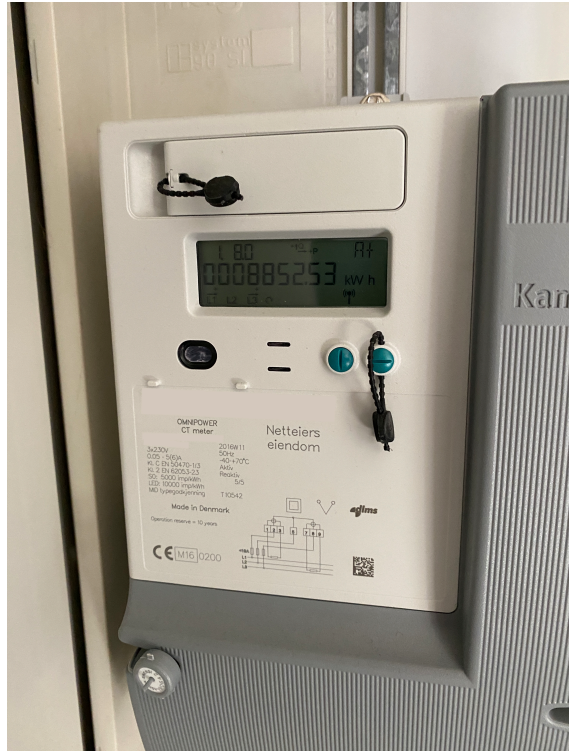
Figure 3.10: Smart Energy Meter (AMS)

In order to assess the energy efficiency of the churches, it is essential to examine their historical energy consumption. Analyzing energy consumption can provide valuable insights into the usage patterns, identify inefficiencies, and serve as a basis for comparing the effectiveness of potential energy efficiency measures. Since January 1st, 2019, all Norwegian electricity customers have been required to have a smart electricity meter installed, known as AMS meters as shown in Figure 3.10 [73]. All the churches examined in this thesis have these smart energy meters installed. These meters continuously and automatically report hourly energy consumption values to the transmission system operator. For all the churches in this thesis, this transmission system operator is Glitre Nett (formerly Agder Energi Nett).

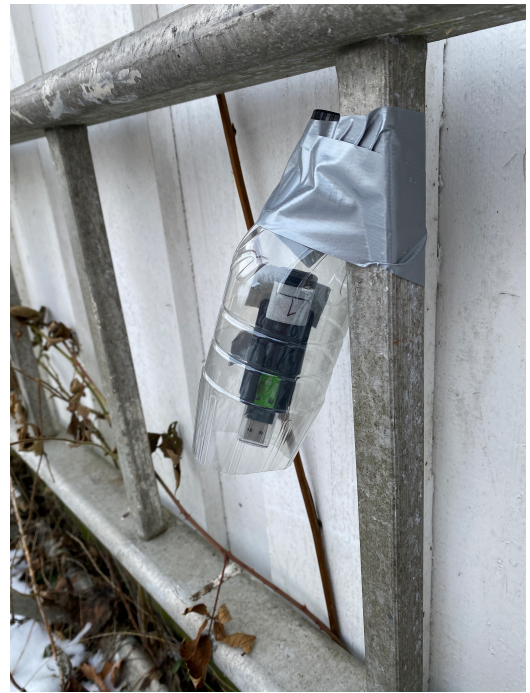
Figure 3.15: Rain Protected Outdoor Logger

Due to the temperature and humidity loggers not being waterproof, the outdoor logger (always Logger 1) has been protected by a rain jacket made from a cut-off plastic bottle shown in Figure 3.15. Figure 3.16 further demonstrates how the outdoor logger, in this demonstration placed on the north-facing wall of Landvik church, correlates with the temperature measured at the weather station only around a hundred meters away. These values are also considered adequate for the context in which the data is used.

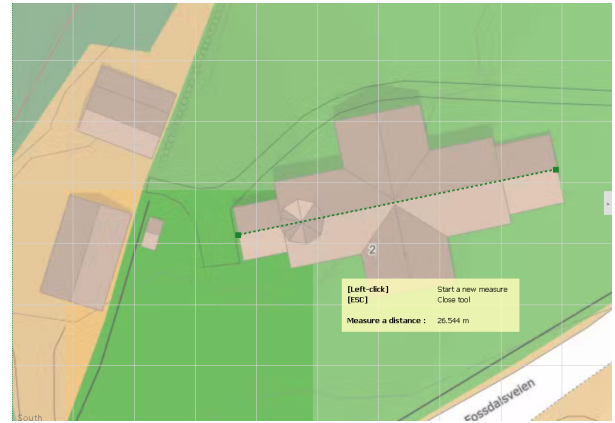
Figure 3.18: Size Matching PVsyst 3D Model to Realistic Size

(b) Length Measurement in PVsyst

To better visualize the different alternatives and to more easily determine the available roof area, a 3D model of the church and the two nearby buildings was created under the "Construction / Perspective" menu of the "Near Shadings" parameter. To ensure that the size of the 3D model corresponds to the actual size of the church, a screenshot of a map of the church area was used as a reference. This screenshot was obtained from the map service of finn.no, which was chosen due to the ease of measuring distances with the tool in the service. The lengths and widths of the church were first measured on the map, and the screenshot in PVsyst was measured using PVsyst's measuring function to ensure the same size. Figure 3.18 on the following page shows the measurement of the length of the church in both the map and in PVsyst.

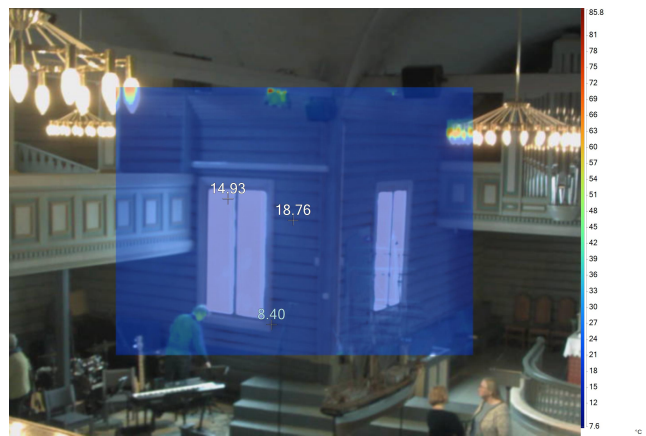
(a) Heat Loss around Window Frame

(b) Heat Loss in Log Intersections

(c) Hot Incandescent Bulbs
