## **COMPARISON OF FAULT-DETECTION METHODS IN PHOTOVOLTAIC MODULES**

An analysis of techniques utilising IV-tracing, UVF-imaging, EL-imaging,  
and IRT-imaging via visual analysis for fault-detection in PV-modules

**University of Agder, 2022**

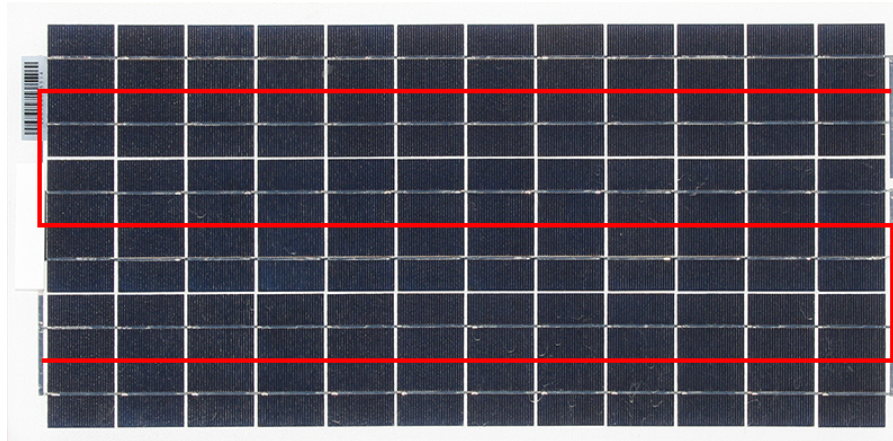
Figure 5.1.1: Photography of module with designation  $\alpha$ -I, with circuit diagram overlay.

This chapter addresses the results from the testing of the mini-module with designation  $\alpha$ -I, from RS Pro (ref: Table 4.3.1). Figure 5.1.1 shows the RGB photography of the module, with a circuit diagram overlay, inferred from the visible circuits on the module (and the junction box). No bypass-diodes are present in this module.

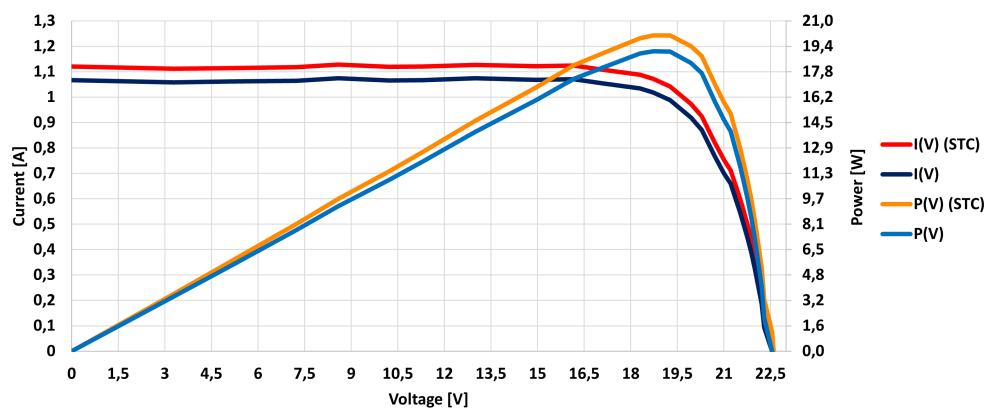
Figure 5.1.2: Measured and STC-corrected current- and power- curves as a function of voltage, module  $\alpha$ -I.

The manually traced IV- and PV-curves of module  $\alpha$ -I is presented in Figure 5.1.2. The figure shows both the measured values, and the values corrected to STC, according to the method discussed in Chapter 4.5.2. Wherein, STC-correction of the measured curves of  $I(V)$  and  $P(V)$  are marked by the red and orange plots, respectively, while the purple and blue show the measured curves of  $I(V)$  and  $P(V)$ , respectively. The measured PV temperature ( $T_0$ ), and measured irradiance ( $G_0$ ) used for for the STC-correction and a proposed nominal curve are shown in Table 5.1.1, the STC-irradiance ( $G_1$ ), -temperature ( $T_1$ ), and current temperature coefficient ( $\alpha$ ) are  $1000 \frac{W}{m^2}$ ,  $25^\circ C$ , and  $0,003 \frac{A}{K}$ , respectively.

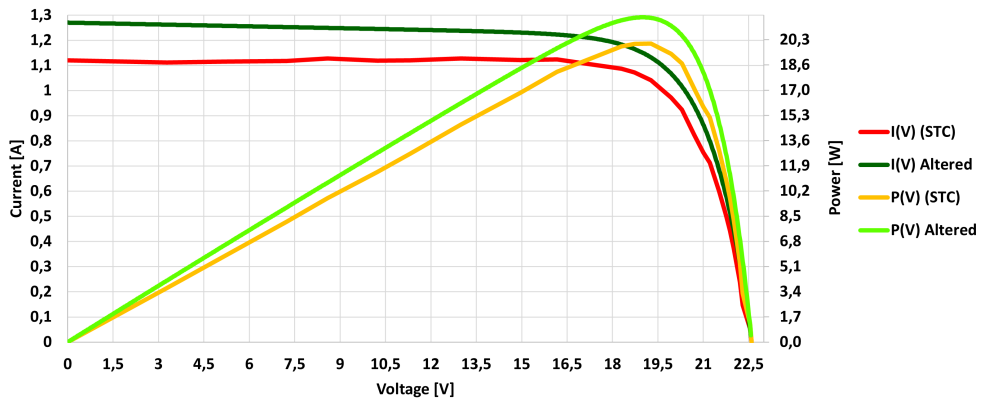
Figure 5.1.4: STC-corrected and nominal current- and power- curves as a function of voltage, module  $\alpha$ -I, according to measured maximum power point-, and open-circuit voltage.

Figure 5.1.4 shows the STC-corrected IV- and PV-curves, as well as the altered curves based on the values from the measured IV-curves. This was done with the assumption of the data-sheet values being imprecise, as an increase in  $V_{OC}$  is not expected at STC, under any known circumstances based on the literature review. The altered curve was created by adjusting the open-circuit voltage ( $V_{OC}$ ) from 22 V to 22,6 V, and the maximum power point (MPP) voltage ( $V_{MPP}$ ) from 17,5 V to 19 V, both based on the manually measured data, and otherwise keeping all current values the same.

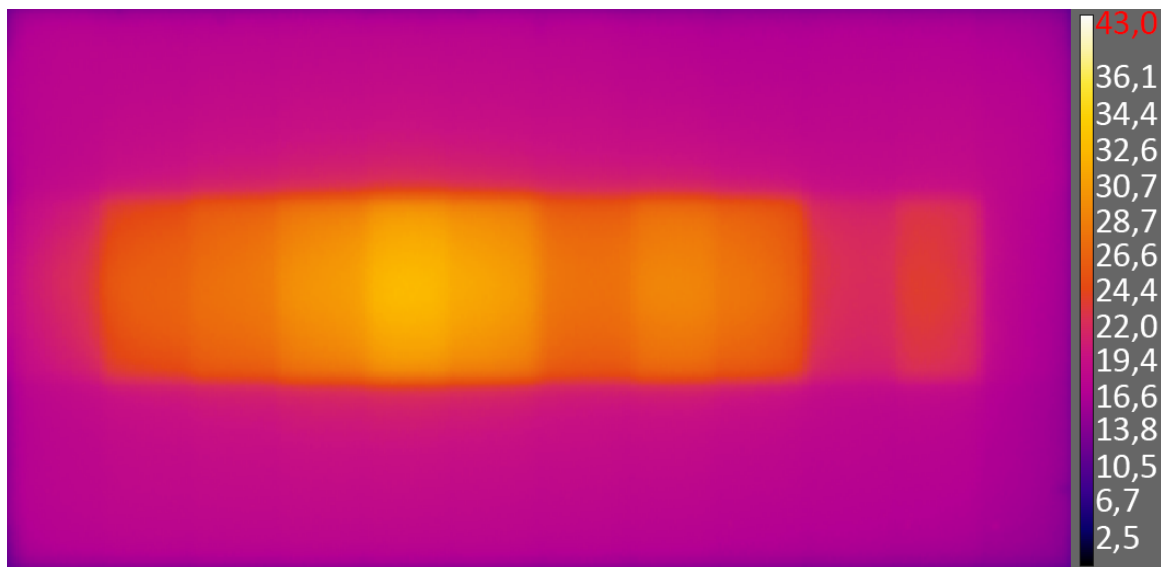
Figure 5.1.6:  $\alpha$ -I operational, outdoor infrared thermography image.

Figure 5.1.6 shows the infrared thermography (IRT) image results, acquired with the FLIR camera. Table 5.1.2 shows the main points of interest from the IRT results, using digital colour-matching of the module to the colour/temperature-bar.

Maximum Temperature	Minimum Temperature	Temperature Difference
32,6°C	16,0°C	16,6°C

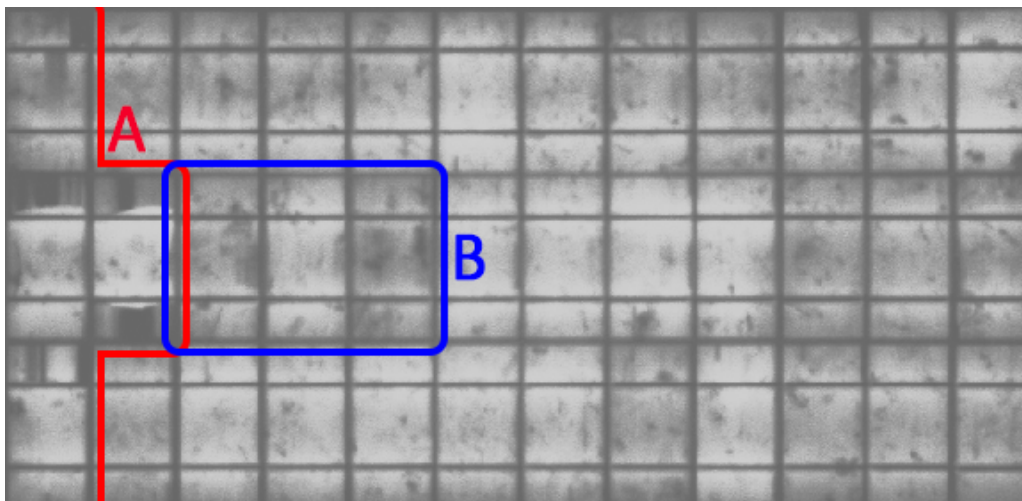
Figure 5.1.7:  $\alpha$ -I indoor electroluminescence image.

Figure 5.1.7 shows the result of the electroluminescence (EL) image of module  $\alpha$ -I, after histogram equalisation and greyscale-conversion.

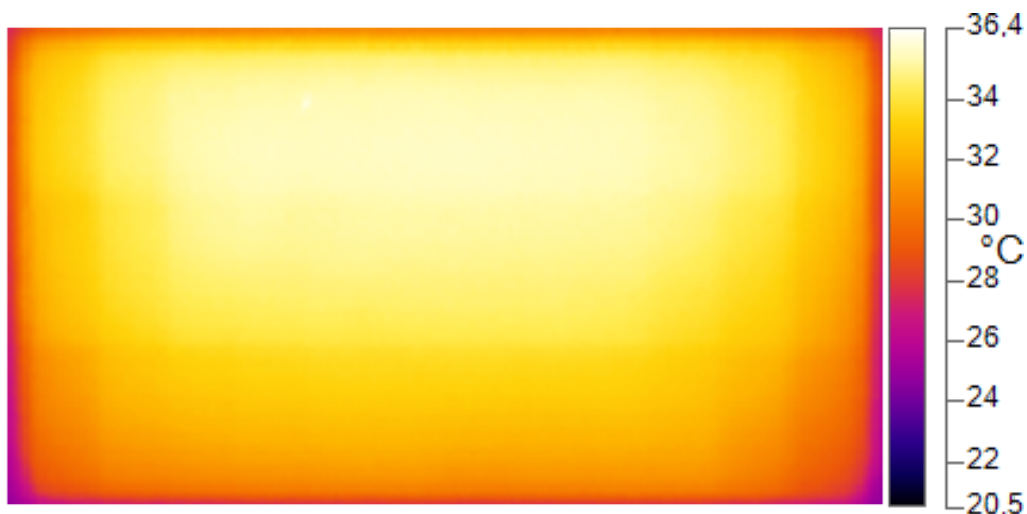
Figure 5.1.8:  $\alpha$ -I forward-current infrared image.

Figure 5.1.8 shows the IRT-image of the front of module  $\alpha$ -I done indoors, with forward current equal to the short-circuit current applied to the module. The results show the module having a maximum-, and minimum temperature of 36,1°C, and 27,5°C, respectively.

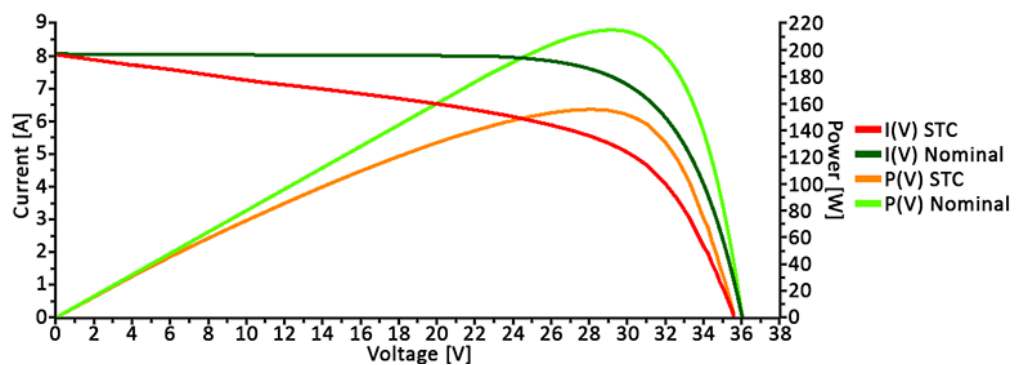
Figure 5.2.2: Current- and power- curves as a function of voltage, module  $\alpha$ -II.

Figure 5.2.2, and Table 5.2.1 shows the results of the IV-curve tracing of module  $\alpha$ -II. In the figure, the red and green coloured plots represent the IV-curves at STC-, and nominal conditions, respectively. Meanwhile, the orange and lime coloured plots represent the PV-curves at STC-, and nominal conditions, respectively.

STC	Nominal	Unit	Abbreviation
<b>Open-Circuit Voltage</b>	35,59	36,04	V	$V_{OC}$
<b>Short-Circuit Current</b>	7,79	8,06	A	$I_{SC}$
<b>MPP Voltage</b>	28,14	29,16	V	$V_{MPP}$
<b>MPP Current</b>	5,53	7,73	A	$I_{MPP}$
<b>MPP Power</b>	155,62	215,00	P	$P_{MPP}$
<b>Fill-Factor</b>	0,54	0,74	-	$FF$
<b>Measured PV Temperature (<math>T_0</math>)</b>		<b>Measured Irradiance (<math>G_0</math>)</b>		
15,1°C		962 $\frac{W}{m^2}$

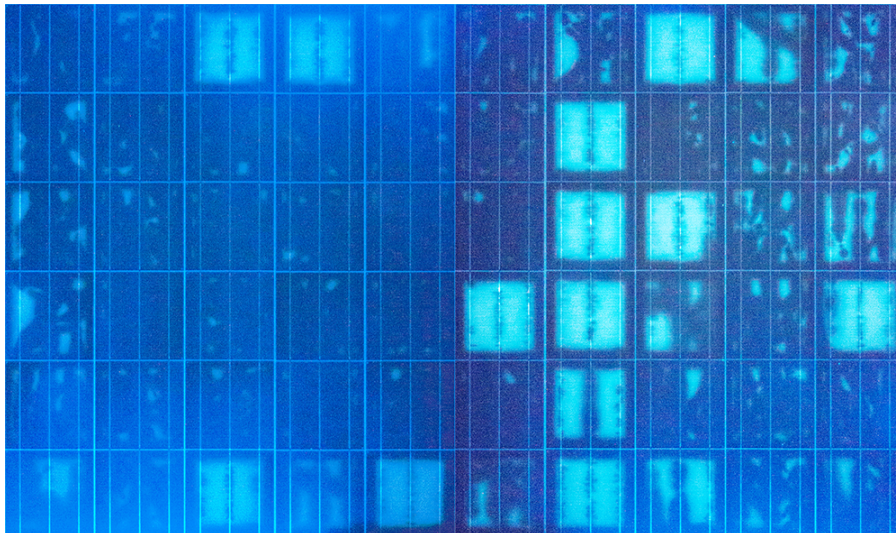
Figure 5.2.3:  $\alpha$ -II indoor ultraviolet fluorescence image.

Figure 5.2.3 shows the UVF-image results of module  $\alpha$ -II. This image is a compound of two images, as the torch used in this experiment was unable to illuminate the whole module.

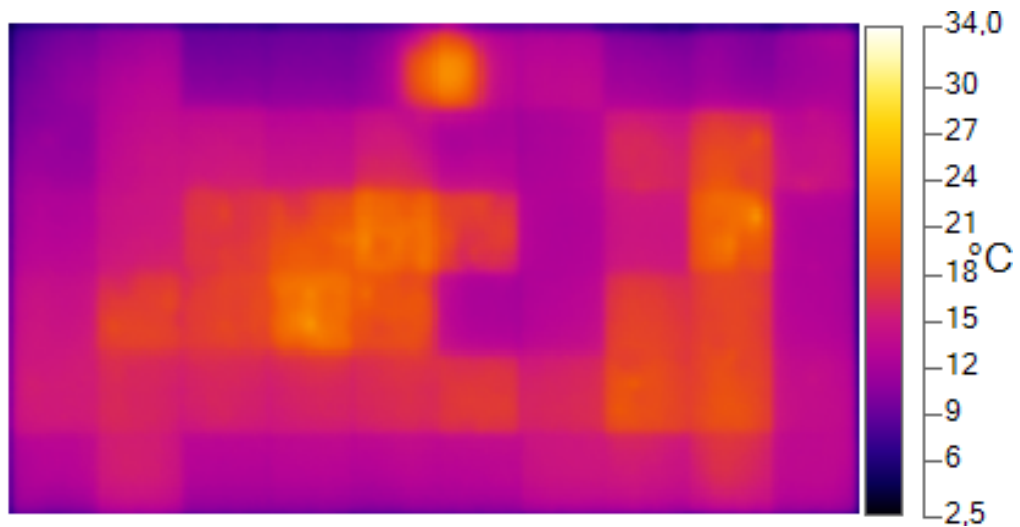
Figure 5.2.4:  $\alpha$ -II operational, outdoor infrared thermography image.

Figure 5.2.4 shows the outdoor, operational IRT-image results of module  $\alpha$ -II, the relevant temperature measurements are shown in Table 5.2.2.

Maximum Temperature	Minimum Temperature	Temperature Difference	Average Temperature
23,7°C	7,7°C	16,0°C	15,6°C

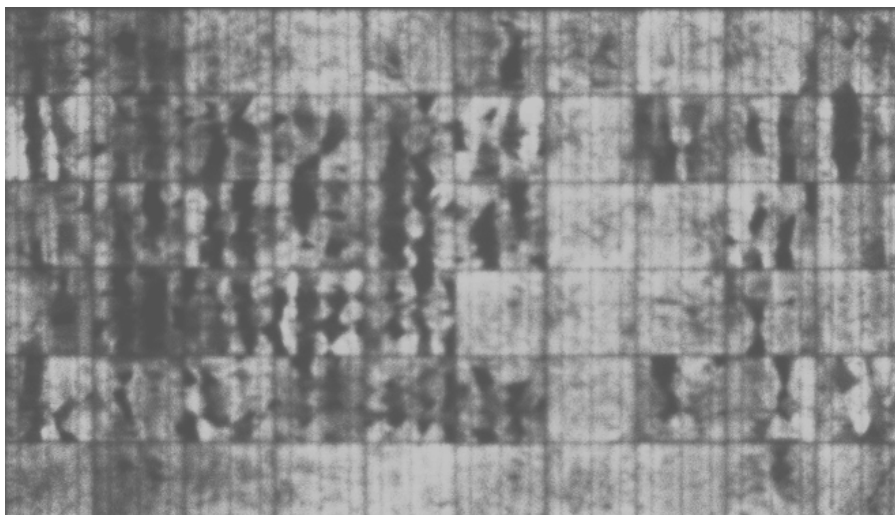
Figure 5.2.5:  $\alpha$ -II indoor electroluminescence image.

Figure 5.2.5 shows the result of the EL-image of module  $\alpha$ -II, with histogram equalisation and greyscale-conversion.

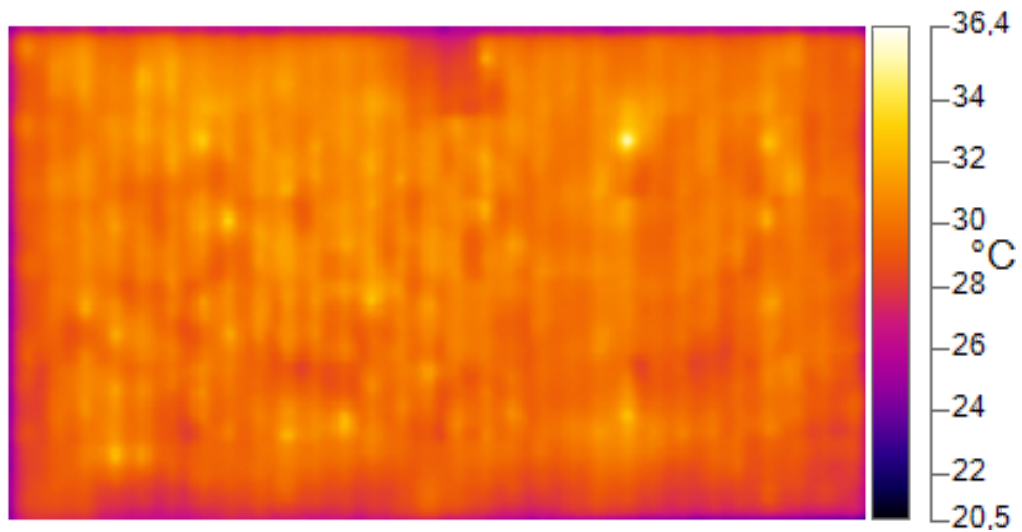
Figure 5.2.6:  $\alpha$ -II forward-current infrared image.

Figure 5.2.6 shows the IRT-image of the front of module  $\alpha$ -II done indoors, with forward current equal to the short-circuit current applied to the module. Table 5.2.3 shows the measured data from the IRT-image.

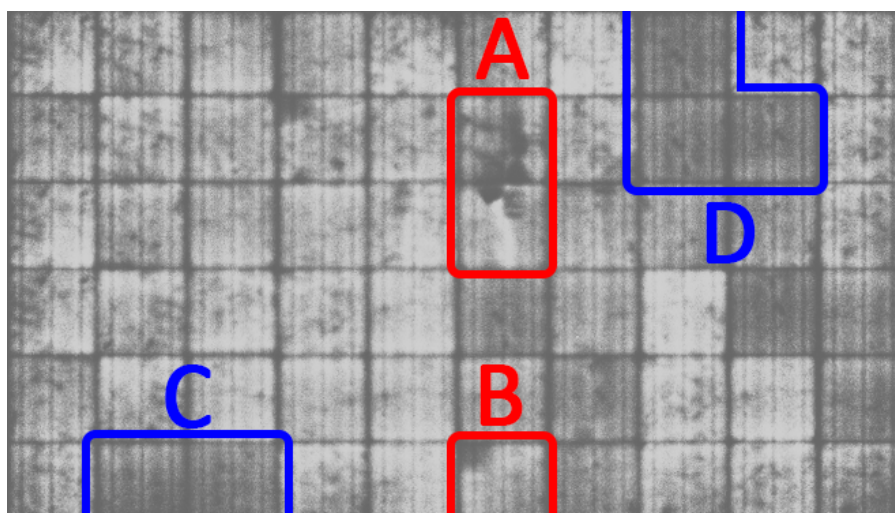
Figure 5.3.5:  $\alpha$ -III indoor electroluminescence image.

Figure 5.3.5 shows the result of the EL-imaging of module  $\alpha$ -III, with histogram equalisation and greyscale-conversion.

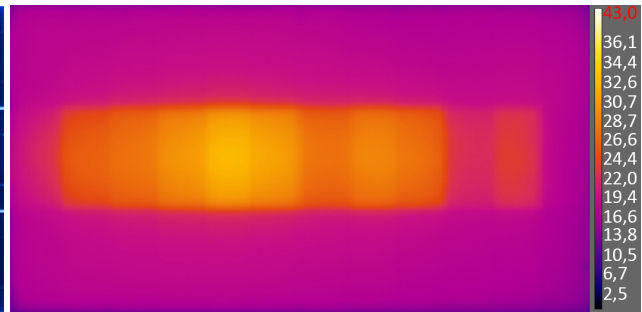
(c)  $\alpha$ -I outdoor IRT-image.

The areas of increased temperature in the IRT-image of the module might suggest that there is an increased resistance in some of the cells, causing them to generate more heat than the neighbouring cells. From the results of the EL-experiment, one can see that there are several cells in the module with areas of reduced and absent EL-response. Highlighted in box "A" seem to be two types of finger contact issues where the cells in the middle row in seem to show the presence of finger-contact issues caused by cell-cracks, while the other two cells seem to have finger-contact issues caused by improper soldering. The cells highlighted by box "B" seem to have reduced EL-response in addition to some smaller areas of no electroluminescence, suggesting that these cells also have some issues that may reduce their efficiency. As discussed in Chapter 3.3, all of the areas with lower/no EL-response may correspond to a lower power output of the cells in question, causing an overall lower module efficiency.

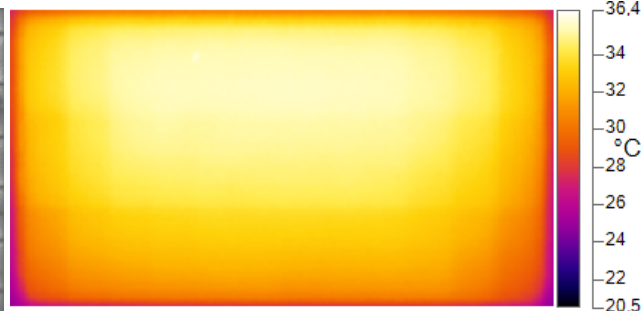
(e)  $\alpha$ -I indoor IRT-image.

The temperature gradient across the module, in the indoor IRT-image, with heat seemingly concentrating at the top of the module, may suggest the difference in temperature being caused by the heat rising. The low amount of useful diagnostic information available in these results, may point to this method being unproductive in the diagnosis of PV-module faults.

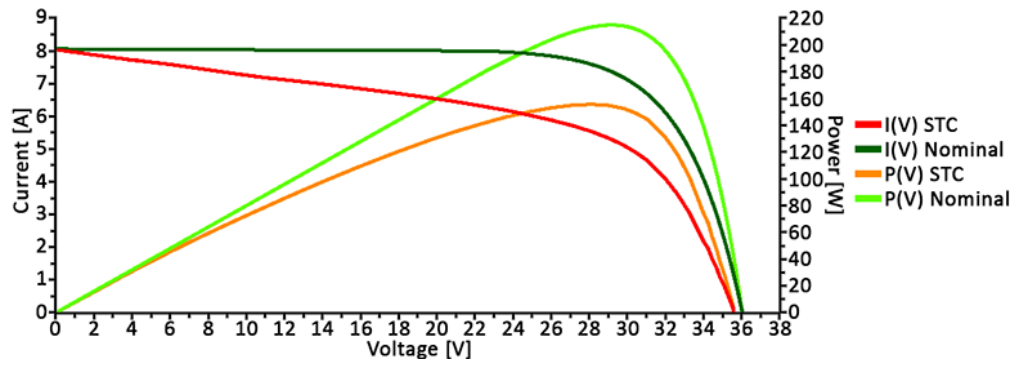
(a)  $\alpha$ -II IV-trace.

Figure 6.2.1 shows all of the results from each experiment performed with module  $\alpha$ -II. It is clear from the IV-trace results that this module suffers from some kind of fault causing the shunt resistance of the module to decrease from its nominal conditions, as according to the findings by Huang et al., discussed in Chapter 3.1. The power output at MPP in STC is at 72,38% of the rated power, which is a significant reduction of power output. The fault type causing this drop in efficiency, however, is not apparent from the IV-tracing alone. The results of the UVF-experiment show a clear reduction in fluorescence in large areas of the module, caused by ingress of water and/or oxygen, with some areas completely devoid of fluorophores. Meanwhile, there is a range of cells seemingly not affected, with high UVF-response, and cells with patterns suggesting cracked cells, as discussed in Chapter 3.4.

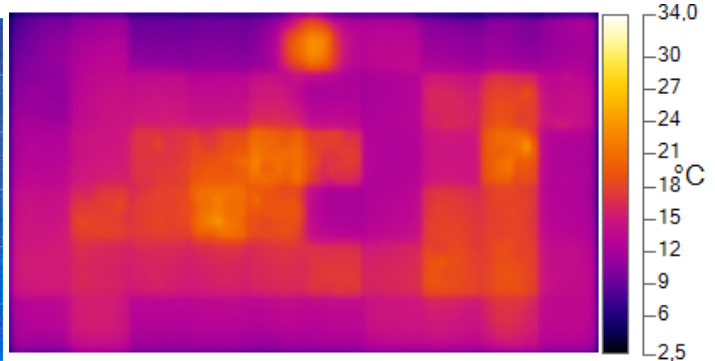
(c)  $\alpha$ -II outdoor IRT-image.

The temperature difference of 16°C measured in the IRT-results of this module, along with the irregular heating pattern, may also be an indication of this module being faulty. The hot spot in the top, centre of the module corresponds to the heat generated in the module's junction box. From the EL-imaging results, it is clear that this module suffers from many areas of inactivity caused by cell-cracks. The indoor IRT-test gave a more detailed result, compared with module  $\alpha$ -I, with more aggressive gradients in the areas standing out in the EL-results, as well as clear vertical stripes of heat in the bus-bars.

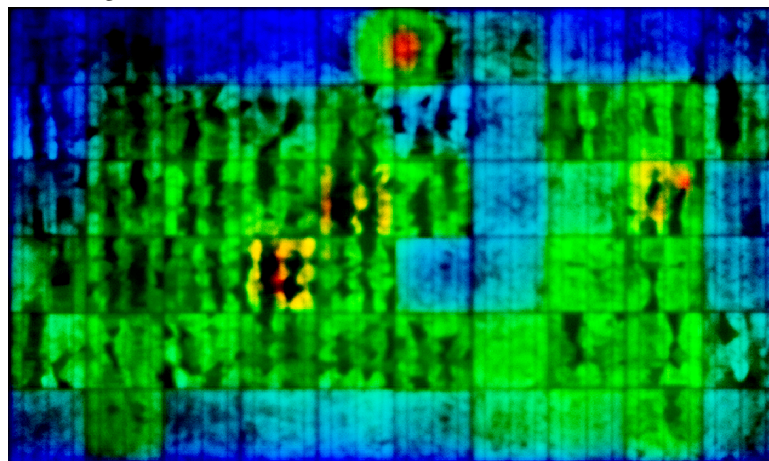
(f)  $\alpha$ -II IRT-image overlaid EL-image.

Figure 6.2.1f shows an image where the outdoor, operational IRT-image is overlaid the EL-image. From this image, there is correlation between the most cracked areas of the module and the heat generated within it.

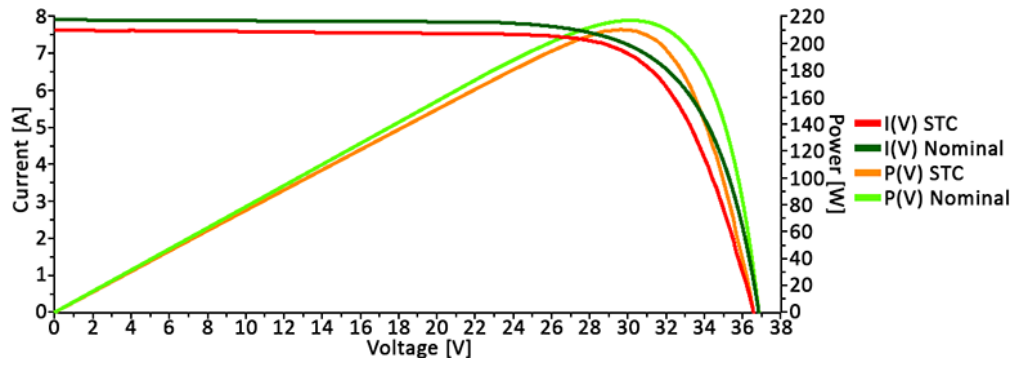
(a)  $\alpha$ -III IV-trace.

Figure 6.3.1 shows all of the results from each experiment performed with module  $\alpha$ -III. From the IV-tracing results it seems that this module is operating close to nominal, at STC conditions, with a 0,30 A decrease in  $I_{SC}$ , and a 0,30 V decrease in  $V_{OC}$ . While the drop in current can be explained by a drop in excitation/recombination in the cells, such a low decrease in voltage, of less than the electric potential generated by a single cell, and may be within the uncertainty of the measurement equipment. One plausible cause of the voltage drop, is the temperature probe of the HT IV-500W being placed behind a cell with a temperature causing the calculated STC-curve to not compensate correctly according to the temperature, relative to the actual performance of the module. Another explanation for the reduction in voltage might be a reduction in shunt resistance, as discussed in the findings by Huang et al. [6] in Chapter 3.1. The power output at MPP in STC is at 96,77% of the rated power, which is a low decrease in power output.

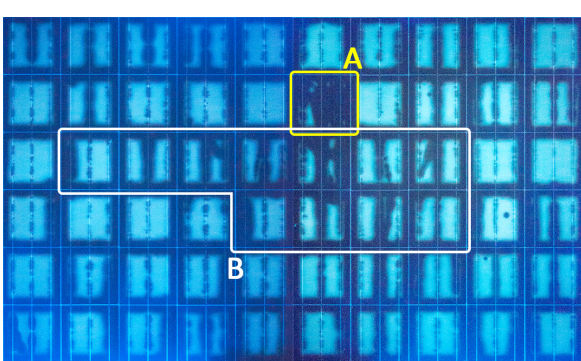
(b)  $\alpha$ -III UVF-image.

The oxygen/water ingress in this module, shown in Figure 6.3.1b, points to some cracking of the cells in the module, based on the pattern of reduced UVF-response in some of the cells. The cell in the yellow box "A" shows a clear example of where the ingress has caused nearly all of the EVA-laminate to lose its fluorescence, while the cells in the white box "B" show less reduction in fluorescence, making it possible to see the implied cell-cracks based on the fluorescence patterns, as discussed in Chapter 3.4. The wide difference, of 27°C between maximum- and minimum temperature, and the sharp gradient of temperature between some of the cells in the IRT-image, may indicate several issues present in the module. Increased resistance caused by and/or causing the hot cells, may lead to a decrease in overall module performance.

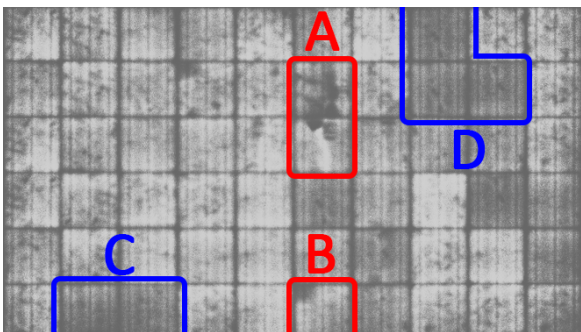
(d)  $\alpha$ -III EL-image.

In the EL-results, there are some interesting areas. The red boxes marked "A" and "B" are some of the cells showing areas within the cell with no EL-response. The blue boxes of "C" and "D" show some of the cells with reduced overall response across the whole cell. Both of these could cause a decrease in efficiency, and the cells to have increased temperature during operating conditions as discussed in Chapter 3.6. The results of the indoor IRT-experiment show some increased temperature around the bus-bars, and a spot on one of the middle columns of cells which may indicate a fault in the module.

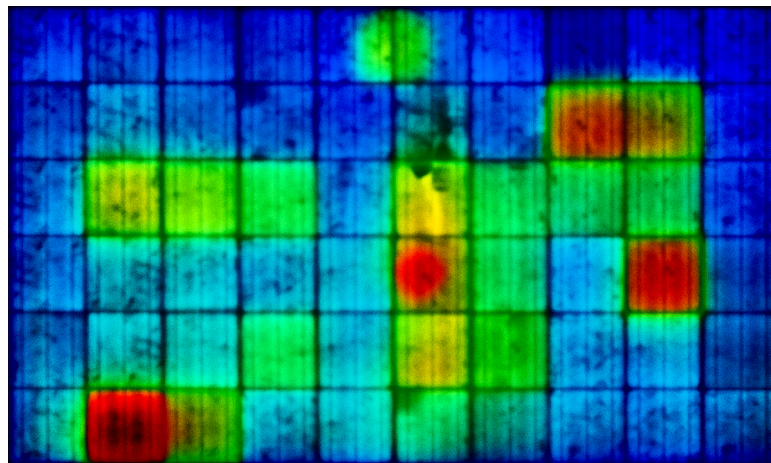
(f)  $\alpha$ -III IRT-image overlaid EL-image.

Figure 6.3.1f shows the IRT-image overlaid the EL-image, where the colour range goes from blue, in cold areas to red, in warmer areas. From this, one could suggest that there may be correlations between the cracked cells and the cells with reduced EL-response and the increase in cell temperature. The IV-trace shows signs of some reduction in efficiency, through a reduction in  $I_{SC}$ . The results of the UVF-, outdoor IRT-, and EL-experiments show some correlations between each other. The blue boxes, and box "A" in the EL-image show correlation with the same areas in the IRT-image. Most of box "B" in the UVF-image shows a correlation with the IRT-image, but is not as apparent in the EL-image. The indoor IRT-image does not give a sign of any apparent faults, other than a slight temperature increase in the area of the isolated parts of the cells in box "A" in the EL-image.

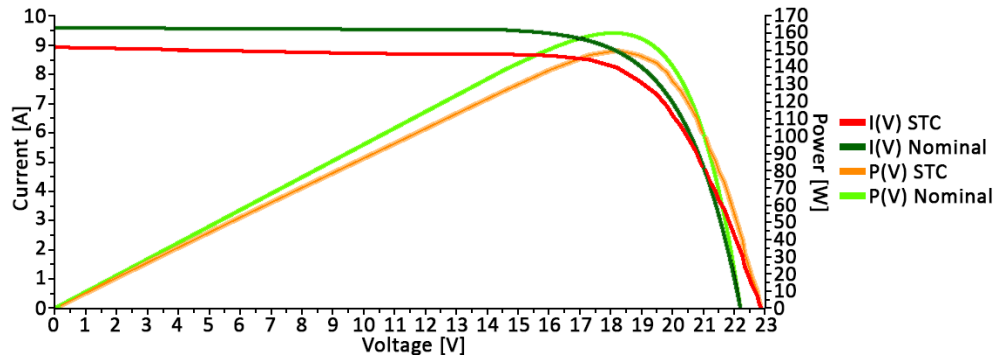
(a)  $\alpha$ -IV IV-trace.

Figure 6.4.1 shows all of the results from each experiment performed with module  $\alpha$ -IV. The decrease in power output, shown in the IV-tracing results, may indicate a decrease in module efficiency. The MPP power output at STC is 93,65% of rated MPP power, which is a noticeable decrease in efficiency. Highlighted in the UVF-results, box "B" shows the area where the junction box is mounted on the back of the module, suggesting that there has been an ingress of oxygen or water through the junction box. This may be caused by sealant failure around the junction-box. The red circle "A" marks a circle of reduced fluorescence, suggesting there is a small point-crack in this spot. Both cases are possible reasons for reduced module efficiency, in the case of the junction box seal being compromised. As shown in the outdoor IRT results, there are several cells with increased temperature in this module, with a difference in temperature of up to 15,1°C. This may suggest there are issues with some of the cells, causing the increase in temperature within them as discussed in Chapter 3.2.

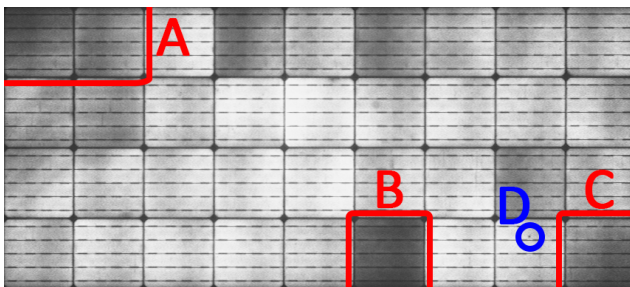
(d)  $\alpha$ -IV EL-image.

Highlighted in the EL-results, the red boxes of "A", "B", and "C" show examples of cells with reduced EL-response, suggesting there might be some issues with these cells. The blue circle "D" highlights a spot on the EL-image, suggesting a small point-crack with a small spot of no EL-response, which may develop over time to a more serious fault of extensive cracking. As with module  $\alpha$ -I, the indoor IRT-imaging method does show a very uniform temperature gradient with signs of the heat rising to the top of the module. Therefore this image does not seem to give sufficient information to diagnose faults in the module.

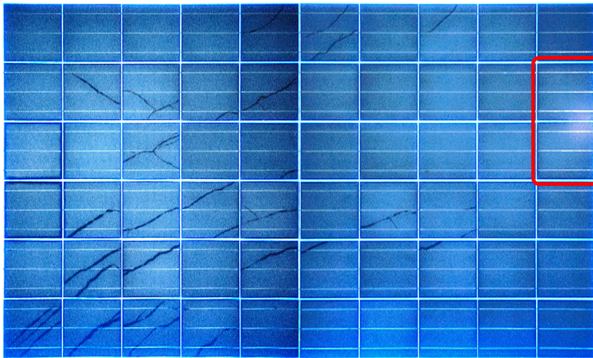
(b)  $\beta$ -I UVF-image.

While the UVF-image may not correlate fully with the IRT-image where the crack pattern is visible in the UVF-image, it does seem to correlate by means of the hot-spot highlighted with a red box in the UVF-image as these cells are the hottest measured in the IRT-image. This hot-spot does also seem to correlate with the low response cell highlighted in box "C" in the image from the EL-experiment. There also seems to be a correlation between the luminosity of the cells in the EL-image and the cracked pattern in the UVF-image.

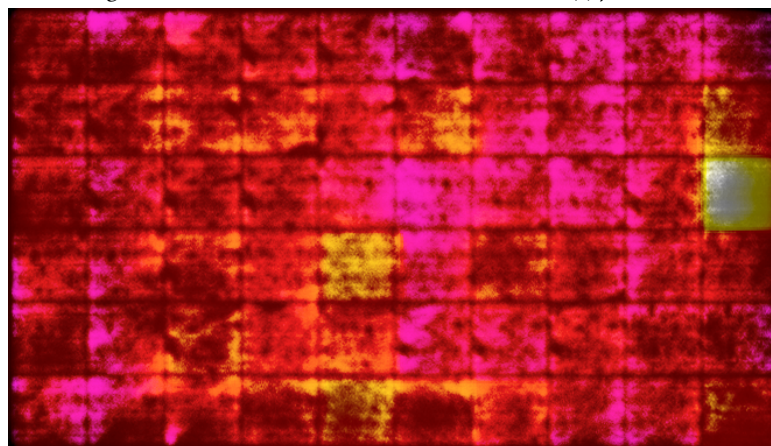
(f)  $\beta$ -I IRT-image overlaid EL-image.

Figure 6.5.1f shows the result from the IRT-imaging, overlaid the result from the EL-imaging of module  $\beta$ -I. The most obvious from this image is the cell on the right side of the module, where there is a significant temperature difference from the rest of the module, suggesting there may be a serious issue with this cell.
