Moisture induced degradation in field-aged multicrystalline silicon photovoltaic modules

Oscar Kwame Segbefia^{*}, Naureen Akhtar, Tor Oskar Sætre

Department of Engineering Sciences, University of Agder, 4879, Grimstad, Norway

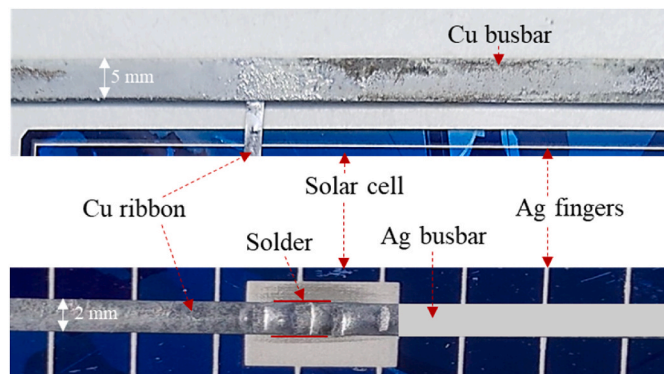
Fig. 2. Components of the field-aged PV module extracted for the SEM-EDS analysis.

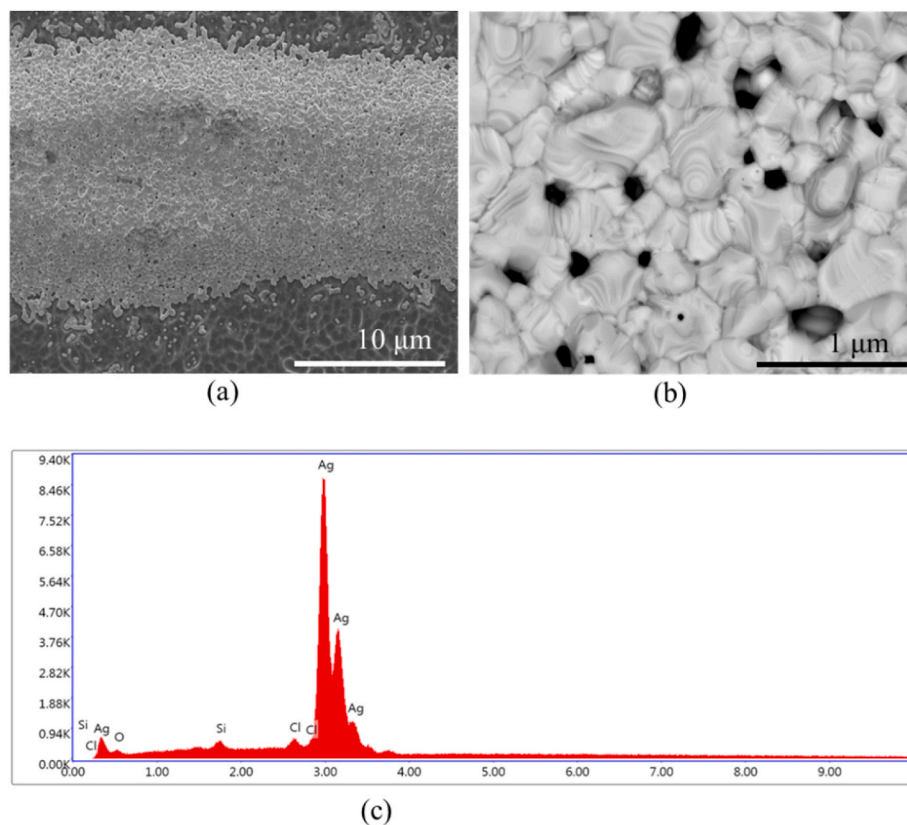
Fig. 13. (a)–(b) SEM micrographs of the Ag finger grid on a newly acquired commercial multicrystalline silicon solar cell and (c) EDS spectra of (b).

impurity Cl and O in Fig. 13c comes from the silicon production process.
